# Maintenance alerts

## A selection of defect reports from overseas operators.

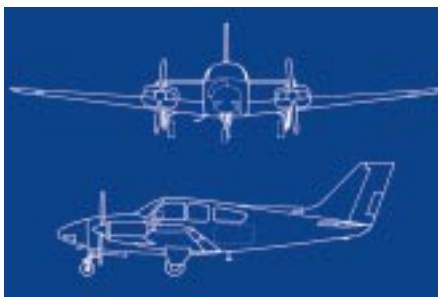
During a scheduled inspection, technicians discovered severe corrosion on the right wing spar cap.

The corrosion progressed to the point of exfoliation and disintegration of the metal. The damage penetrated the entire thickness of the wing spar cap (P/N 95-110022-4). The affected area started at wing station 70 and continued outboard approximately 8 inches.

The corrosion compromised the spar cap to the point that it would hardly bear its own weight, and wing failure was imminent.

Older and high-time aircraft deserve your full attention to structural integrity during maintenance and inspections.

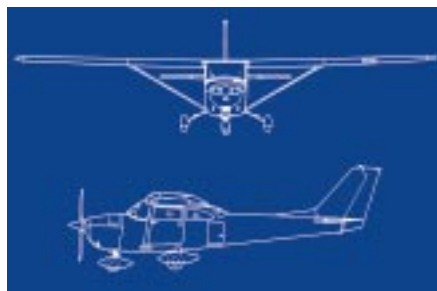
The technician noticed the elevator drooped to its full extent and no elevator movement occurred when he moved the control yoke in the cockpit.

An inspection revealed the control yoke had broken as a result of internal rust rendering the walls of the yoke paper thin. The rust caused the control yoke to break in a vertical portion of the control "U" between the pivot point and the elevator push-pull tube.

He stated that owners and operators of older aircraft should make notes of this problem and properly employ inspection techniques before an in-flight catastrophe occurs.

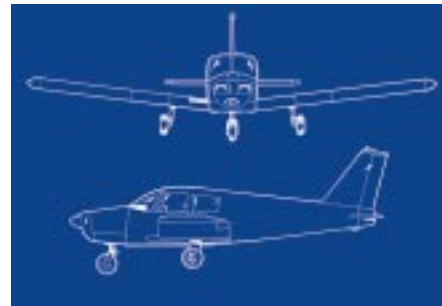
During the ground run-up, in preparation for an annual inspection, the right brake line blew out at the master cylinder connection point.

Since the date code on the hose was

December 1964, the hose was long overdue for replacement to avoid failure.

The submitter states owners will not regularly replace hoses unless there is a mandatory replacement time on all aircraft hoses, and he suggests that manufacturers set the guidelines.
