Air Safety Investigations

A most dramatic runway incursion

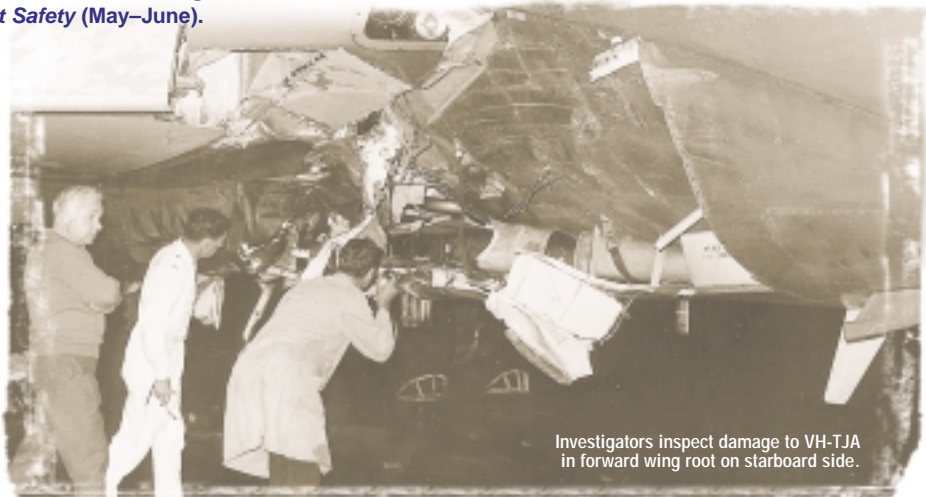
ON THE DARK and wet night of 29 January 1971 one of the closest calls to a total disaster for Australian skies took place at Sydney airport. A Boeing 727, VH-TJA, struck the tail fin of a DC8-63, Empress 301, during takeoff on runway 16.

Investigators inspect damage to VH-TJA in forward wing root on starboard side.

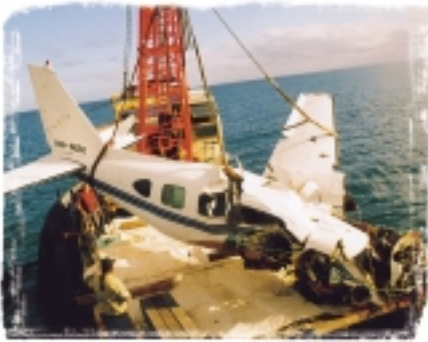
ATSB investigators supervising the disassembly of the aircraft engines at an aerospace engineering facility found significant mechanical damage to both engines. Damage to the left engine included the failure of a connecting rod, together with a broken crankshaft. In the right engine, a piston had suffered significant damage.
