Maintenance alerts

TPE331-12 Engine: Reduction gear

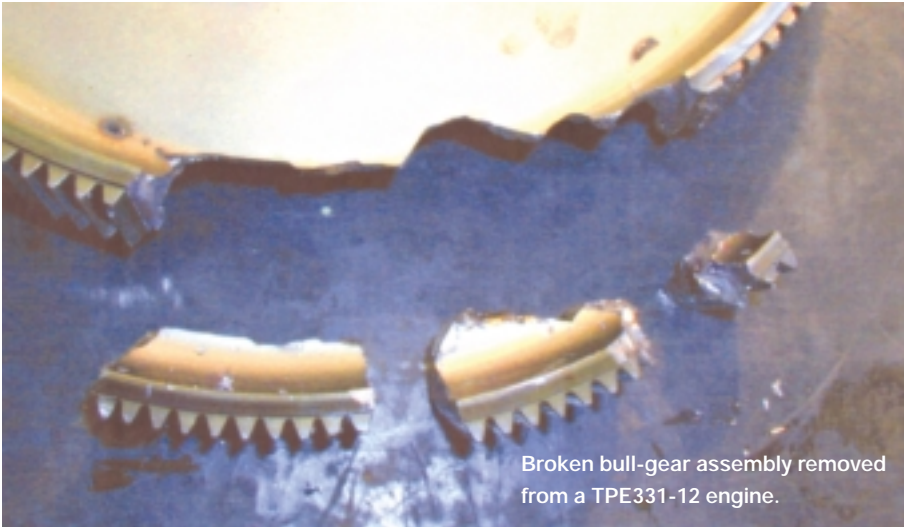
Broken bull-gear assembly removed from a TPE331-12 engine.

Disassembly of the engine reduction gearbox revealed that the in-flight shut down resulted from the failure of the gearbox sun/bull-gear assembly. Approximately 12 per cent of the bullgear rim had separated from the bull gear. There was significant secondary damage evident inside the gearbox. However, the failure was contained inside the gearbox housing.

However, the SOAP sample taken from the failed engine three, hours before failure, did not detect abnormal oil system contamination level. The engine manufacturer has requested access to the failed gearbox to identify the cause of the failure.

CASA issued AD/TPE331/55 (currently Amendment 1) in December 2000 to require oil system monitoring of TPE331-12 engines by spectrometric oil analysis (SOAP) and oil filter sampling in accordance with Honeywell Service Bulletin TPE331-A79-0034. The directive was issued in response to FAA advice of several bull gear failures as of late November 2000. Four of these failures had not been contained within the gearbox housing. One had resulted in bull gear fragments penetrating the aircraft fuselage and lodging in the opposite cabin wall. Fortunately no one was injured on board the Jetstream 3200.

Considering the serious nature of the failure CASA is currently considering several preventive actions. In the mean time, operators of TPE331-12 engines should closely monitor their engines for any sign of failure.
