# The Australian Air Safety

## Main landing gear door separation

Occurrence 200105518

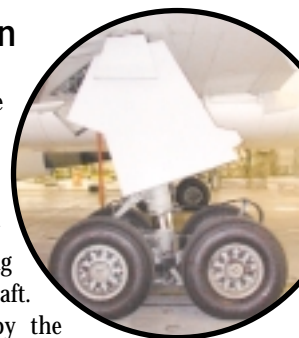
**D**URING the approach, and while below the maximum limit speed of 270 Kts, the flight crew of the Boeing 767 aircraft lowered the landing gear to assist in speed reduction. After a normal landing at Darwin, the crew was informed by a maintenance engineer that the right main landing gear (MLG) strut door had separated from the aircraft. Although an extensive search was conducted by the operator's maintenance staff, the separated door and some attachment fittings were not recovered.

A subsequent examination of the remaining MLG shock strut door attachment fittings revealed that they all showed fractures characteristic of rapid overloading, and were damaged as a result of the door separation but had not contributed to the initial failure sequence.

**Safety action:** As a result of this occurrence, the operator raised an Engineering Instruction (EI), EI-767-032-0102 Rev 0, to immediately inspect all B767 MLG shock strut doors and check the torque values of the door attaching hardware. All of the operator's B767 aircraft were subsequently checked between 23 November 2001 and 8 December 2001. The inspection revealed that a number of MLG shock strut door mounting bolts were found to be below the required Aircraft Maintenance Manual (AMM) torque value and were retorqued to the correct value. As a result of the EI inspection, the operator subsequently issued a revised EI (EI-767-032-0102 Rev 1) requiring that the inspection be conducted on a regular basis; every 3 months.

As a result of reports of loose or fractured MLG shock strut door attach bolts, the aircraft manufacturer developed an engineering change to prevent the MLG shock strut door attach bolts from loosening and indicated that a Service Bulletin to incorporate those changes would be released in the second quarter of 2002.
