Tragic lessons

The final investigation report on the crash of Alaska Airlines Flight 261 finds fault with maintenance procedures and design.

Martin Aubury

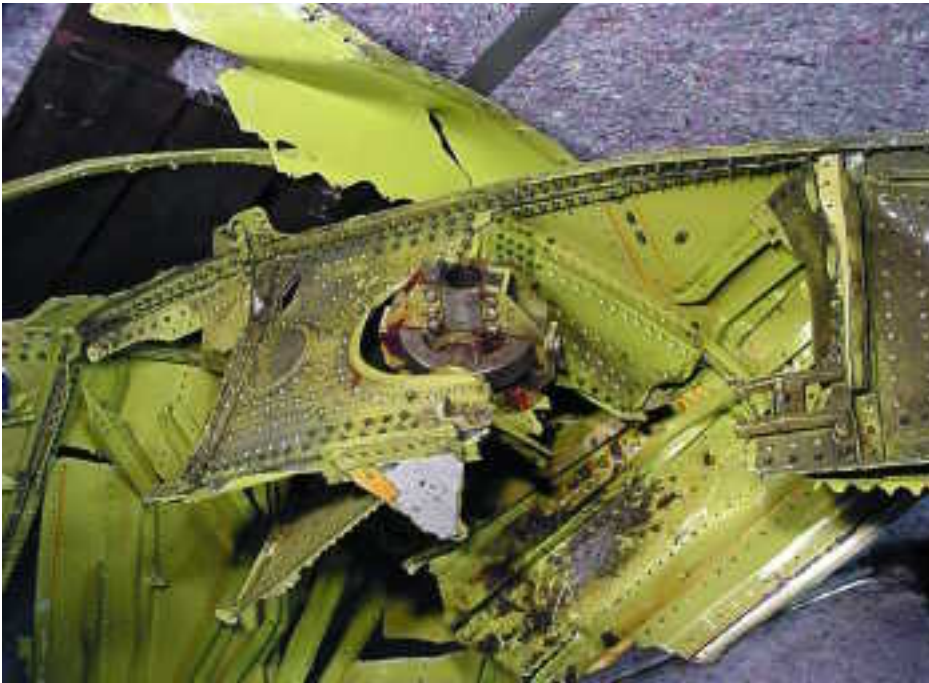
Threads in the gimbal nut had sheared off and remnants were found as spirals wrapped around the jackscrew. There was no lubricant on the jackscrew. An end stop on the jackscrew assembly did not prevent the jackscrew from sliding out of the gimbal nut, nor was it designed to do so once the threads had stripped. There was no mechanical back-up restraint or stop.

Investigation determined that threads in the gimbal nut were worn badly before the accident. During the accident sequence the threads initially jammed in the screw. It is deduced that the crew’s efforts to free the jam caused the threads to shear off completely.

Gimbal nut from Flight 261, shown attached to the front spar of the fin.

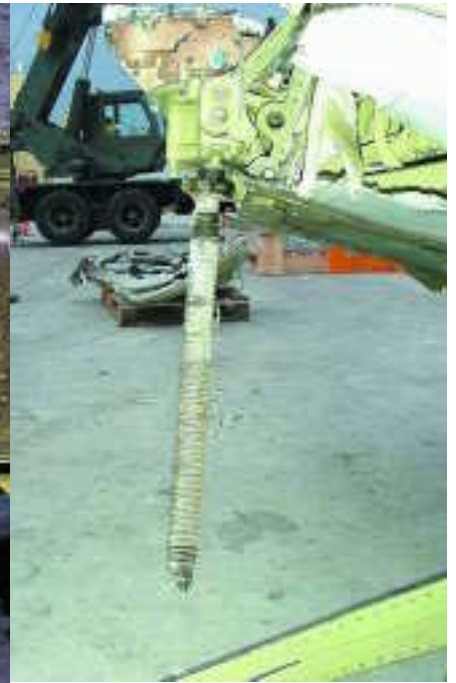
The jackscrew from the horizontal stabiliser of Alaska Airlines flight 261, recovered from main wreckage site.
