Maintenance alerts

Turbine engines

Aileron directive

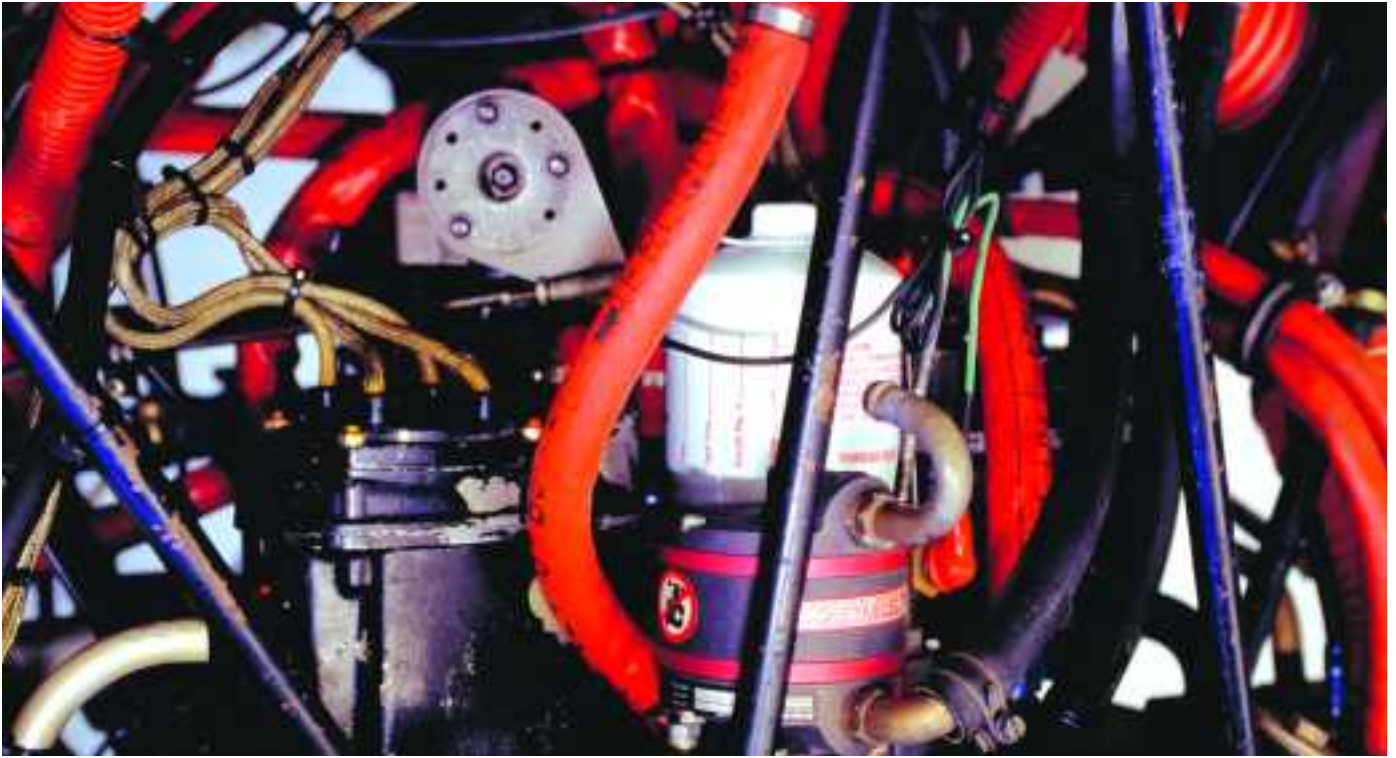
Investigation of the uncontained turbine failure found the second stage turbine wheel had fractured across the wheel web because of low cycle fatigue.

While the wheel had an accurately recorded 2034 engine cycles in service out of a published life limit of 5400 cycles, the engine had been involved in multiple

take-offs and landings between each engine start and shut down. With a revised cycle count, as detailed in SB TPE331-A72-2111, the failed wheel was found to have 17,085 cycles.

Maintainers are required to review aircraft and engine records to establish whether their installed turbine wheels could be affected. If so, they must calculate equivalent and total equivalent turbine wheel cycles based on the number of aircraft take-off and landings per engine cycle. Any turbine wheels that exceed the revised cycle count must be taken out of service.

If there are no records of the number of take-offs and landings per engine cycle before the effective date of the airworthiness directive, a ratio of six take-offs and landings per engine major cycle should be used to determine equivalent cycles and total equivalent cycles.
