Hidden hazard

A patch on a China Airlines jet might have concealed a fatal flaw that killed 225 people. Martin Aubury reports.

ON MAY 25, 2002, at 1528 local time, China Airlines Flight CI 611, a Boeing 747-200 (B18255), crashed soon after takeoff from Chiang Kai-Shek International Airport, Taipei, Taiwan, en route to Hong Kong.

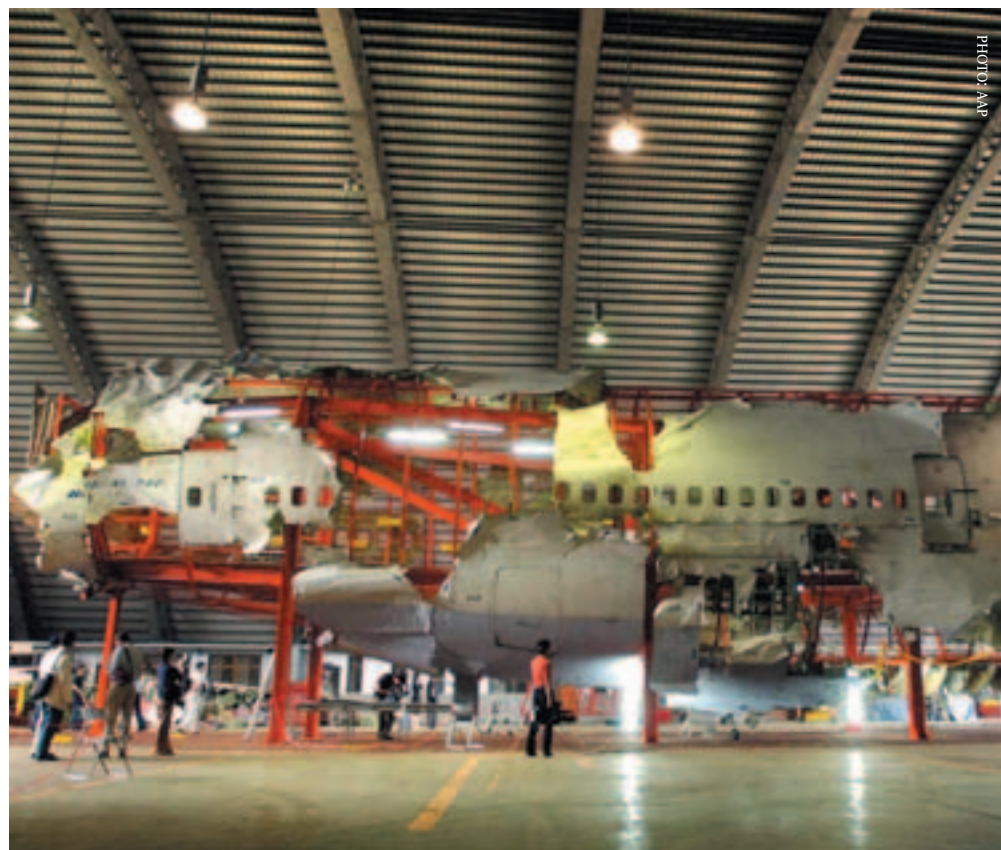
Out of more than 1,400 pieces of wreckage, investigators have focused on item #640. It is the part of the fuselage damaged and repaired in 1980, a large piece of skin panel from the very bottom of the fuselage between Body Station STA 1920 (inches) and STA 2181, and from Stringer 49 left to Stringer 23 right. On the inside of the skin, most of the stringers are still attached. On the outside of the skin there is a repair doubler patch from STA 2060 to STA 2180

Along the lengthwise edge of item #640 just above S-49L there are several fatigue cracks, the longest about 380mm. They are underneath the repair doubler and follow the outermost row of rivets. These cracks evidently existed before the fatal accident. The rest of the periphery of this piece of skin was torn from the adjacent structure during the break-up.

- many scratches on the fuselage skin beneath the repair patch, metal rubbing and widespread fatigue crack growth
- fatigue cracks at multiple sites in the skin, mainly tracing the scratches where they correspond to the outermost row of rivets through the patch
- 1,765mm (total end-to-end length) of multiple site fatigue cracks, covered by the patch, including a critical 645mm length in the fuselage skin below one edge of the patch. 383mm of this crack is continuous and penetrates the skin.

Reconstruction Investigators piece together fragments of Flight 611.
