CRACK ATTACK

It is two years since Ansett Australia's last flight. Mark Wolff and Martin Aubury report on the lessons learnt from the airline's collapse.

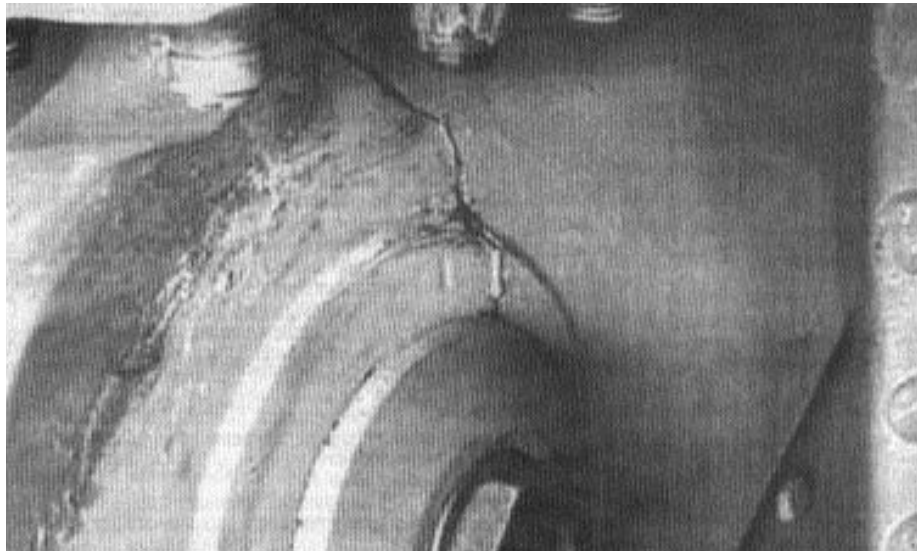
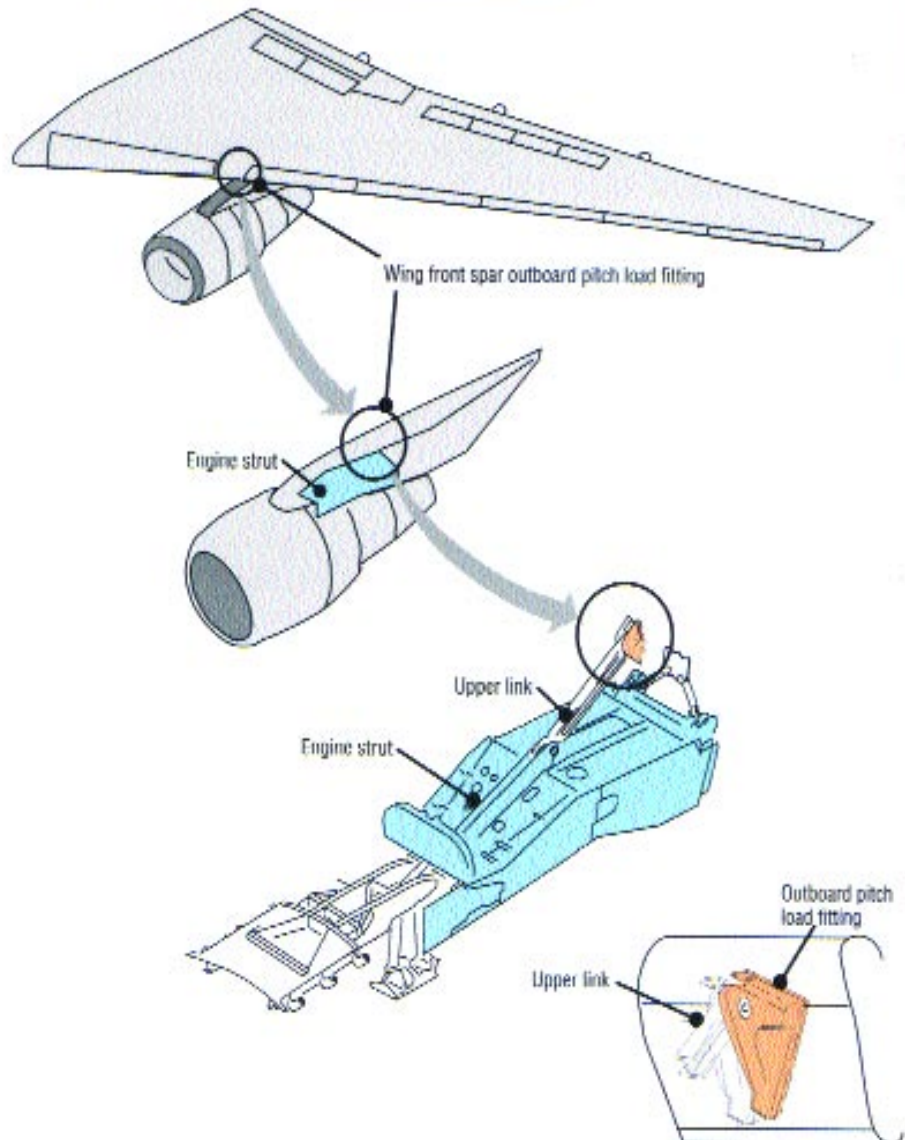
Critical condition Fatigue crack in an Ansett B767 wing front spar outboard pitch load fitting. Location of the fitting (below).

On April 10, 2001 inspections of seven Ansett 767-200s covered by the Boeing engine pylon SB of March 2000 revealed that three aircraft had cracks in the pylons which required grounding and repair. A fourth 767 was quickly repaired and returned to service.
