FATAL NIGHT FLIGHT

An investigation report on a 2003 air ambulance accident that cost three lives highlights the hazards of night VFR flying.

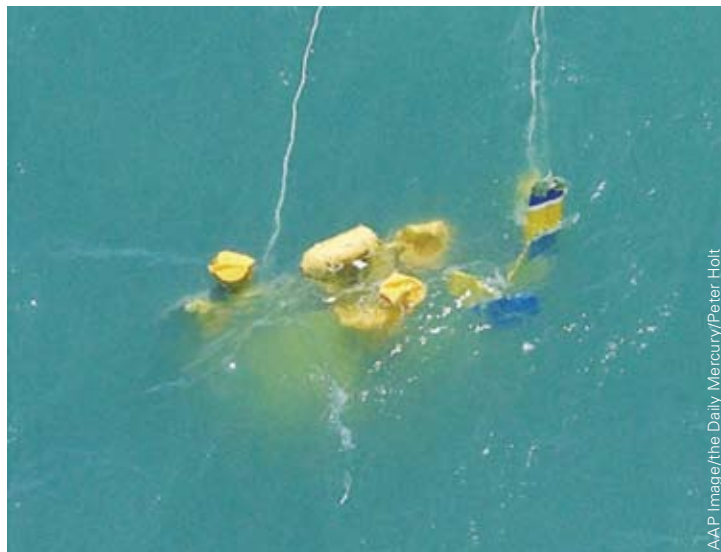
Flotation devices attached to the helicopter wreckage assist recovery.

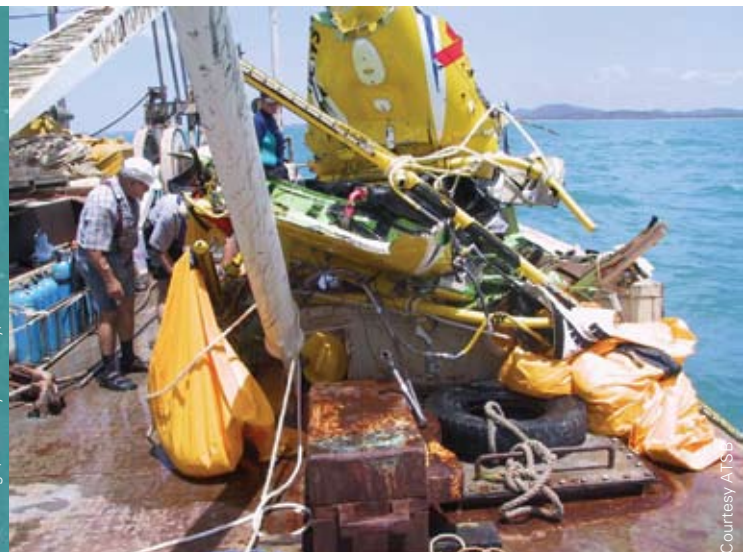
Main parts of the wreckage are hauled aboard the recovery vessel.

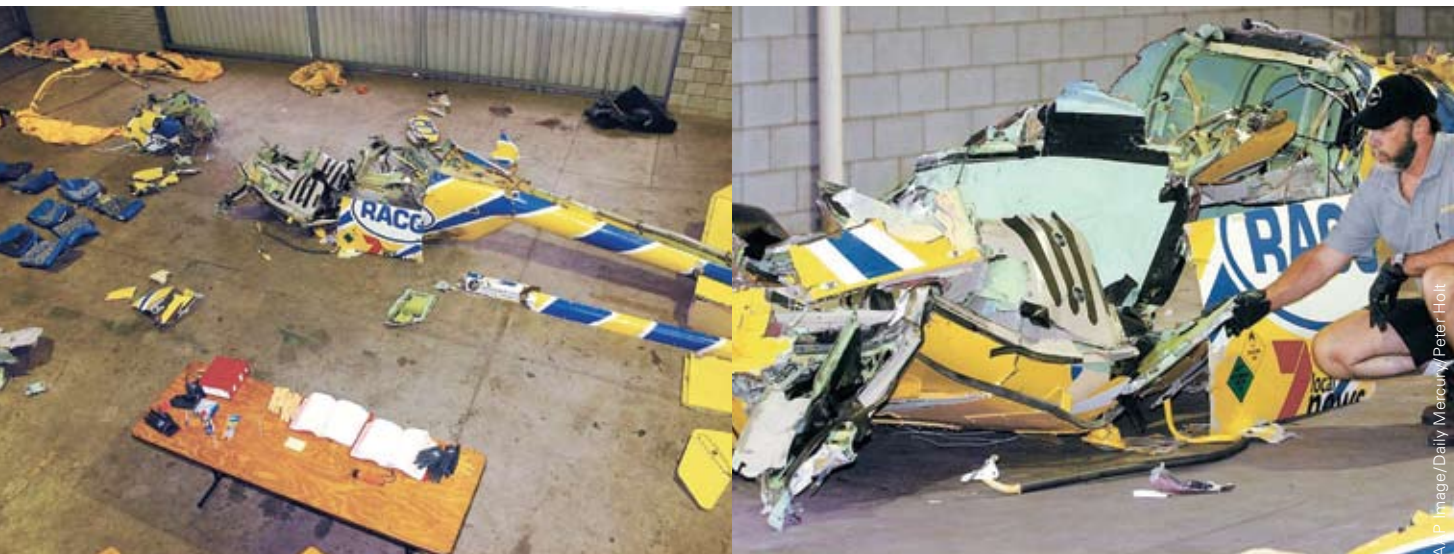
ATSB investigators piece the wreckage together.

Senior air safety investigator, Sam Webb, looks over recovered parts.
