Australian Transport Safety Bureau

The Australian Air

Crash after takeoff at El Questro, Western Australia

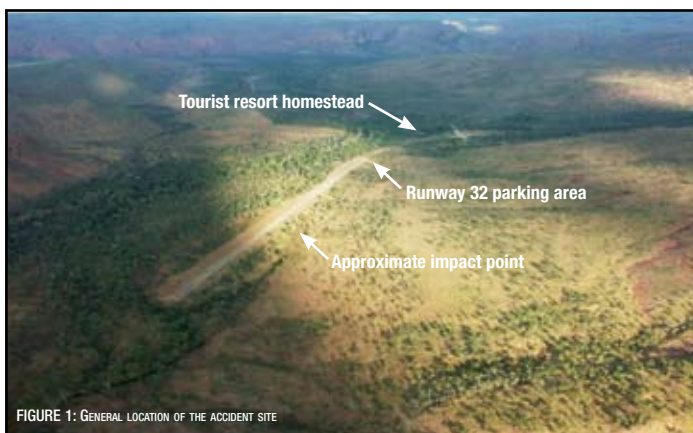
The aircraft came to rest about 106 m left of and abeam of a point about 888 m from the runway threshold. The general

location of the accident site is depicted at Figure 1. A severe post-impact fire consumed the majority of the aircraft and damaged the left engine. The right engine separated from the aircraft during the impact sequence and was located about 26 m from the main wreckage.
