APPROVED AIRWORTHINESS DIRECTIVES 21 DECEMBER 2006**Part 39-105 - Lighter Than Air**

SELECTED SERVICE DIFFICULTY REPORTS NOVEMBER-DECEMBER 2006

SERVICE DIFFICULTY REPORTS

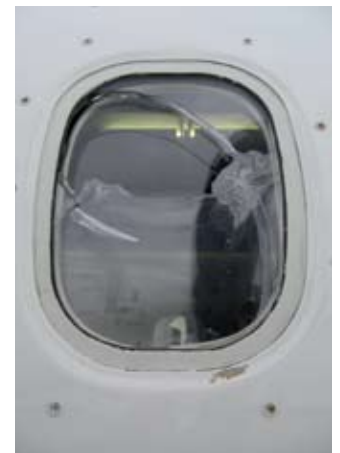
Bombardier DHC8102 Passenger compartment window cracked. Ref 510003582

Cabin window located at seat 2CD cracked. Failure happened during severe icing condition which caused airframe vibrations. (1 similar occurrence)

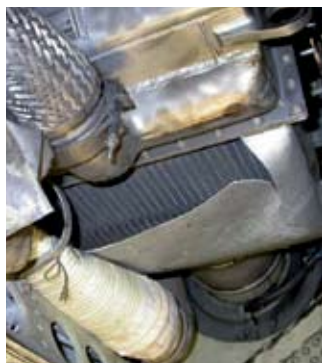
No 2 air conditioning system heat exchanger split.

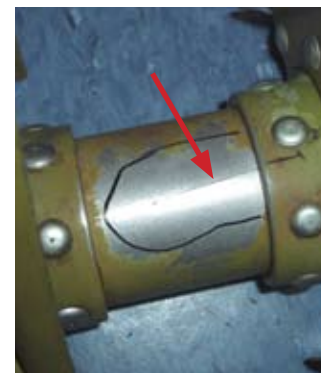
Piper PA34220T Rudder torque tube corroded. Ref 510003593

Rudder torque tube corroded under paint at steel fitting. P/No: 96319802. TSN: 3369 hours/63 months.

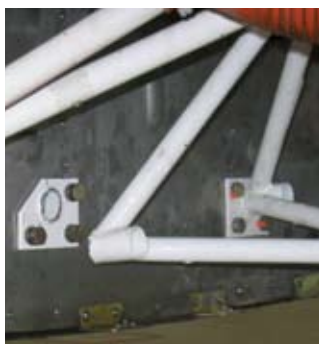
Socata TB10 Nose landing gear support frame cracked.**Ref 510003797**

Nose landing gear support frame broken away from firewall at lower RH attachment point.
