Australian Transport Safety Bureau

Safety **briefs**

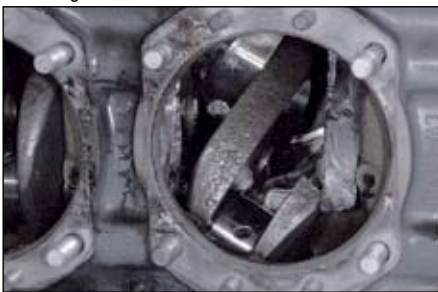
During a flight from Essendon to Armidale, the left engine of a Piper PA31P-350 (VH-IGW) failed during cruise at 17,000 feet. An engine examination revealed that the crankshaft had fractured in two locations: through the web between the No. 4 main bearing journal and the No. 4 connecting rod journal; and through the web between the No. 3 main bearing journal and No. 3 connecting rod journal. It is evident that rubbing contact between the main bearing insert and the No. 4 main bearing journal fillet radius initiated surface damage, which created the multiple fractures of the crankshaft and the subsequent engine failure. The factors that contributed to this event may be related to the retention of the main bearing insert in its housing and the crankshaft loading conditions that act to displace the bearing insert from its location in the bearing housing.

Photograph showing the fractured section of the crankshaft in the position found during initial engine examination

The movement of main bearing inserts during engine operation is a function of the magnitude of the forces that resist movement (created by establishing an interference fit) and the magnitude of forces acting to move the insert (crankshaft bending moments).

One factor that lowers the resistance of an insert to movement, the inclusion of material between the parting faces of the main bearing housings during engine assembly, was identified. However, other factors that may contribute to bearing insert movement, such as the magnitude of crankshaft bending moments, could not be established from an examination of the physical evidence.

The restoration of the surfaces of the main bearing housings indicated that main bearing insert movement was not an isolated case. ■

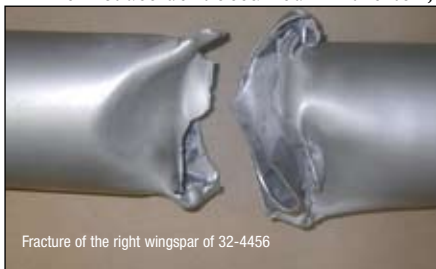
In all three accidents, the failure of the main wingspars (Airborne Edge design) had occurred near the wingtip. Qualitative analysis of the structural design and loading of the part during this safety investigation and the examination of the coronial findings from the Hexham accident, revealed that the main wingspar had failed under negative G loading. Such loading was likely if the aircraft entered or encountered flight conditions outside of the manufacturer's specified flight envelope. Examination of material characteristics of the failed wingspars did not show evidence of material deficiencies that could have contributed to these accidents.

In addition, examination of the propeller assembly from 32-4388 and the canopy material from 32-4456 indicated that the failure of these components was unlikely to have contributed to the accidents. ■
