## ALTERNATOR ALERT

His standard was quite high, but his previous 200 hours had been flying a parachute plane, so he had a tendency to rush the checks

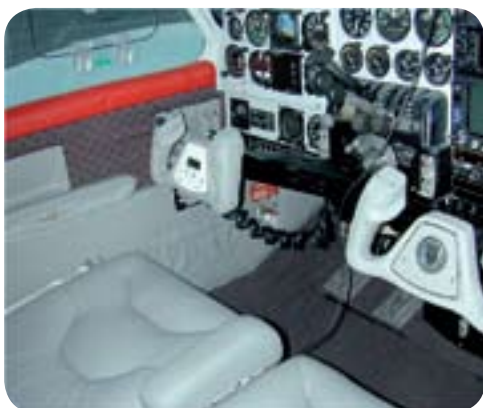
The first error happened at start-up: the previous student had left the alternators on. There were no markings indicating the position of the alternator switch, and this was not picked up. So, during our start, the switches were placed from 'on' to 'off' instead of the other way around

Moments later, we discovered that the alternators were in the off position. We turned them on which triggered the radios, navs, altimeter and autopilot back on line. Problem solved. The battery had powered the electronics until it began to deplete, and then as it ran out of charge, these systems had started falling offline, one by one. We continued circling while we reset the aircraft up before continuing to Tamworth to conduct the ILS and VOR approach. The remainder of the flight onto Bankstown went smoothly.

The errors then compounded. We missed checking the alternators after start, in the run ups, and in the rolling phase – standard operating procedures for our company. Another major error occurred while we were scanning the cockpit trying to identify the problem, and didn't notice that the primary altimeter had gone offline. This one could have cost us our lives. We didn't see the big picture; too busy trying to solve the immediate problem.

This Baron 55 was new to our fleet. My previous flying had been in the Baron 58, which has slightly different alternator warnings. There, with the alternator switches on or off, and no charge coming through, the warning light positioned right in your scan lights up. In the B-55, the alternators need to be turned *on*, *and* not producing any charge for the warning lights to come on. If we had made the same mistake in the B-58, the warning lights would have been illuminated.

After our debrief, I sat down with the chief flying instructor of the organisation and went through the events of the flight. He made some good points about teachers becoming complacent when they're sitting in the right-hand seat. He also stressed that every aircraft is different: as instructors, it's our responsibility to make sure we are familiar with every system, and how all the instruments are powered and sourced.
