Australian Transport Safety Bureau

Aviation Safety Investigator

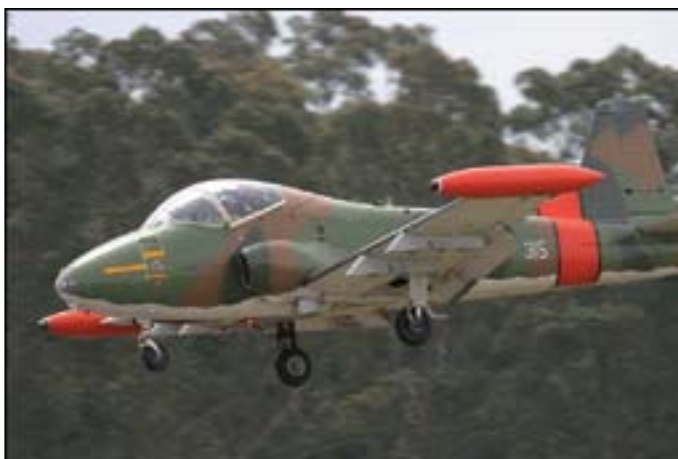
The aircraft wreckage was located on the north-eastern side of the Woolpacks feature and in the valley floor, distributed over about 800 m of sloping, treed, terrain. The main wreckage, which consisted of the fuselage, engine and left wing, was located about halfway up the north-eastern side

of the Woolpacks feature, and was mostly destroyed by impact forces and the subsequent post-impact fires. Witness marks on trees in the vicinity of the main wreckage indicated a downward impact angle of about 50 degrees. Other items of wreckage were damaged to varying degrees by impact with the ground and trees, and by the bushfire. The rudder mass balance weight, attached to part of the upper rudder, was the first item found in the wreckage trail, and was located about 120 m from other empennage items.

During the low-level simulated strike mission, the aircraft broke up in flight, with the right wing, tailplane, tail fin, elevators and rudder separating prior to impact with terrain. The available evidence was consistent with the break-up being initiated by the separation of the tail surfaces, with the rudder mass balance experiencing a vertical load that was sufficient to tear it off over the top of the rudder. It could not be conclusively determined from the wreckage what imparted the vertical load, however

With the loss of the rudder mass balance, the loads on the tail increased until it fractured and separated from the aircraft. The right wing, being weaker than the left due to fatigue cracks, subsequently fractured and separated from the aircraft. The engine was producing significant power at the time of impact and the wing flaps and landing gear were

As a result of this occurrence, the ATSB briefed the Civil Aviation Safety Authority (CASA) and the UK Civil Aviation Authority on findings relating to the separation of the wing and tail. CASA has released a number of Airworthiness Bulletins to alert Australian operators of issues relating to Strikemaster and Jet Provost aircraft. CASA has also approved the Australian Warbirds Association Limited to administer aircraft operating under the Limited Category. ■
