SELECTED SERVICE DIFFICULTY REPORTS

1 August 2008 –
30 September 2008

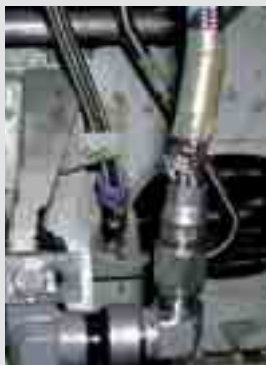
Airbus A321231 Landing gear door actuator pressure hose ruptured. **Ref 510006957 (photo below)**

RH main landing gear door actuator hydraulic pressure hose ruptured. Loss of hydraulic fluid.
P/No: AE2463921G0181. TSN: 20,554 hours/8,052 cycles.

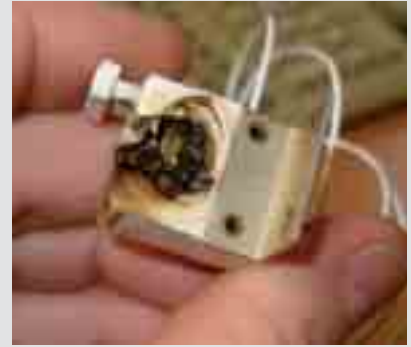
Saab SF340B Cabin fluorescent light fitting burnt. Ref 510006894 (photo below)

Cabin fluorescent light fitting burnt.
P/No: BV00330025.

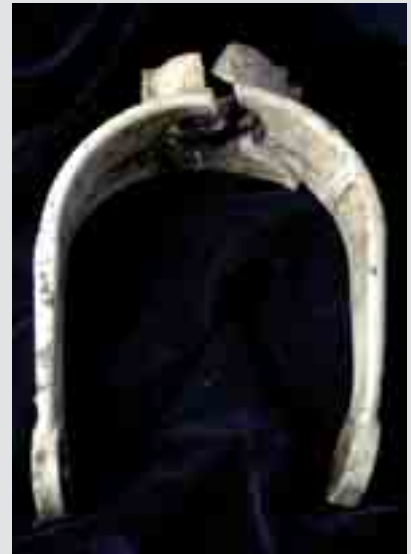
Cessna 152 NLG fork failed at oleo tube attachment bolt hole. Ref 510006935 (photo below)

Nose landing gear fork failed at oleo tube attachment bolt hole. Fork separated and nose landing gear contacted runway. Propeller strike and engine stoppage. Suspect caused by heavy landing.
P/No: 0442504201.
(1 similar occurrence)

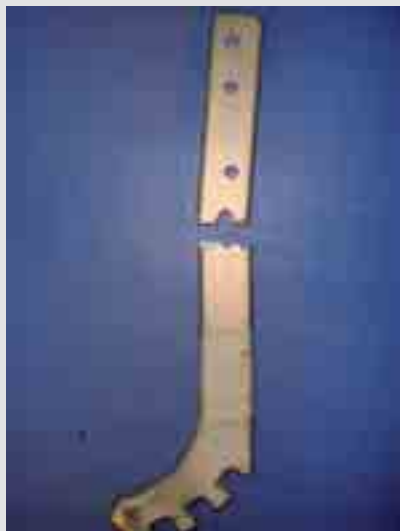
Cessna 172M Co-pilot's seat back adjustment cam broken. Ref 510007065 (photo below)
Co-pilot's seat back adjustment cam broken and separated from seat. See attachment for photograph.
P/No: 14142301. TSN: 6,790 hours.

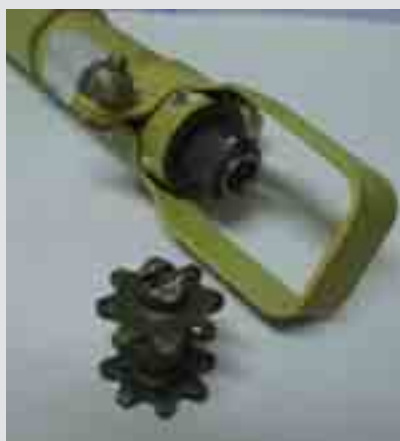
Cessna 182S Elevator trim jack drive gear failed. Ref 510006990 (photo below)
Elevator trim jack drive gear sheared through roll pin hole.
P/No: 12600747. TSN: 748 hours.

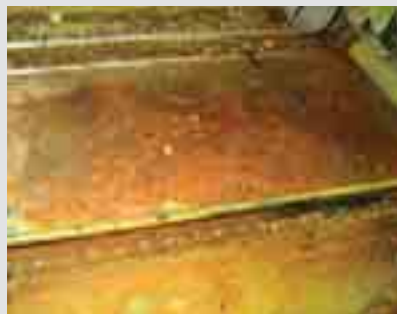
Gulfstream 500S Wing spar strap corroded – incorrect material. Ref 510006845 (photo below)
Wing spar strap corroded. Investigation found the strap was made of 4130 steel instead of 301 stainless steel. The strap was also found to be disbanded from the wing bottom skin. Found during inspection iaw AD/AC/87.

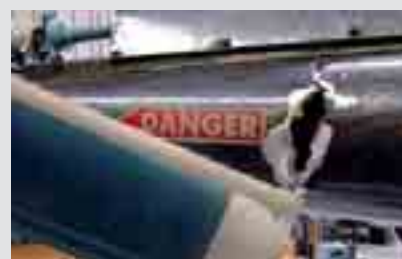
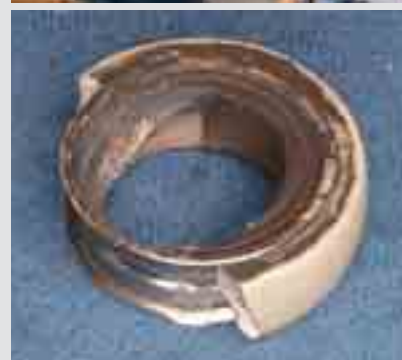
Bottom photo - pitch change link - Courtesy of the ATSB

Eurocopter AS350BA Tail rotor blade pitch change link failed. Ref 510007088 (photos below)
Tail rotor blade skin cracked and pitch change link broken. Tailcone departed aircraft. Tail rotor blade contacted tail boom. Suspect initial failure was pitch link failing at rodend bearing which caused excessive vibration. Investigation continuing.
P/No: 350A33-2145-01.

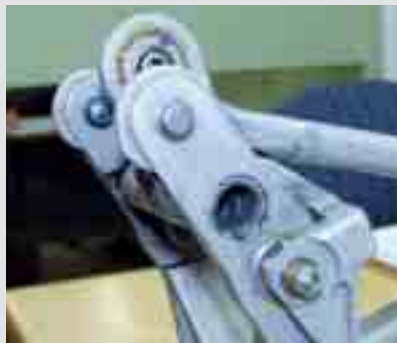
Main rotor servo feedback linkage drive pin cover missing. Investigation found that the drive pin had moved laterally and was sitting proud. A large amount of black powdery debris was also present. When the drive pin retaining bolt was removed, the bearing surface of the bolt was worn to approximately 0.762mm (0.030in) total bearing surface area. It was also noted that the bearing surface was the threaded part of the bolt and not the unthreaded section of the bolt. A ridge in the centre of the wear pattern was all that was retaining the drive pin.

TSN: 9,270 hours/49,553 landings/143 months. TSO: 1,212 hours/7,727 landings/19 months.
