Australian Transport Safety Bureau

Investigation briefs

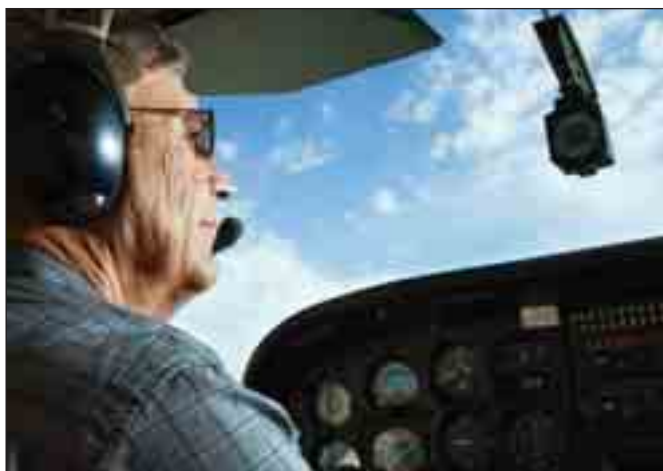
The ATSB examined recordings of the transmissions made on the Port Macquarie CTAF. That examination revealed that the pilot of the C152 commenced a departure broadcast, but was over-transmitted 2 seconds later by another broadcast from the pilot of the Foxbat, making both broadcasts almost incomprehensible. The pilot of the C152

A club instructor inspected the Foxbat's radio after engine shutdown and found that the radio volume was at a low setting. In addition, the pilot of the Foxbat advised the ATSB that he subsequently believed that there was an intermittent fault with the Foxbat's radio. While he had an awareness of the aerodrome frequency response unit's (AFRU) operation, the pilot had not fully considered the implications of a lack of response from the AFRU.

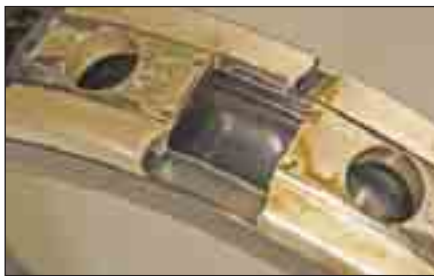
The examination found that the engine's number-5 bearing, the high pressure (HP) turbine disc and stub-shaft had failed. Those components were sent to the ATSB for further examination. That examination determined the number-5 bearing had failed at its roller cage through fatigue cracking, the stub-shaft had failed under overload and the HP turbine disc had suffered blade tip rubbing. Most of the cage pockets had been enlarged, with evidence of the rollers skewing and rotating up to 90 degrees within some pockets

The operator had experienced a previous number-5 bearing failure on another of its engines. That bearing displayed the same failure pattern of its roller cage and was consecutively serial numbered to the VH-TYQ engine's number-5 bearing.

The ATSB found that, while the precursors to roller instability could not be identified, early identification of number-5 bearing distress can reduce the likelihood of an in-flight engine failure. Both failed bearings had consecutive serial numbers and were possibly from the same manufacturing batch. As a result of this investigation, the engine manufacturer identified a batch of 15 bearings required replacement and introduced procedures to minimise the risk of further bearing failures. ■

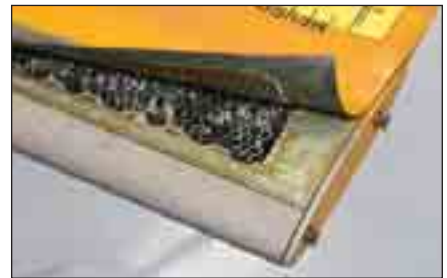
At approximately 1500 EST on 15 March 2007, a student helicopter pilot and accompanying flight instructor were conducting an instructional flight test in a Robinson Helicopter Company (RHC) model R22 Beta II helicopter, registered VH-HPI. They noted an unusual mechanical noise, followed by the onset of severe vibrations from the main rotor system. After immediately landing the helicopter, it was found that the skin from the underside of one main rotor blade had disbonded from the leading edge spar over a length of approximately 450 mm from the blade tip.

The skin separation was found to be associated with abrasion and loss of the rotor blade leading edge paint across the bond line between the skin and leading edge spar. Erosion along the bond line had produced an undercutting effect and a feathering of the skin edge. Associated with random voids and pores in the adhesive that filled the gap between skin and spar recess edges, it was probable that the erosion had produced localised stresses within the adhesive joint, promoting the lifting of the feathered edges and the subsequent peeling separation of the skin.

As a result of a number of similar failures in both R22 and R44 main rotor blades, the helicopter manufacturer published a series of safety alerts, service letters and service bulletins, recommending the regular inspection of the blades for evidence of skin disbonding and the refinishing of blades showing abrasion of the leading edge paint to, or beyond, the skin bond line. Airworthiness directives from the US Federal Aviation Administration and CASA subsequently mandated the initial and repeat inspection of R22 and R44 main rotor blades for this issue. ■
