SELECTED SERVICE DIFFICULTY REPORTS

1 June 2008 – 31 July 2008

AIRCRAFT ABOVE 5700KG

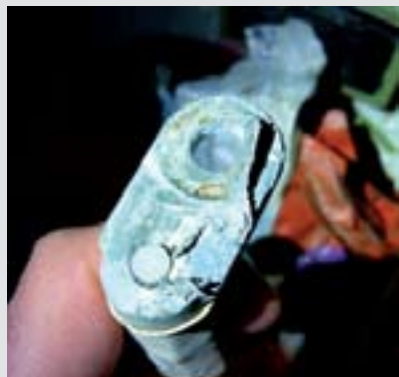
Boeing 717-200 Electrical power wiring connector corroded. Ref 510006768 (photo below)

LH generator feeder cable terminal T2 corroded at aft pressure bulkhead feed through terminal block S3-803. During replacement terminal stud T1 separated leading to complete replacement of the aft pressure bulkhead feed through terminal block S3-803 P/No CTB395-03-1.

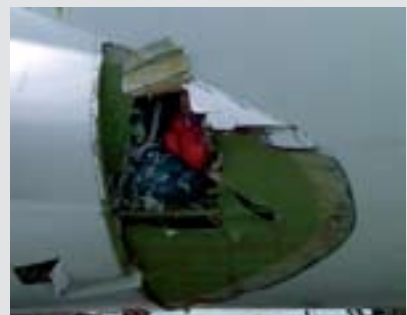
Boeing 747-438 Aircraft structures - damage. Ref 510006789 (photo below)

Aircraft damaged. Loud bang and aircraft jolted. Aircraft suffered depressurisation and numerous warning messages. Oxygen system problems. Emergency descent and emergency landing carried out. Crew found damage to the floor in the area of the R2 door and a large hole in the side of the fuselage. Investigation continuing.

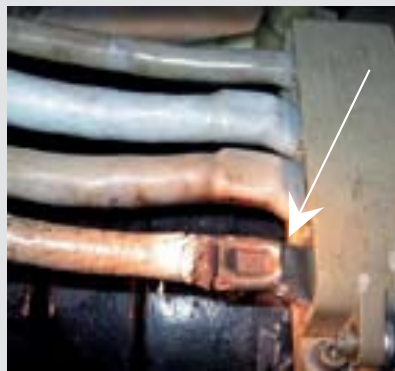
Boeing 767-338ER IDG cable burnt. Ref 510006666 (photo below)

RH integrated drive generator (IDG) feeder cables and terminals burnt. One IDG terminal stud was found to be loose. Investigation continuing.
P/No: BMS1358TY1CL1G0.

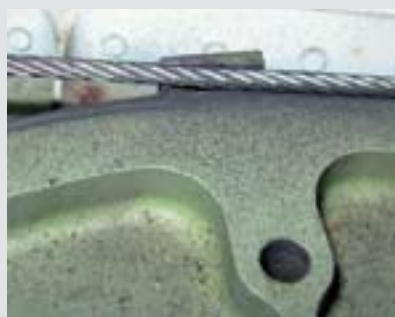
Bombardier DHC-8315 Aileron control system cable chafed wiring. Ref 510006740 (photo below)

Aileron control cable low tension. Cable chafing on cable guard assembly. Investigation continuing.

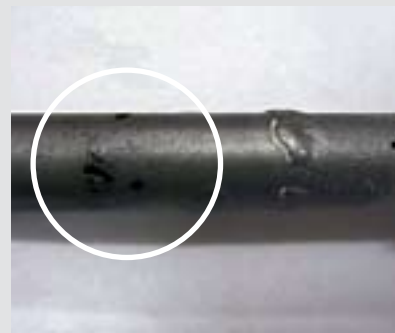
Cessna 441 Elevator trim tab actuating rod corroded/holed. Ref 510006582 (photo below)

Elevator trim tab actuating rods (Zoff) corroded and holed in numerous places. Holes approximately 0.762mm and 3.048mm (0.030in and 0.120in) in diameter. Investigation of the remaining two rods by X-ray found severe internal corrosion.

P/No: 571515823. TSN: 21,444 hours/16,447 cycles/16,447 landings

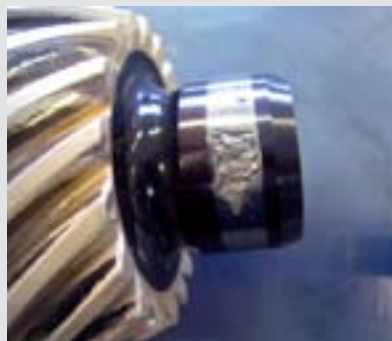
Bell 206L3 Main rotor transmission bearing failure. Ref 510006444 (photo below)

Main rotor transmission bearing failure. Investigation continuing.

P/No: 206040004101. TSN: 13,291 hours/TSO: 3,737 hours

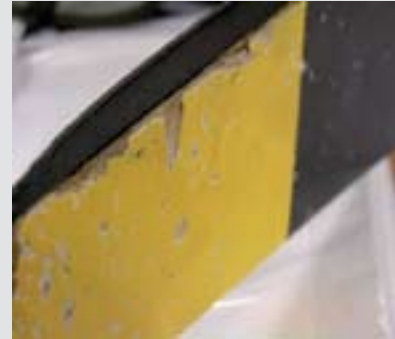
Woodcomp SR200 Propeller blade damaged. Ref 510006442 (photo below)

Propeller blade damaged in area on the leading edge located approximately 152.4mm (6in) from the tip. Investigation found the fibreglass had delaminated. Investigation also found significant corrosion and fretting in the area of the blade butts and propeller hub.
TSN: 336 hours
