AIRWORTHINESS BULLETIN

AWB 62-006 Issue 1 – 23 December 2016

Alert – R22 Main Rotor Blade cracking

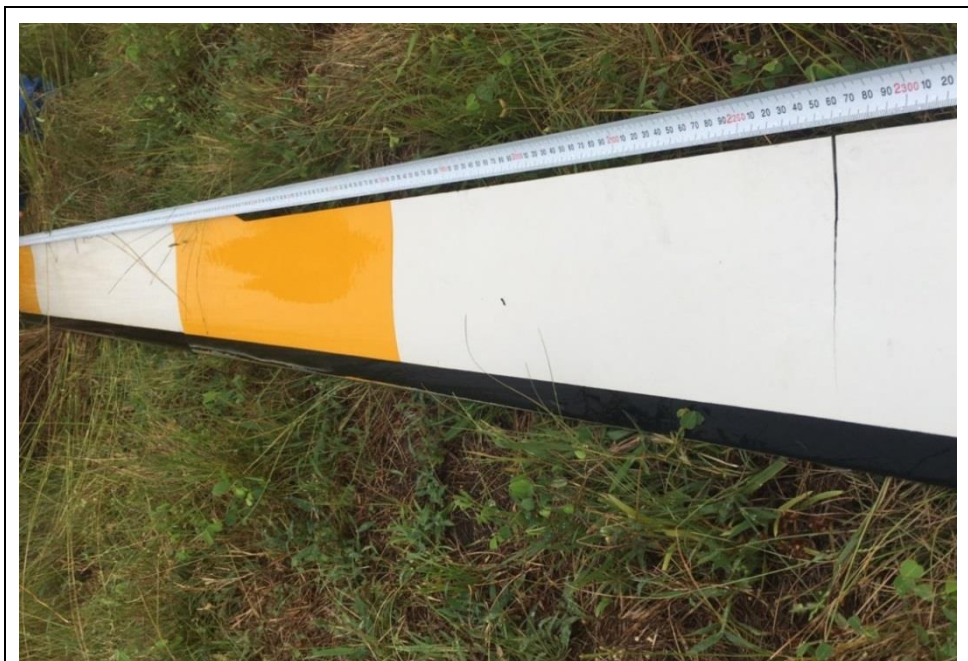
Figure 1 – Location of crack

During low level operations at slow airspeed the pilot of a Robinson R22 Beta II helicopter experienced an unusual increase in vibration levels and commenced a landing. Shortly before making a successful landing and whilst in the hover the pilot reported an increase in vertical vibration levels and a decrease in power available. Subsequent inspection revealed a crack approximately 160 mm in length emanating from the trailing edge and running chord wise toward the D section spar; refer to figure 1.

The crack location is in the vicinity of blade station RS61 which, measured from the blade tip (with tip cap removed) is approximately 2285mm inboard of the blade end.

Evidence of very minor corrosion was observed on the trailing edge in the vicinity of the crack. The operator reported that the total time in service of this blade was 1782.7 hours, the manufacturer stipulates a life limit of 2200 hours or 12 years for part number A016-6 Main Rotor blades.

The blade is currently being investigated by the ATSB however at this stage details are limited with the root cause yet to be determined.

CASA highly recommends that when carrying out the MR blade inspection required as part of the Daily or Preflight checks contained in the Robinson R22 Pilot's Operating Handbook (POH) particular attention should be directed to the MR blade trailing edges.

This inspection may provide more reliable results by conducting the inspection on the white upper surface of the blades due to colour contrast.
