AIRWORTHINESS BULLETIN

AWB 22-002 Issue 3 – 5 August 2016

AW139 Inadvertent Autopilot Disengagement

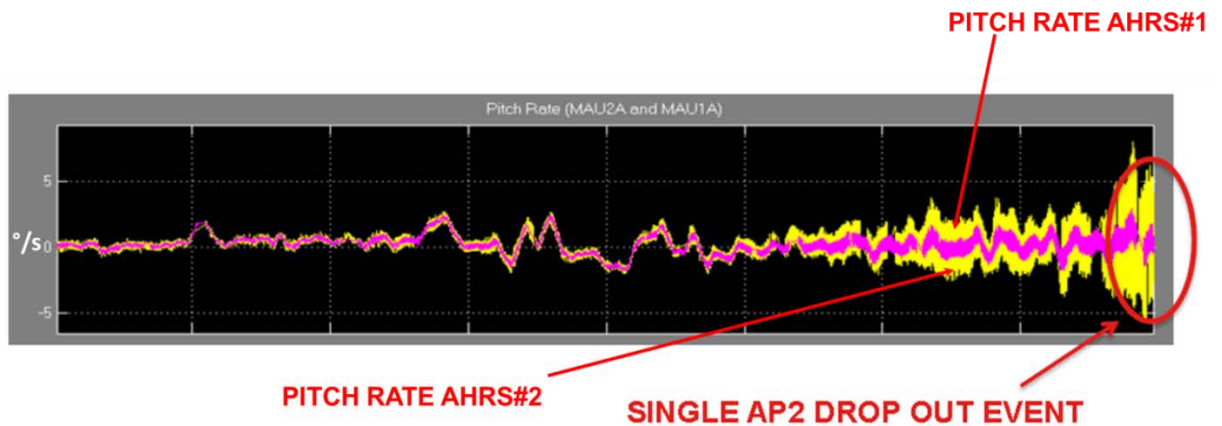
Figure 1 – Pitch rate vibration

In the case shown in Figure 1 AHRs#1 pitch rate magenta trace has experienced a much lower amplitude of approximately $\pm 1^\circ$ per second and did not cause an AFCS disconnect. In comparison the yellow trace of the pitch rate of AHRs#2 caused a disconnect event with excess of more than $\pm 5^\circ$ per second. AHRs#2 is more prone to AFCS disengagement.

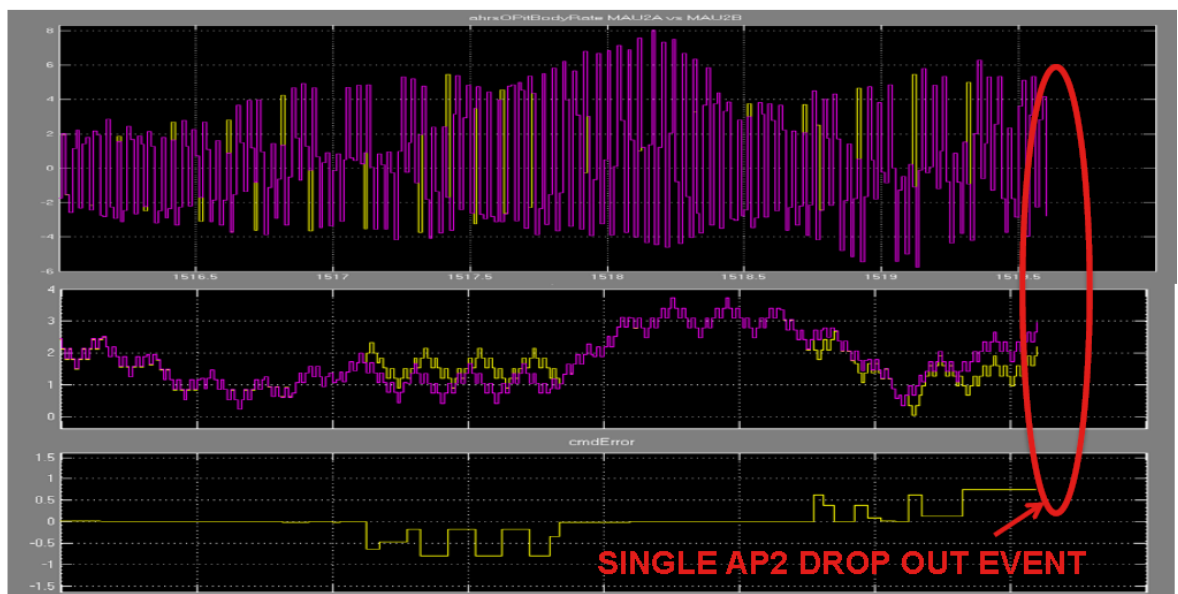
Figure 2 - Periodic splits in data reads between lanes

Figure 2 shows difference between each lane of pitch rate in the AHRs. The top trace shows noisy pitch rate data where periodic splits in data read occur between lanes. The centre trace shows how the commands in each lane react to the split in the data reads. The bottom trace shows the command error that builds up and eventually causes the command calculation comparison monitor to disconnect the AFCS channel.
