Beech B200/300.

To alert operators of Beech B200/300 aircraft of the potential for inverter wiring damage that may lead to a fire in the inboard wing.

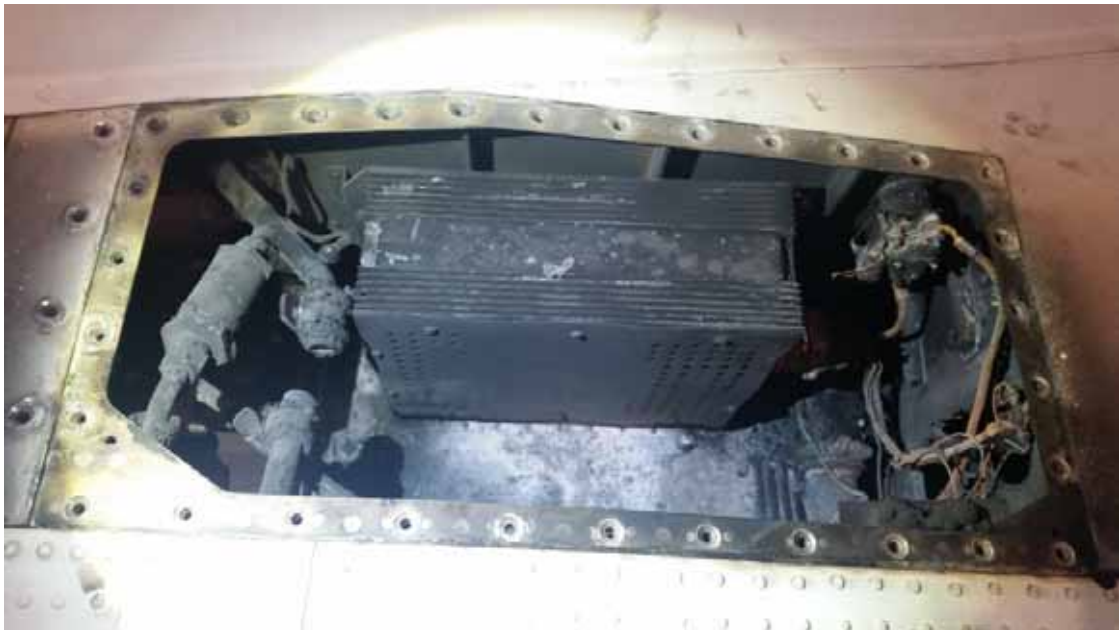
Figure 1 – Inverter location

The cavity (Figure 1) that the inverter is mounted in is a confined area between the main and aft spars, outboard of the port engine nacelle. Significant fire/heat damage occurred to critical aircraft structure requiring extensive repair. Detailed examination of the fire zone identified the most probable seat of the fire as being the rear panel of the inverter cavity, on which the main DC contactor and earth stud were mounted (Figure 2). This area showed extensive fire damage and, of particular interest, was electric arc damage (circled) behind the DC input wire. Figure 3 shows the damage to the DC input wire adjacent to the site of the arc damage which has evidence of the melting of the copper wire consistent with the length of the arc damaged area.

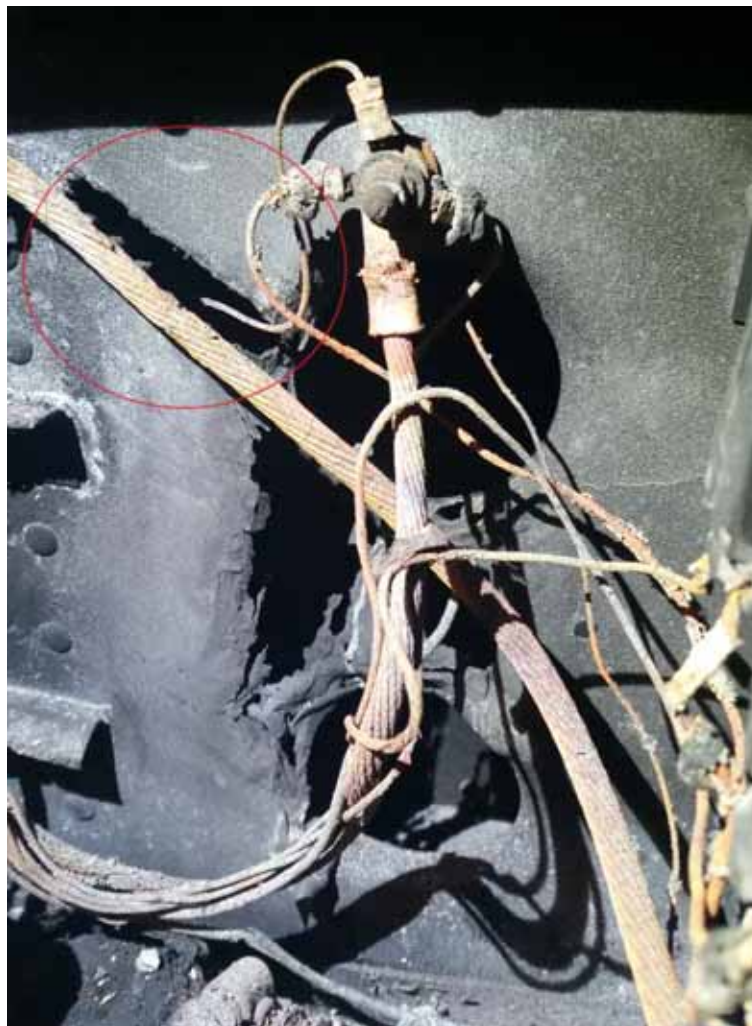
Figure 2 – Arc / fire damage to aircraft structure

There is strong evidence that the arcing of the inverter DC input cable did not draw sufficient current to cause the 50 amp fusible link to fail. This is possible if the contact between the power wire and metal structure is intermittent and the aluminium structure vaporised due to arcing. Either the electrical arc or the molten metal generated would be hot enough to ignite either fuel or fuel vapour in the cavity.

The most obvious contributing factor to this incident appears to be the arcing from the DC input wire. This was probably caused by the wire chafing against the aircraft structure over an extended period of time. Further evidence has been found confirming that chafing had occurred in other locations.

B200/300 operators should inspect the aircraft wiring and installation, particularly those associated with the inverters to identify any chafing. If evidence of chafing is found, consideration should be given to raising a modification to introduce wiring standoffs, re-routing or renewal of the wiring to eliminate the potentially unsafe conditions that allow chafing to occur.

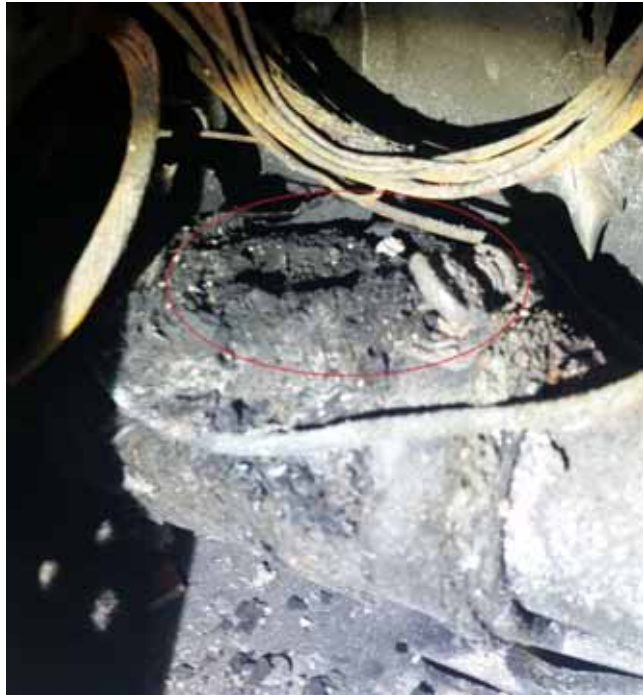
Figure 4 – Fuel line flexible coupler

Figure 4 shows the main fuel line flexible coupler directly below this arc damaged area. There is evidence of fire damage to the top of the coupler.

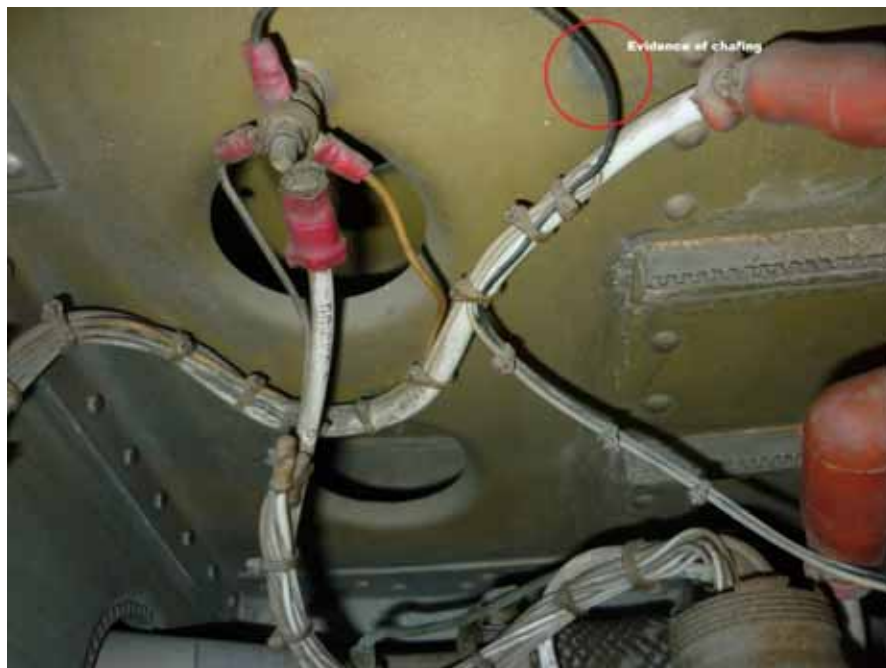
Figure 5 – Wire routing for starboard inverter.

As a comparison, Figure 5 shows that the starboard inverter input line which is routed differently having some evidence of chafing on the structure from an earth wire
