Beechcraft Duchess Model B76 Series aeroplanes

Beechcraft Duchess B76 Series
Control Column Pivot Failures

AWB 53-009 **Issue** : 1
Date : 29 January 2016

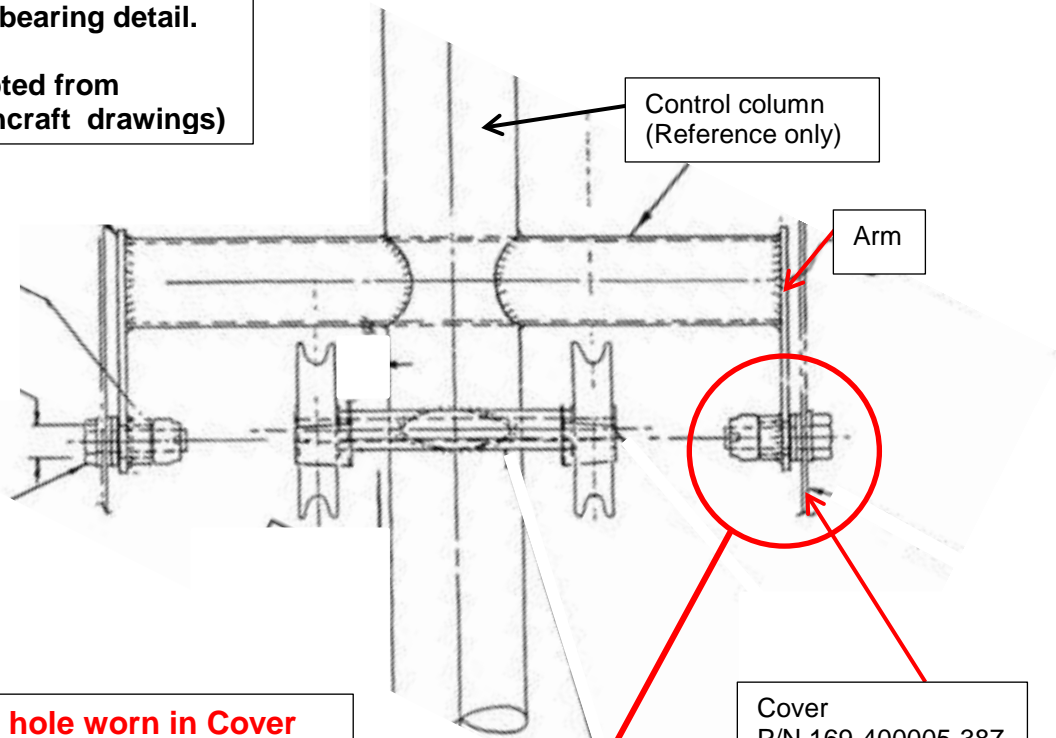
Figure 2a.

**Control Column &
Pivot bearing detail.**

The column is designed to rotate about two bushings (Figure 1 Item 21) which should be tightly clamped against the cover assembly by the bolts (Figure 1 Item 20). The bushes should be slightly longer than, and move freely within the welded tube bushing housings in the control column arms.

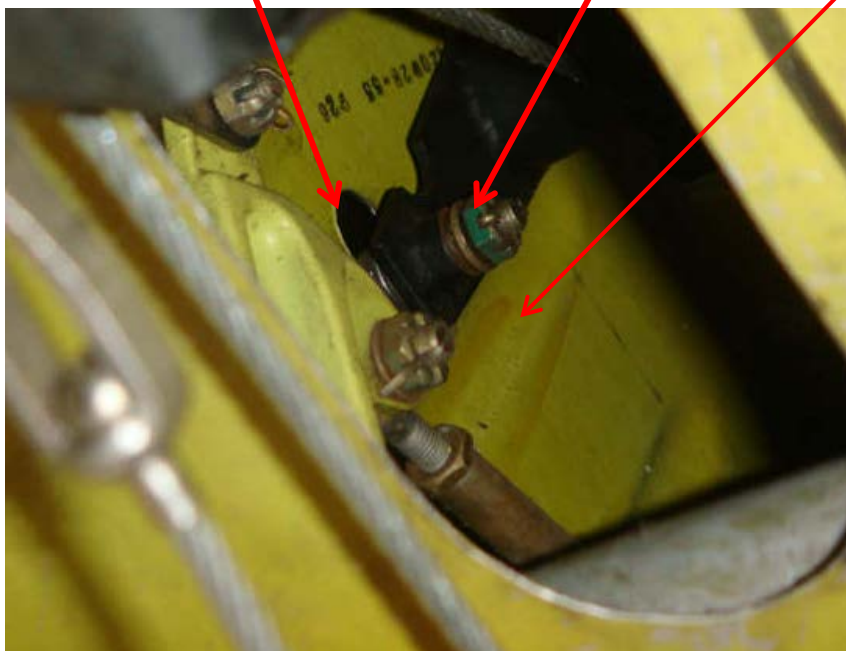
Figure 2b.

**Note hole worn in Cover
P/N 169-400005-387**

If the pivot bushes are not lubricated, they will likely become seized inside the control column arm tubes, together with the bolt, and possibly wear into the sheet metal cover, reducing the thickness of the cover in the local contact area and severely reducing the clamp-up torque on the bolt. This can then allow the thin sheet metal cover to support the pivot bolt and inadvertently become a bearing, allowing the bolt and washer to rapidly wear a hole in the cover assembly.

As the hole in the cover assembly increases in size, there will be increasing 'slop' or play in the control column pivot assembly, to the extent that the head of the bolt may pull through the cover, resulting in reduced and possible loss of elevator control.

- a. The control column pivots (left and right) are inspected for wear, lack of lubrication, loss of bolt torque and damage to cover P/N 169-400005-387.
- b. The pivot bushings are correctly installed and functioning as intended, and
- c. Defects discovered as a result of the inspection are rectified at each 100 hour/12month inspection, and that consideration be given to reducing the current manufacturers lubrication interval for the control column pivot bushes from 1000 hours to 500 hours, in accordance with the provisions of the Beechcraft Duchess 76 Maintenance Manual Chapter 05 - Time Limits / Maintenance Checks; *SECIAL CONDITIONS CAUTIONARY NOTICE* to reduce the risk of bushings seizing.

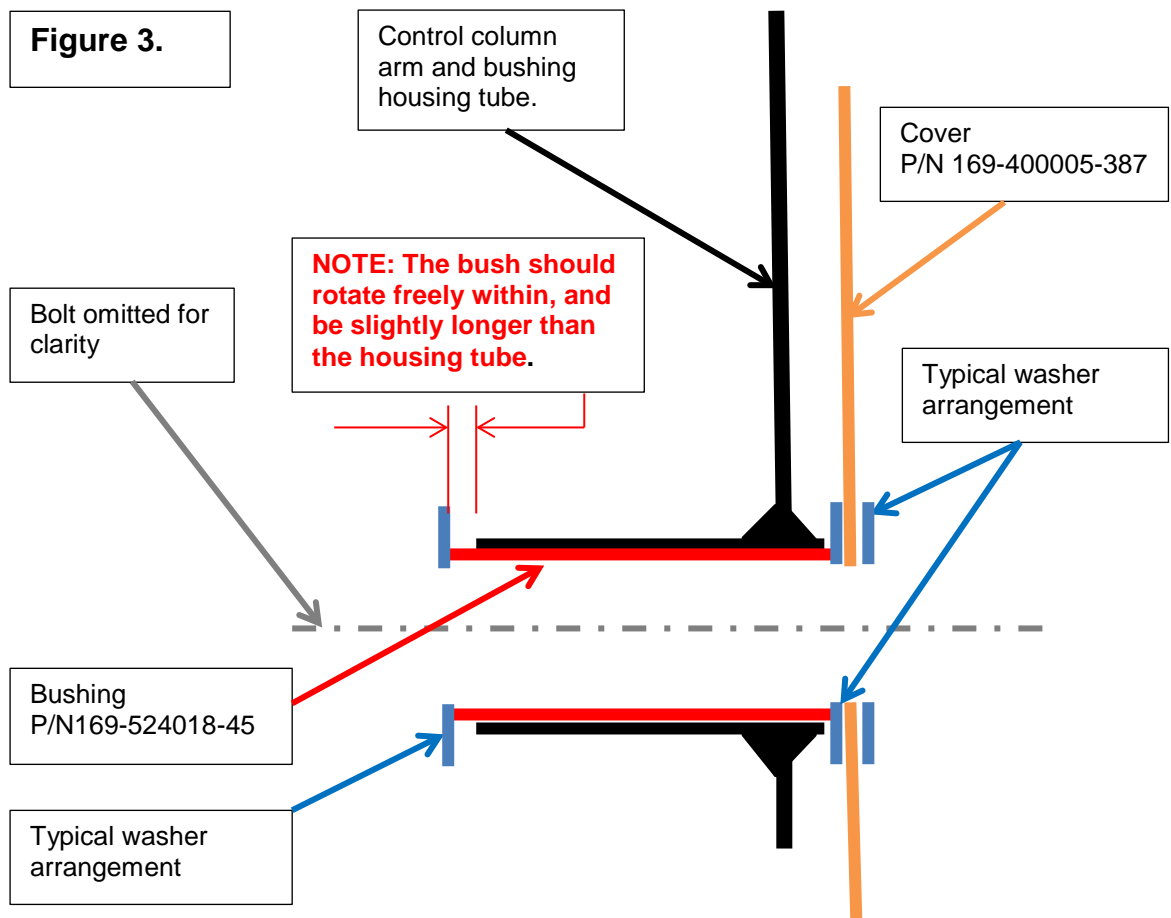
When the bolts are correctly torqued, the bushes will be clamped against the tunnel wall which is protected by steel washers. (Figure 3) The only relative motion should be between the control column and the bushings as the yoke is moved back and forth to control the elevators.
