Airworthiness Bulletin

AWB 52-001 Issue 2 - 25 November 2021

Beechcraft Super King Air 200 and 300 Series Aircraft - Emergency Exit Cracking

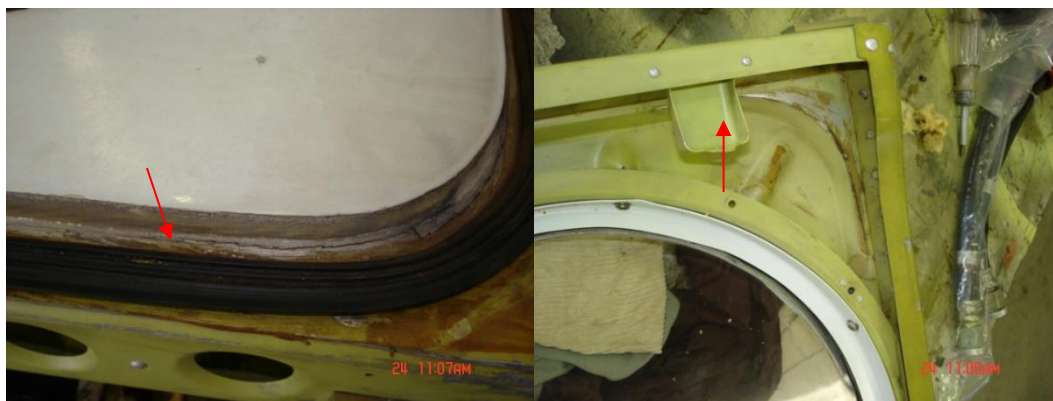
During an investigation into a pressurisation leak, an operator discovered a large crack in the Emergency Exit door structure fitted to a Beech 200 series aircraft.

Figure 1. This aircraft contained a crack in the door structure that was detectable from the outside.

At the next available opportunity and at each future routine inspection of the Emergency exit door in accordance with the Maintenance Manual, carry out the Emergency Exit inspection in accordance with the requirements of the Beech Maintenance Manual with the addition of an internal inspection:

- i) Remove the internal lining/trim of the Emergency Exit door to gain access to the extruded curves of the door structure.
- ii) Inspect with a bright light source and magnifying glass in the area of the extruded curves for cracks and/or corrosion.
- iii) Report any findings of defects to CASA via the CASA Defect Reporting System.

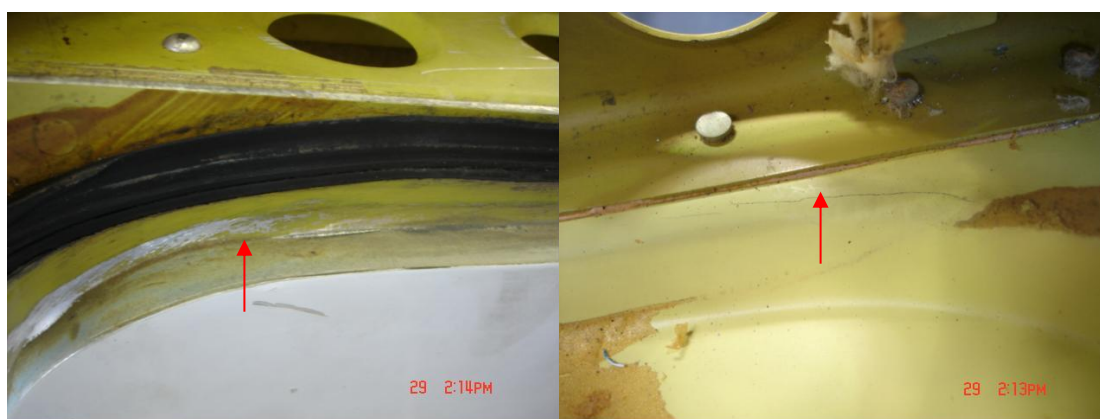
A similar internal crack finding was reported recently on a Beech B300C aircraft where an operator reported that a crack was found during a scheduled high utilization inspection program check on the inside of the Emergency Exit door curved panel at the lower aft door corner, but that the crack found was not otherwise apparent from the outside direction that the Beech 300 Maintenance Manual visual inspection calls for.

Figure 2. This aircraft contained a crack that was not apparent from the outside, but was found by removing the internal door trim.
