# AIRWORTHINESS BULLETIN

AWB 63-002 Issue: 4 - 8 March 2019

## Bell 206 Freewheel Unit Failures - Mast Yielding / Main Rotor Separation

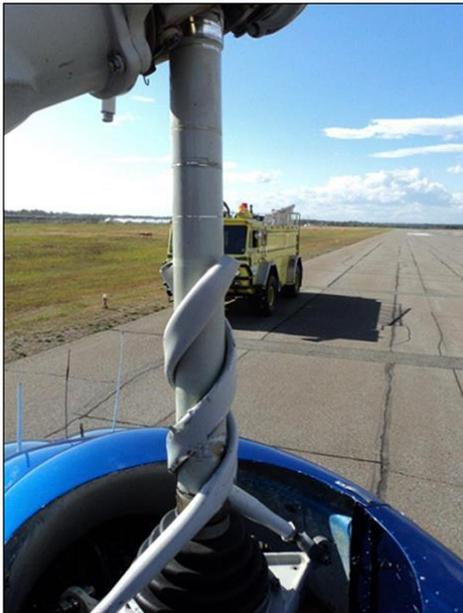
During the final stages of a practice power-recovery autorotation, the pilot rolled the throttle to full power. The engine spooled up to 100% but the free-wheel unit did not engage the engine to the transmission.

Rotor RPM decayed as the collective was raised to cushion the landing at the end of the descent, at which point the freewheel unit suddenly engaged.

The inertia built up by the engine was immediately resisted by the mass of the decelerating rotor system and the shock resulted in the main rotor head separating from the mast. The touchdown was firm and the helicopter slid about 5 feet.

Fig 1. - Main rotor mast to rotor head separation failure. Accompanying text is a summary based on TSB Aviation Investigation Report A11C0152.

The investigation found that the free wheel unit had failed due to lack of lubrication caused by debris in the oil supply restrictor or oil jet, the same prime causal factor for freewheel failures and mast yielding in Australia.

1. In addition to the current AD requirements to inspect the one-way clutch oil supply orifice filter for cleanliness anytime an opening occurs to the freewheel oil supply between the restrictor and the filter, CASA recommends that the operator take action to ensure the filter is checked for cleanliness:
  - (i) Between 100 to 200 flying hours after the transmission has been opened for maintenance,
  - (ii) Following main transmission failure,
  - (iii) Whenever the main transmission is changed, or
  - (iv) The freewheel unit is removed or changed for any reason.
2. Activating the associated chip detector.

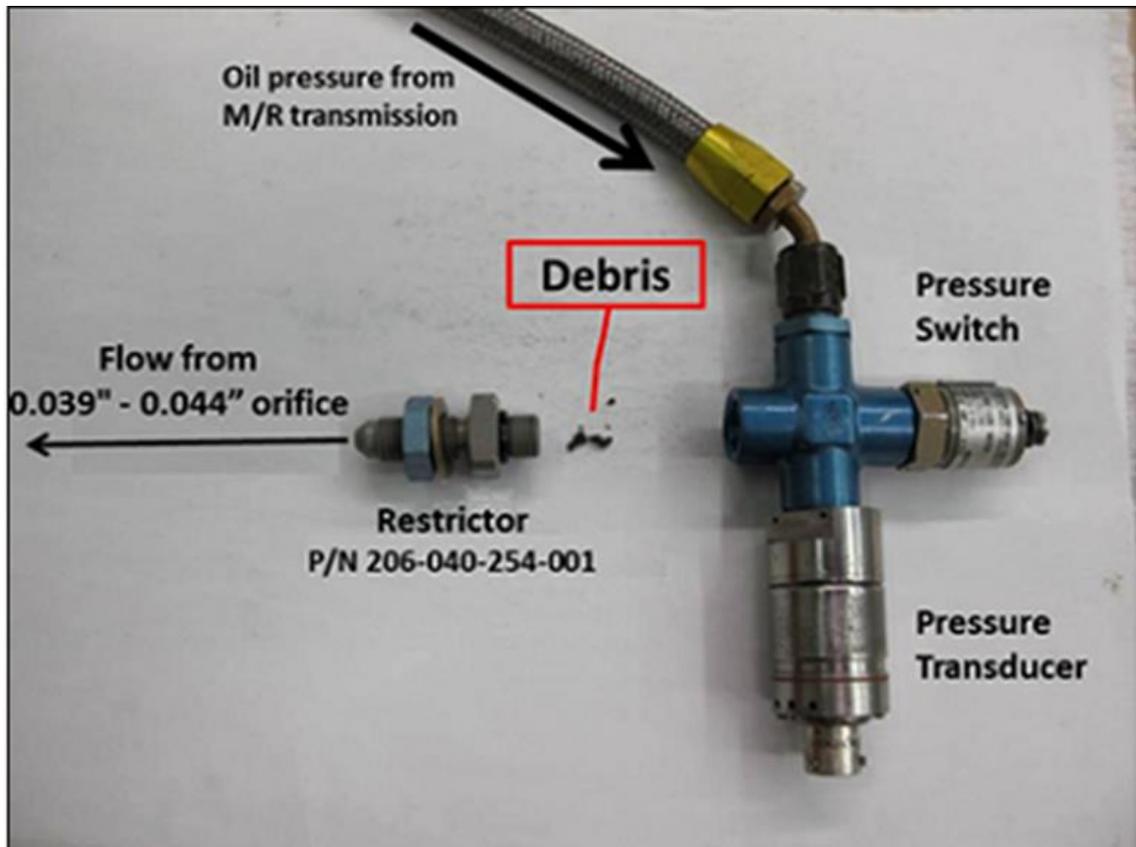
Fig. 2 - General arrangement of the failed freewheel oil supply, also note the debris blocking the restrictor or oil jet. (Ref. TSB Aviation Investigation Report A11C0152).

As with the investigation into the mast separation event in Canada, local investigations into mast yield events usually finds that the freewheel unit oil jet or metering orifice is blocked with debris, such as lint, corrosion, and 'O' ring fragments, typically from previous maintenance activity.

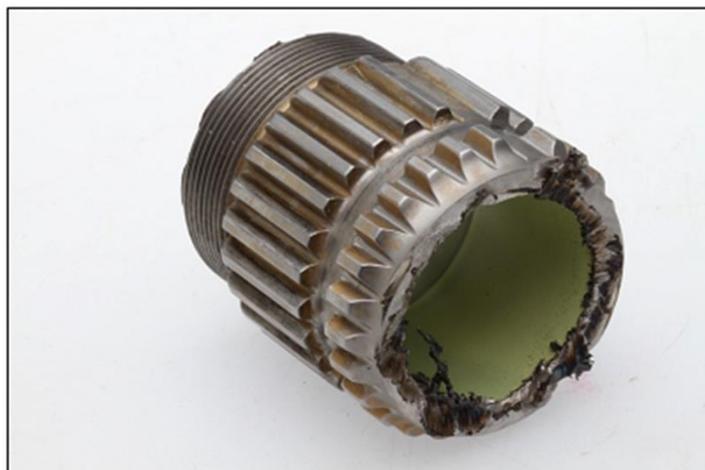
Free wheel failure of this kind usually results in a torsional yield failure of the main rotor mast, evidenced by a misalignment between the mast spline that engages with the main rotor head and the comparison spline in the mast below where the main rotor head engages with the mast splines. (See figure 3).

Fig. 3 - Upper mast stub which separated from the main rotor mast. (Ref. TSB Aviation Investigation Report A11C0152).
