AIRWORTHINESS BULLETIN

AWB 53-011 Issue 1 – 12 Jul 2019

Cessna 210 and 177 Wing Carry-through Spar

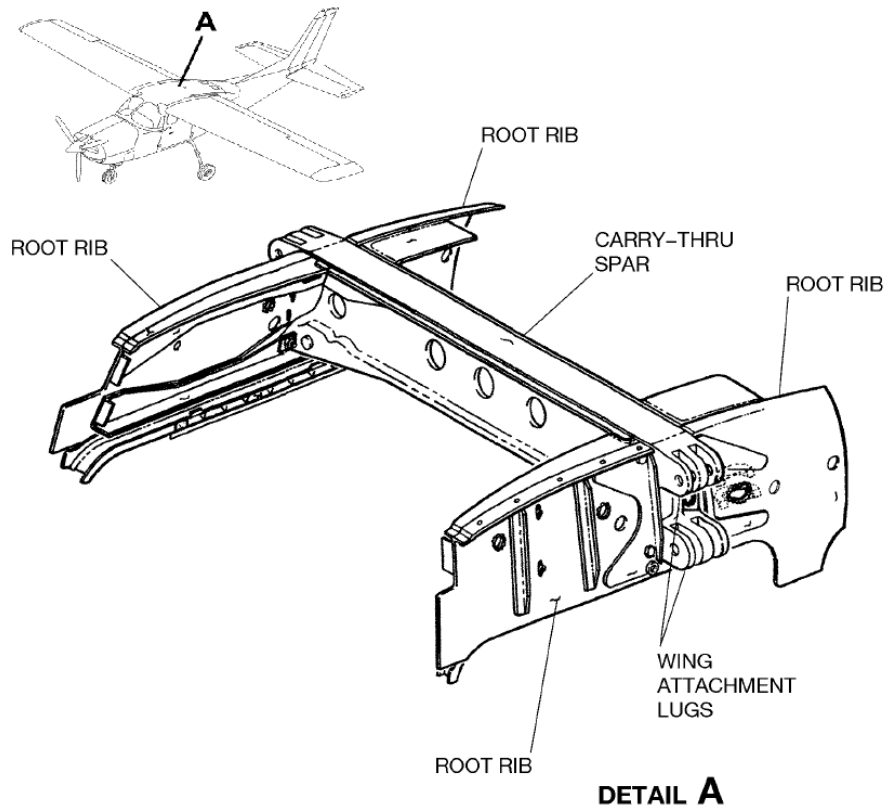
Figure 1: CESSNA Aircraft Company Model 210 Series (1970-1976) Service Manual Carry-Thru Spar Corrosion Inspection Figure 1 (Sheet 1) D2002-5-13 Temporary Revision Number 11 Aug 1/2011

A recent fatal accident on an Australian registered Cessna T210M aircraft may have been caused by a fatigue fracture of the spar where cracking had initiated from a corrosion pit on the lower surface of the wing carry-through spar. The spar failed inboard of the right-hand wing attachment lugs where the lower cap transitions into a carry-through tension tie that connects to the left-hand wing attach lugs (Figure 1).

- Cessna 210 Service Letter SEL-57-06 and Cessna 177 Service Letter SEL-57-07 or later revisions as appropriate which relate to one-time inspections of the lower surface of the carry-through lower cap. It is prudent to extend the enhanced inspection (10 x magnification and bright light source) to the upper surface of the lower cap and the carry through web where visible with the aid of a mirror and/or borescope.

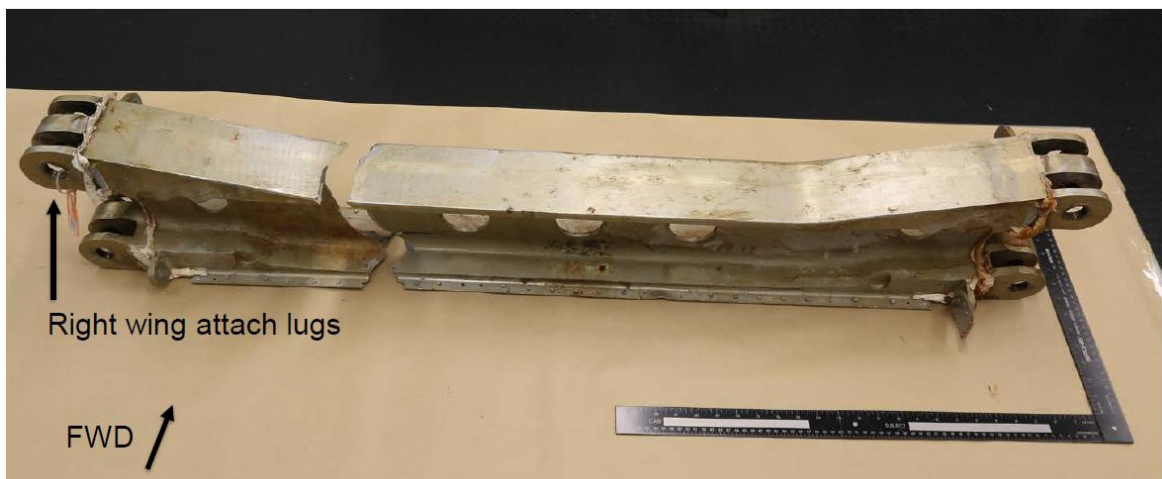
Figure 2: Photograph of Cessna T210M Fractured Carry-Thru Spar. View looking AFT at lower chord surface. Photo: ATSB AO-2019-026 Preliminary Report

Note: Preliminary investigation of the failed carry-through structure showed that a crack quickly grew to a critical size from a very small corrosion pit. Detection of any crack is likely to be very difficult, even with eddy current methods on the forging lower cap lower surface, as it will be in compression on the ground. It is recommended to mark out small zones on the lower surface and overlap the ECI probe path to ensure no areas are missed. The crack on the failed carry-thru spar propagated in the fore/aft direction across the lower cap lower surface.

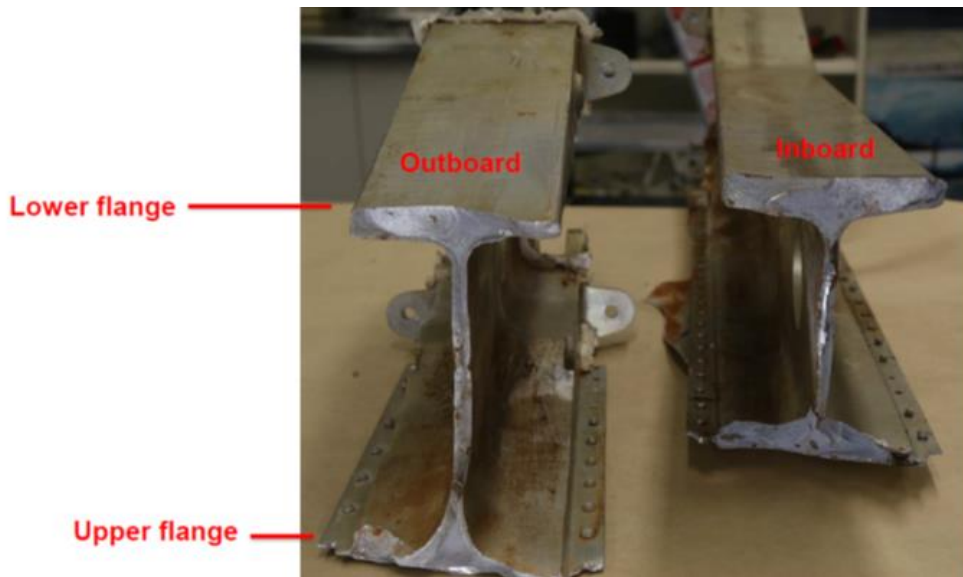
Figure 3: Photograph of Cessna T210M Fractured Carry -Thru Spar Fracture Surfaces
Photo: ATSB AO-2019-026 Preliminary Report

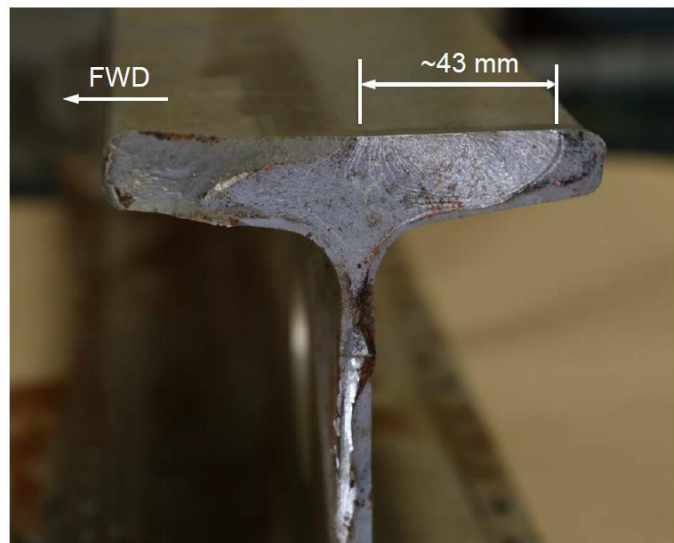
Figure 4: Photograph of Cessna T210M Fractured Carry -Through Spar INBD Fracture Surface.
Photo: ATSB AO-2019-026 Preliminary Report

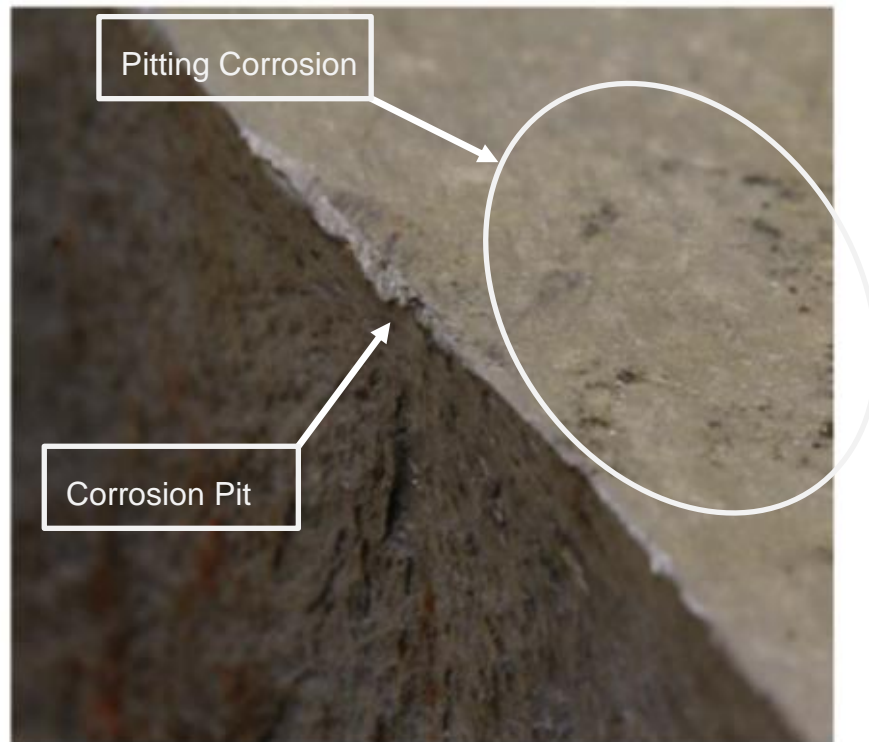
While the accident investigation is currently being carried out by the ATSB, a preliminary ATSB report shows that the spar had experienced very minor surface corrosion pitting on the lower cap lower surface and that no other mechanical damage was found at the fracture surface. The corrosion pit was 1.82mm long and 0.3mm deep. Figures 2 through 4 refer to the fractured spar, and Figures 5 and 6 show pitting corrosion evident on the lower surface of the lower spar cap.

Figure 5: Photograph of Cessna T210M Fractured Carry -Through Spar INBD Fracture Surface.
Pitting Corrosion Pits evident.
Photo: ATSB AO-2019-026 Preliminary Report

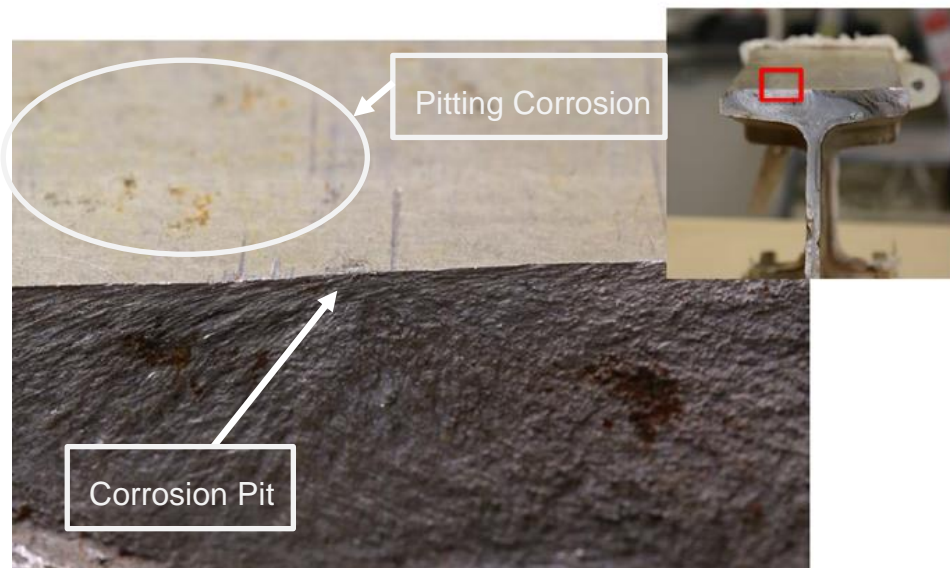
Figure 6: Photograph of Cessna T210M Fractured Carry-Through Spar OUTBD Fracture Surface
with Corrosion Pit evident.
Photo: ATSB AO-2019-026 Preliminary Report

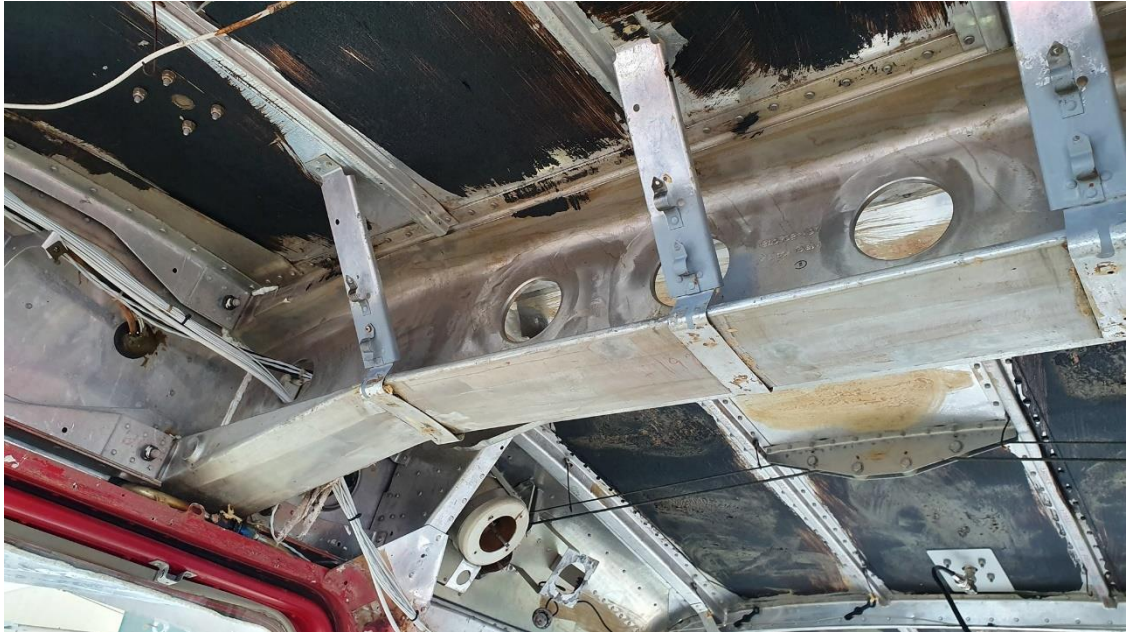
- Some aircraft have modifications to ensure the cabin headliner is securely attached to the forging which may promote retention of water and chaffing against the carry-thru structure thereby exacerbating the potential corrosion problem (Figure 7).

Figure 7: Photograph of strap configuration on some aircraft.
