AIRWORTHINESS BULLETIN

AWB 57-016 Issue 1 – 26 October 2017

Cessna 402C Wing Main Spar Strap Modification Non-Conformity

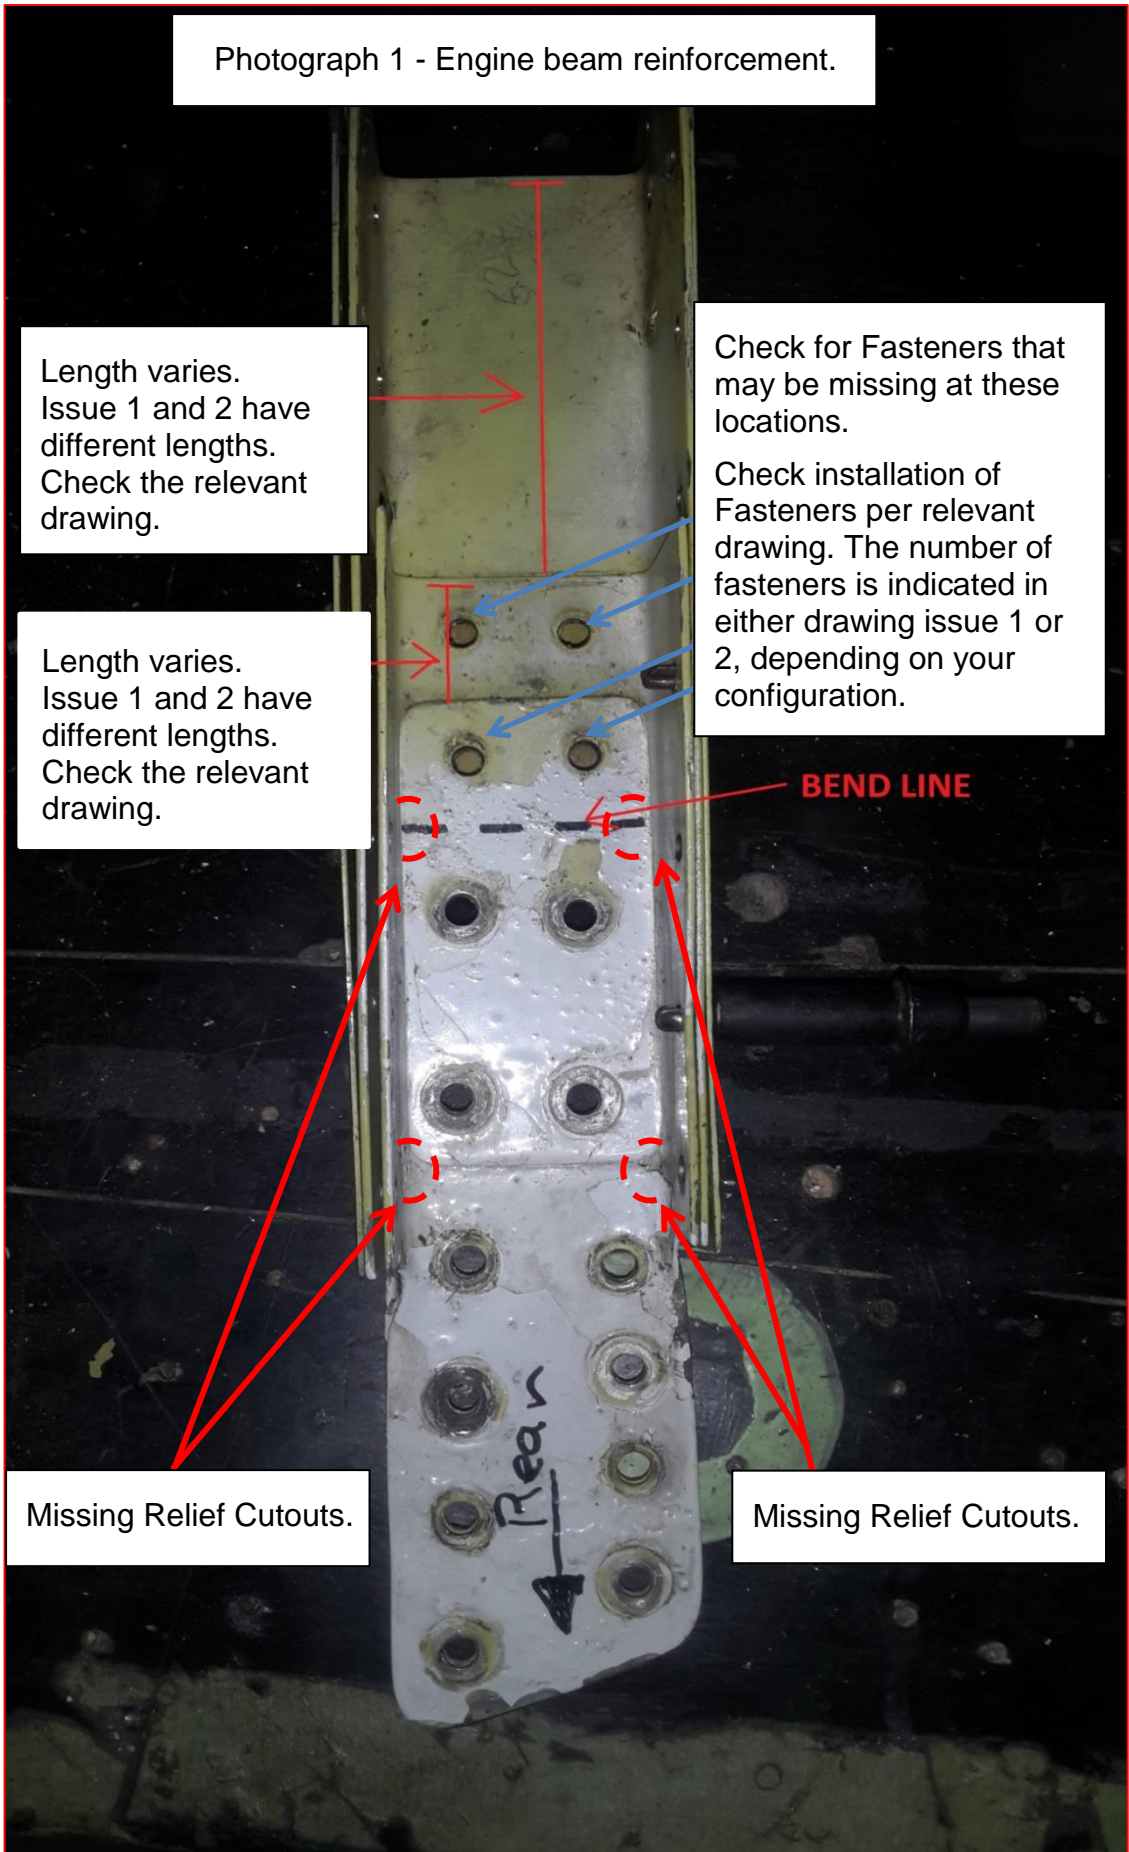
Photograph 1 - Engine beam reinforcement.

At this stage, two aircraft have been identified as potentially non-conforming with the drawings. This is being further investigated. The main discrepancy is pictured in photograph 1 on page 3, which shows the engine beam/spar strap reinforcement components that do not match the approved configuration per HDH EO 006-035. The specific features that did not conform are:

1. Absence of a bend relief radius detail in the cross hatched areas shown in photograph 1 indicated by the red arrows. The non-conforming part may have no relief cutout and has a straight edge. This should be relatively easy to detect after gaining access to the area. Check against the drawing for your particular configuration. This relief radius may/may not be required depending on whether or not there is a bend in this location.
2. Missing fasteners in location as indicated by the arrows. The required number of fasteners is indicated in either drawing Issue 1 or 2, depending on what version is installed in your aircraft.
3. The use of issue 1 of the installation drawing on a particular aircraft when only issue 2 was approved for use on that aircraft.

Length varies.
Issue 1 and 2 have
different lengths.
Check the relevant
drawing.

Check for Fasteners that
may be missing at these
locations.

Check installation of
Fasteners per relevant
drawing. The number of
fasteners is indicated in
either drawing issue 1 or
2, depending on your
configuration.

Missing Relief Cutouts.

- Whether or not the aircraft is modified per HDH EO 006-035. If so:
 - (i) Determine if this modification was carried out in conformance to and using the correct revision of the approved data. In order to achieve this, it is recommended, for modified aircraft, that the Left and Right hand engine beam area be inspected as soon as practically possible and a visual verification of the strap configuration be made against the approved data as defined in HDH EO 006-035 Issue 1 or Issue 2 (See appendix A to this AWB for a list of applicable drawings). There are only two approved configurations for this modification.

- (ii) If the modification is not in conformance with the approved data, do not operate the aircraft and contact a CASR 21M authorised person for further advice on the effect that operation in a non-approved configuration may have had on wing spar fatigue life and damage tolerance inspection intervals. Carry out any remedial action required before further flight.

- (iii) Inspect the modification and surrounding structure for defects, including missing or loose fasteners.
 - (iv) Report the results of any defects or non-conformance to CASA.

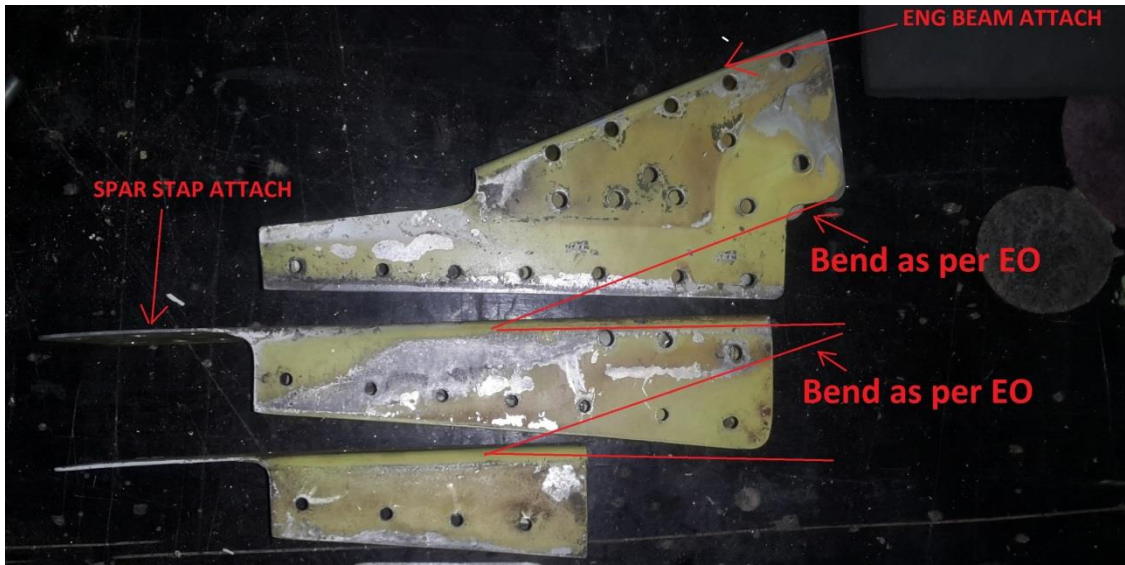
An additional discrepancy (Photograph 2) was discovered in the fabrication of other parts (P/N 006-57-10-056-001/002) in the engine beam area to Issue 1 of the drawings instead of Issue 2.

Photograph 2 - Issue 1 configuration. Red lines indicate bends made for Issue 2 configuration.
