AIRWORTHINESS BULLETIN

AWB 25-032 Issue 1 – 23 April 2018

Cessna Pilot Seat Track Locking - Pre-Flight Check, Maintenance and Mod Status

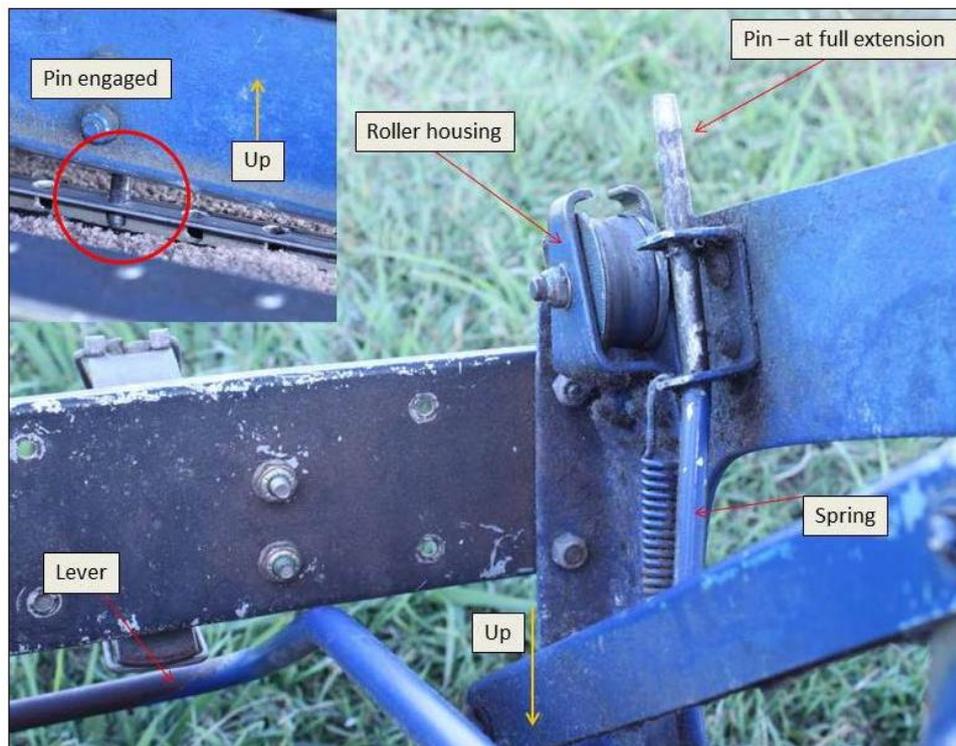
Figure 1: Exemplar of a primary seat stop showing the primary seat stop (latch) pin engaged in the seat rail at left inset (circled in red).

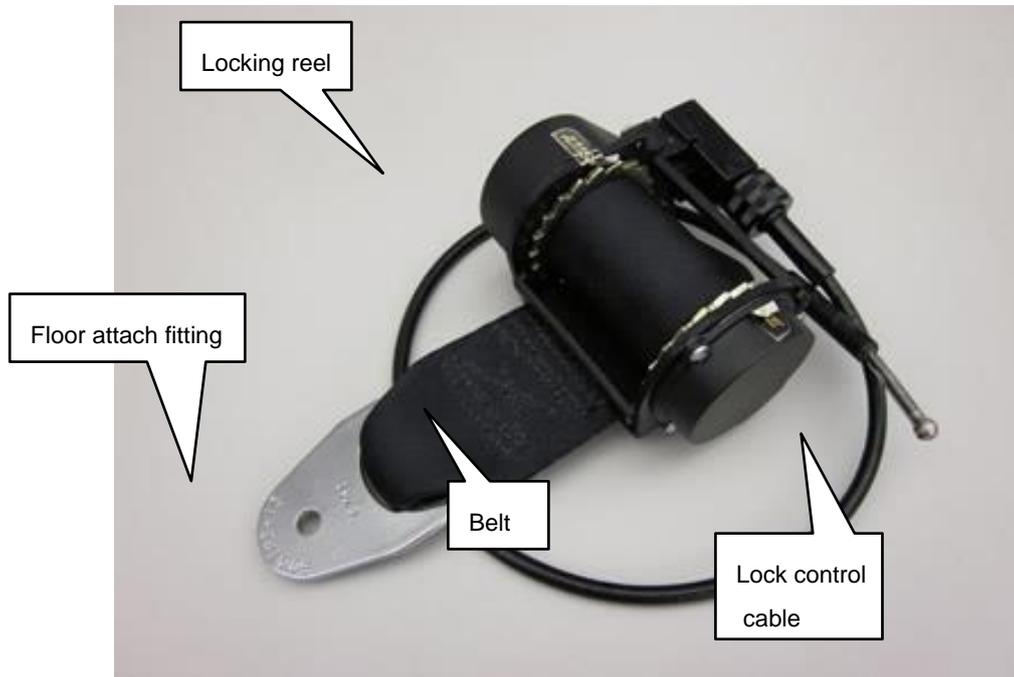
Figure 2: Close-up view of Cessna Mod Kit SEB07-5 Secondary Seat Stop locking reel, belt, floor attach fitting and lock control cable.

CASA highly recommends the incorporation of the Cessna Secondary Seat Stop Mod Kit SEB07-5 on the applicable aircraft. The kit is available to applicable aircraft via warranty claim (credit) via the local Cessna distributor.

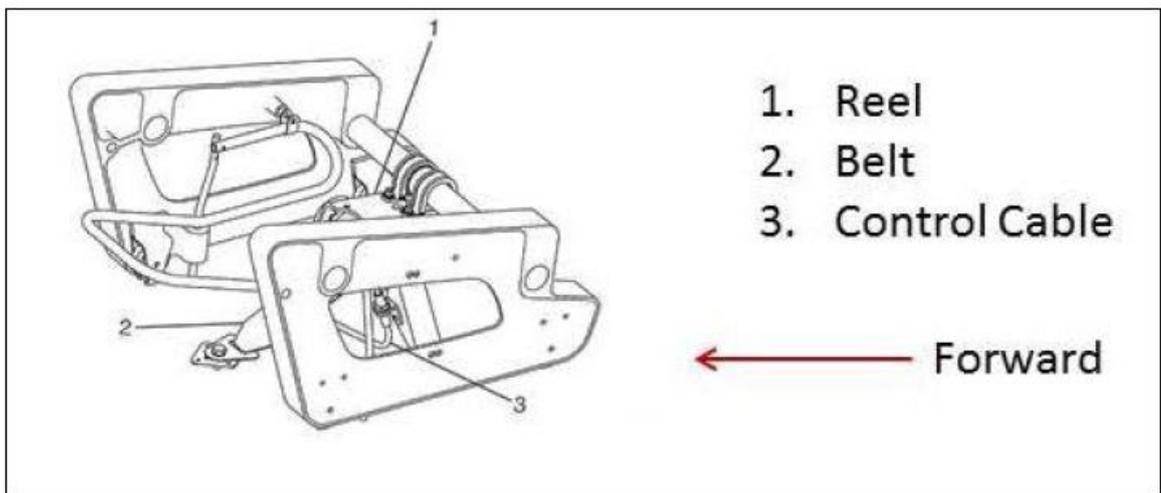
Figure 3: Exemplar installation of a secondary seat stop showing the locking reel, belt & lock control cable (items 1 and 2) that connect the seat frame to the cockpit floor

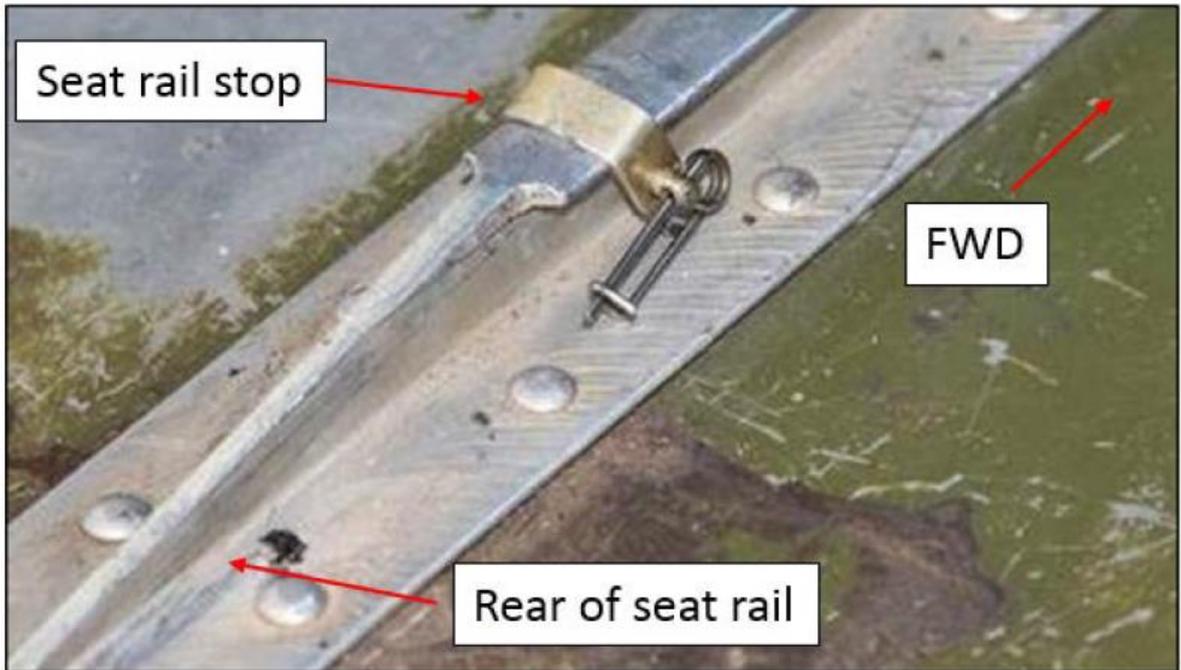
- Past operation of VH-FRT with fuselage damage...
- ***It was likely that the pilot seat rear rail stop was not fitted in VH-FRT at the time of the accident. This increased the risk of seat feet disengagement from the rear of the seat rails and, if the primary locking pins were not secure or failed, uncommanded rearward movement of the seat and subsequent in-flight loss of control.***

Figure 4: Exemplar of a Rear Seat Track/Rail Stop

Although removal and installation of seats may seem a mundane task, the importance to ensure correct positioning of the primary seat locking mechanism, the secondary seat stop, and rear track seat stops cannot be overstated. Maintenance personnel should check that the seat operates correctly throughout its entire range of movement (forward/aft, recline and height). Seats should be verified both visually and operationally for the functionality of the adjustment mechanism, particularly at the extreme positions of the seat travel. Inspection should also extend to any approved supplemental or secondary seat stop devices to ensure correct operation.
