Electrical Power – Transformer–Rectifier
Unit Failure

AWB 24-010 **Issue :** 1
Date : 27 April 2016

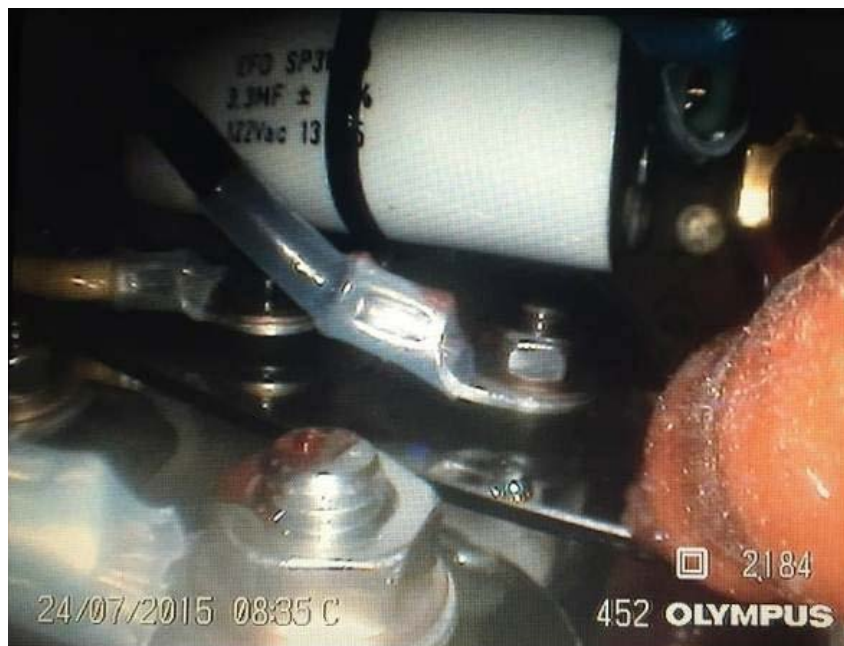
Figure 1 - Serviceable Capacitor

During troubleshooting, the number 2 TRU was removed and strong burning smell was evident from the TRU. A boroscope was used to inspect the internals of the TRU and there was evidence of at least one of the three filtering capacitors having a major failure (Figures 1 & 2).

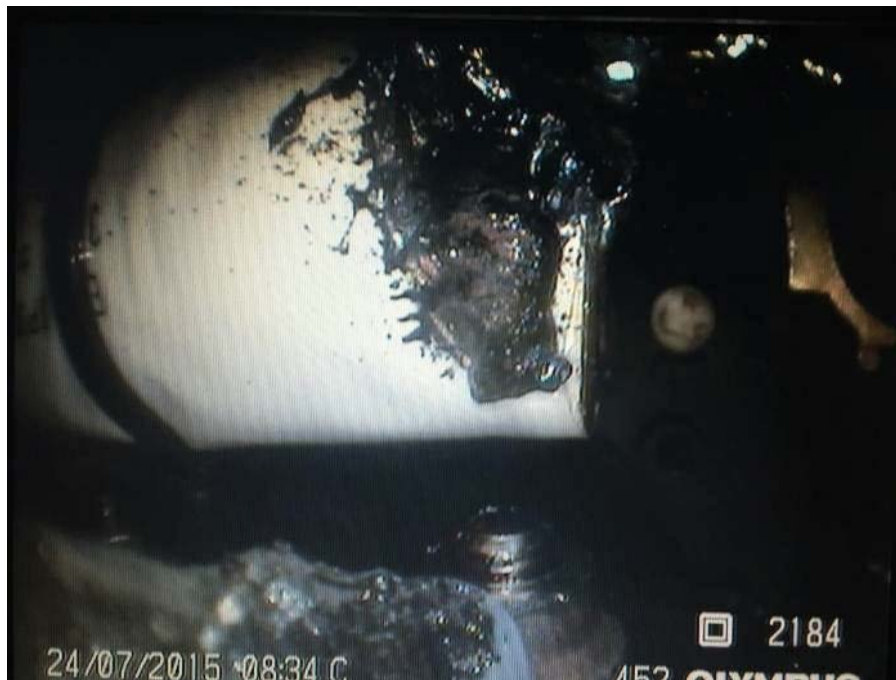
Figure 2 - Damaged Capacitor

Airbus has acknowledged that this was a known issue with amendment F TRU's and was the fourth occurrence, but first on an operational aircraft.

Airbus Helicopters has issued a Service Bulletin (SB) EC225-24-025 and Thales who is the vendor of this TRU has also issued SB F11RD4221-24-003 to address this issue.

CASA strongly recommends that operators of Airbus Helicopters take the corrective action as described in Airbus Service Bulletin EC225-24-025.

Other operators are also encouraged to check if the applicable TRU part number is installed on their aircraft and take action as advised by Airbus Helicopter SB and/or Thales SB F11RD4221-24-003.
