# AIRWORTHINESS BULLETIN

AWB 25-034 Issue 2 – 24 April 2020

Helicopter Rescue Hoist Wire Rope – Wear, Fatigue and Failure

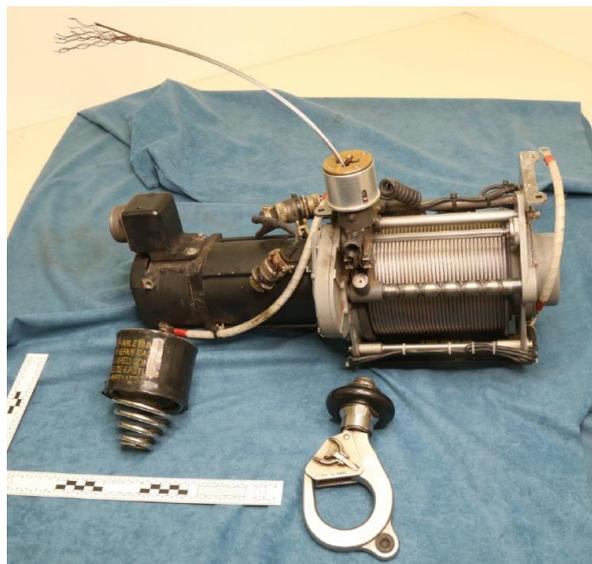
An AS350 helicopter and crew had completed 'live' winching of personnel and were carrying out winch cable maintenance. Whilst under load, the cable failed approximately 8mm from the hook assembly. The cable had completed 617 cycles. The manufacturer recommends for this system, cable replacement after 1500 cycles. No injuries or aircraft damage were sustained. See Figure 1, 2 and 3.

Figure 1. Failed Hoist Assembly (Winch, Bumper and Hook)

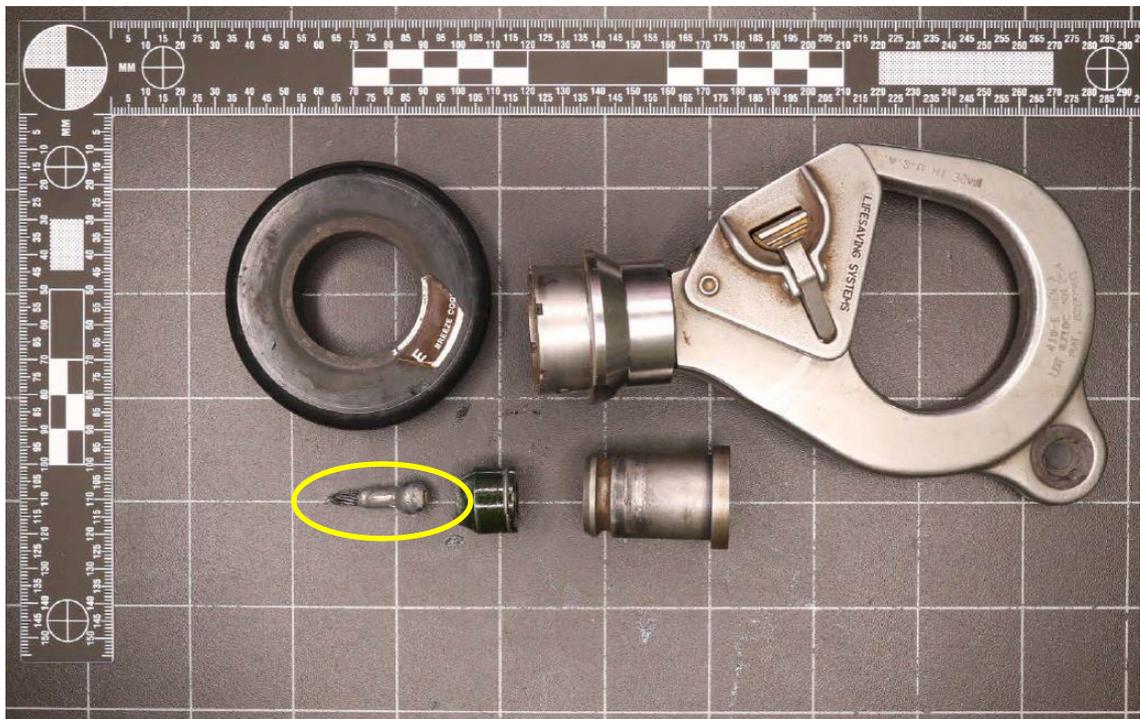
Figure 2. Disassembled Hook (showing swaged (Ball) end)

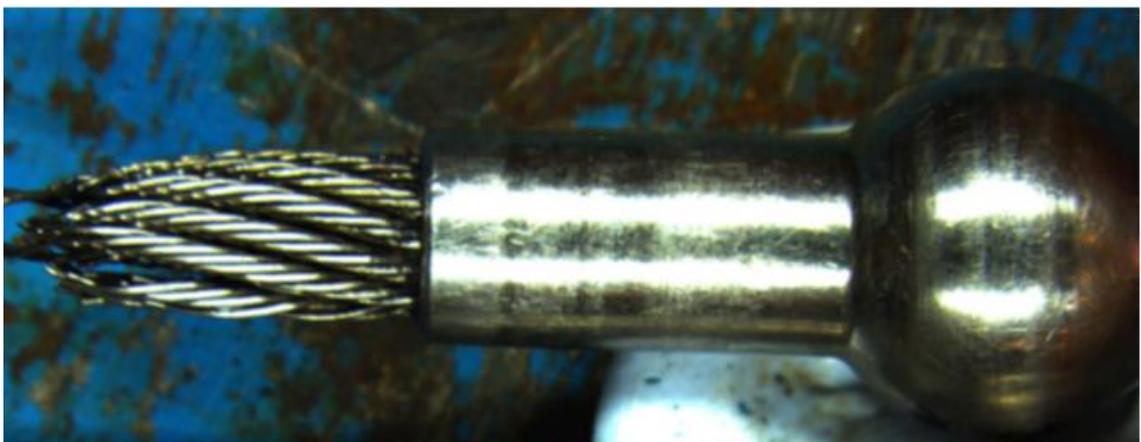
Figure 3. Swaged (Ball) end of failed cable

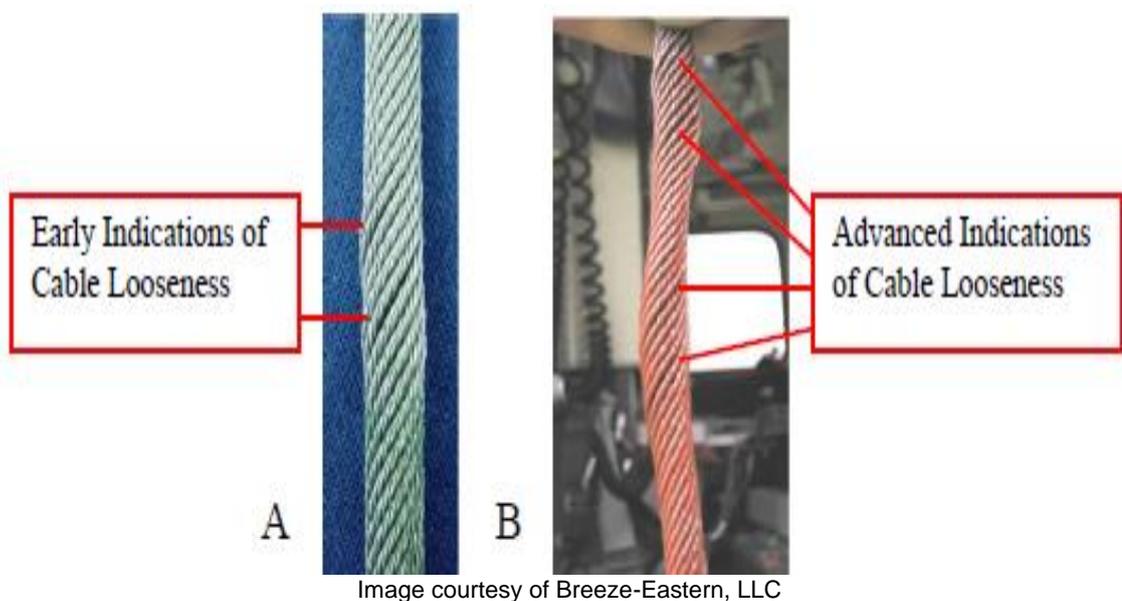
As part of normal winch cable maintenance, a 'conditioning' procedure was being carried out. Conditioning, also known as salvaging, seasoning or load cycling, is an activity to rebalance or tighten cable strands after they become unwound or loose due to unbalanced loading on the inner and outer strands. See Figure 5.

Figure 5. Examples of Wire Rope Cable Looseness

Cable looseness is typically observed near the hook following multiple small length deploy and retrieve cycles or no-load cycles. Further no-load cycles can occur during inspection and maintenance activities. For this system, conditioning requires fully deploying and fully retrieving the cable 5 times with an attached weight equal to the rated load of the winch/hoist. Or removal and storage of the cable for several days. If looseness remains following conditioning or storage, the cable must be replaced IAW the manufacturers requirements.

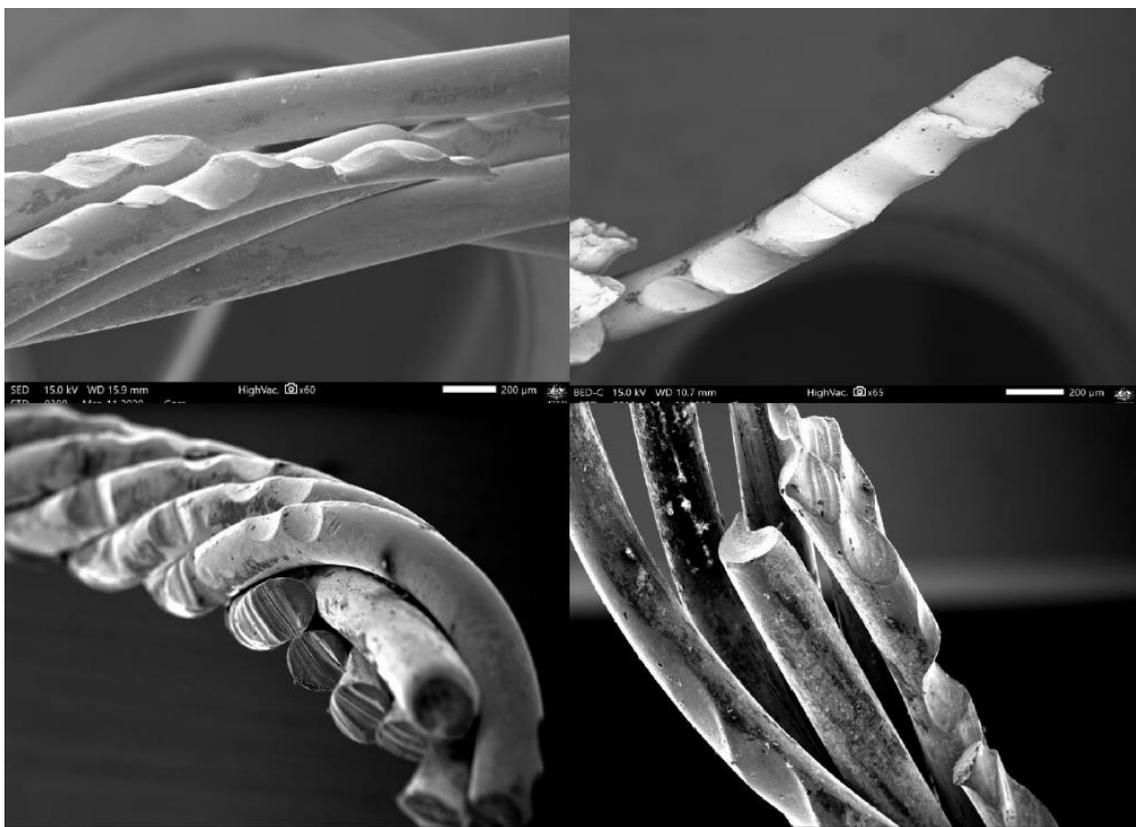
On initial investigation, ATSB inspections revealed no corrosion or any significant debris within the cable strands. The ATSB indicated two potential sources that may have contributed to the failure. Firstly, mechanical wear on the inner surfaces of the outer strands. See Figure 6.

Figure 6. Internal mechanical wear to the wire strands

Secondly, the inner strands are believed to have prematurely failed due to wear and vibration fatigue. Both failure mechanisms are indicative of a hook that has not been correctly 'homed' after operations. Homing, is a procedure that ensures the hook assembly abuts up against a specified part of a winch or hoist. In this system, the hook is correctly homed when the 'full in' limit switch stops the winch

- Operate and maintain hoist/winch systems in accordance with approved data.
- Review and highlight acceptance and rejection criteria in accordance with winch/hoist manufacturer requirements.
- Ensure inspections are completed methodically and thoroughly.
- Always ensure the hook has been homed securely, as per approved data. This will prevent the hook causing premature cable fatigue.
- Winch/hoist system cycle counters cannot be used to replace physical and visual system inspections. These cycles are based on fatigue life determined in laboratories. Many winch/hoist operations consist of much shorter deploy and retrieve cycles, than a counter may show. Additional inspections may be warranted.
- Environmental and operational factors may require recommended maximum hoist cable cycles be reduced.

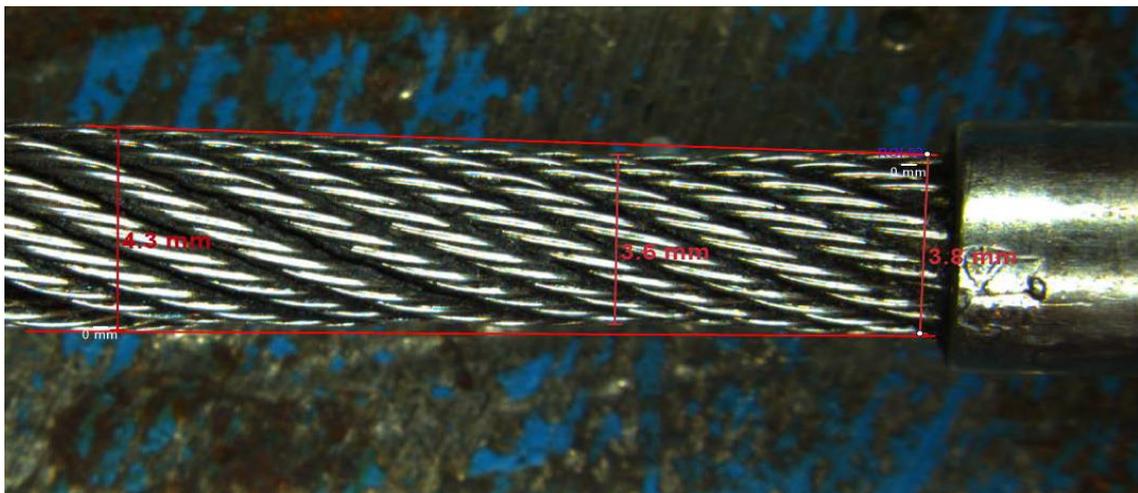
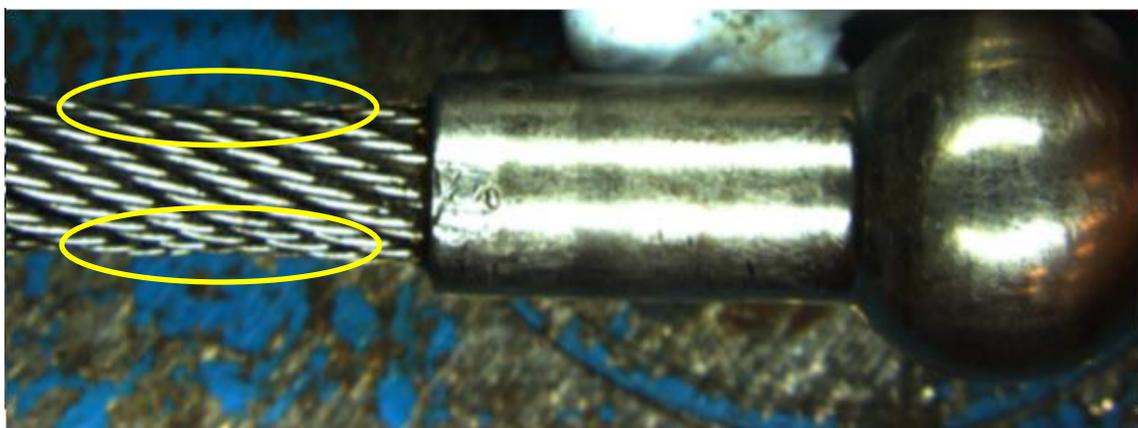
A second operational cable was supplied to the ATSB by the operator for disassembly and inspection. External observations before disassembly showed local 'necking' in the same area as the failed cable. Necking, can visually indicate the onset of a serious defect such as worn or broken internal wires and strands. The subtle changes in diameter associated with necking could also be felt when handling the cable during a physical inspection. See Figure 8.

A detailed internal inspection of the second cable confirmed that the inner wire strands had also started to significantly wear. Necking in the vicinity of the ball end requires immediate replacement, in accordance with manufacturer data.

Figure 8. Operational cable with local necking and measurements
