# Airworthiness Bulletin

## AWB 31-009 Issue 2 - 14 July 2021

### Horizontal Situation Indicator - Premature timing belt failure

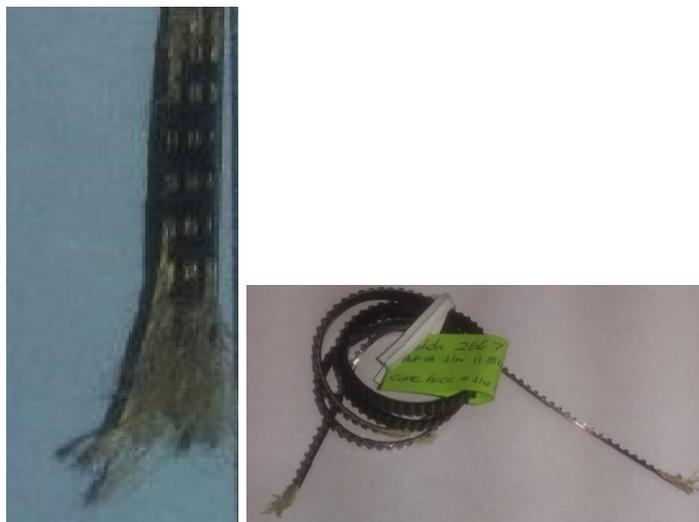
- Stripped teeth.
- Fraying on edges – see Figure 6
- Broken reinforcing strings
- Broken belt – see Figure 5

**Figure 5 - Broken belt**

In some instances, the individual cords can snap and become wrapped around other critical components, or the belts can stretch or break completely causing loss of indicated direction.

Please quarantine any failed or damaged drive belts for further investigation.

As of June 2021, the FAA have approved an alternate means of repair via a Repair Specification document (MCIA-RS-NSD360-1). The specification allows a compliant repair to be carried out by an FAA authorised maintenance facility holding an appropriate repair specification certificate.

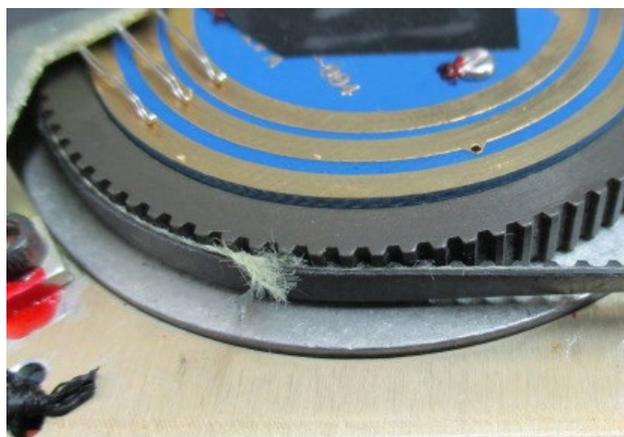
The drive belt part number: 30B437 are currently lasting between 3 to 12 months in service before failing. After approximately 60-100 hours, the belts are starting to fray and weaken, resulting in failure soon after. These issues are identified with Certificate of Conformance number 4100, 3803, 3117 and 2508; however this issue may relate to other batch numbers.

**Figure 6 - Fraying belt**

When the belts fray, the cords can get caught around the brush assembly P/N 81B340 - which is mounted on top of the gyro can - or other critical parts within the HSI.

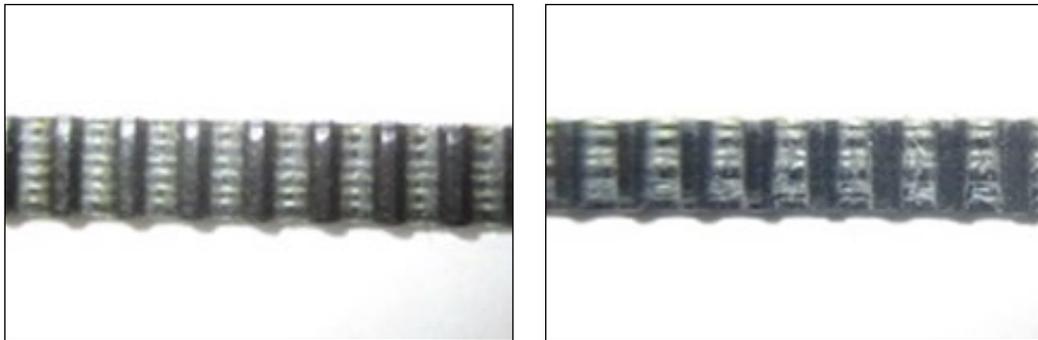
The belt is comprised of a number of load carrying tensile cords. The construction of the belt has changed see Figure 7.

**Figure 7 – Left image, older timing belt with finer tensile cords shown. Right image shows changed newer belt.**
