# Airworthiness Bulletin

## AWB 27-021 Issue 1 - 10 February 2021

### Jabiru Control Surface Hinges and Aileron Control Tube - Inspection

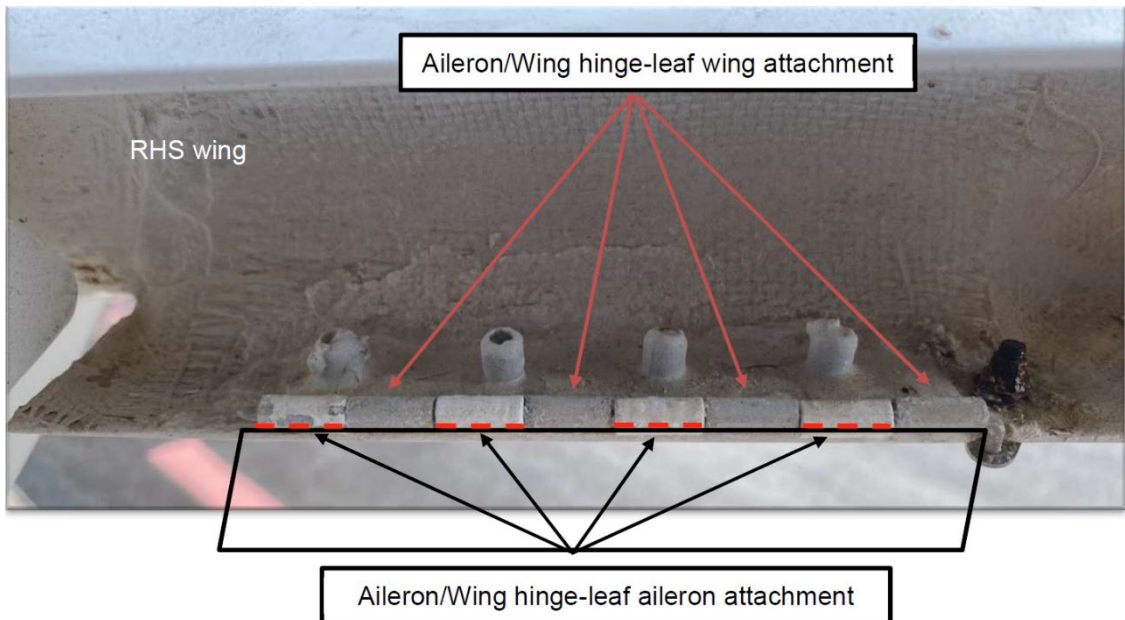
the aileron was able to droop down. If this had occurred inflight, aileron control could have been lost or severely impaired. Figure 1 shows the failed aileron hinge, showing where the failure occurred. Note that the hinge pin securing screw and other hardware of the aircraft had visual signs of corrosion.

**Figure 1:** Failed hinge (leaf on wing detached from leaf on aileron)

The purpose of the Service Bulletin is to inform Jabiru aircraft operators and maintainers of this potential condition and prescribes an inspection to check that all control surface hinges are in serviceable condition. If any corrosion or cracking is detected during the prescribed inspections, contact Jabiru for repair instructions.

- a. inspect all control surface hinges in accordance with the technical requirements of Jabiru Service Bulletin (JSB) JSB044-1 Section 4 - 'Inspection Procedure' and repeat the inspection at each routine service interval thereafter.

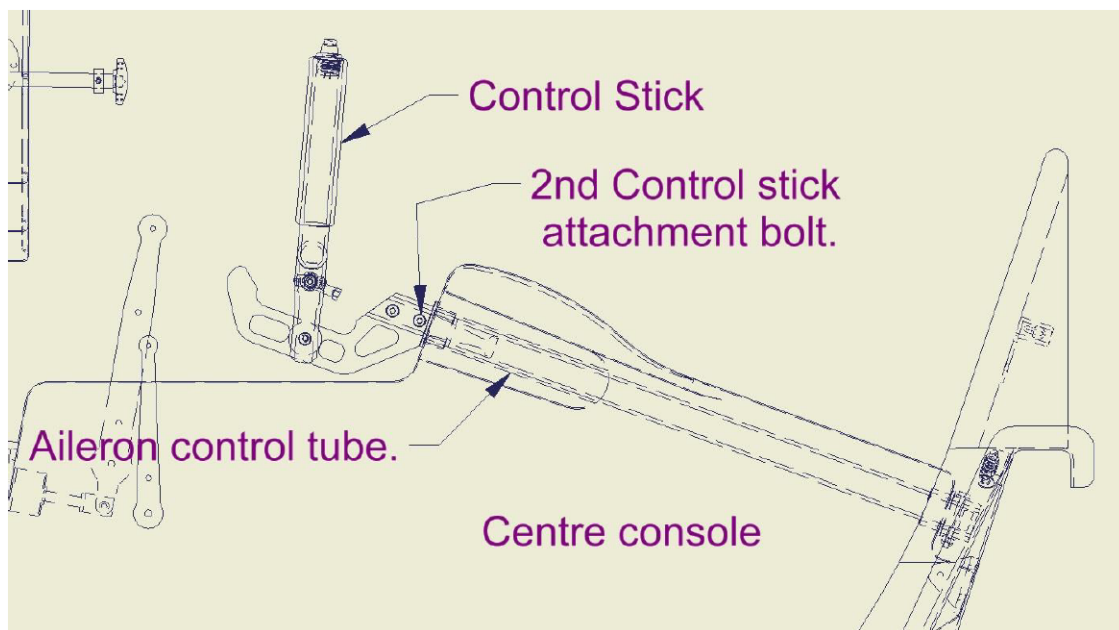
The Jabiru Aileron Control Tube is a machined aluminium tube that runs from the control stick assembly through the centre console to the aileron cable bell-crank, as seen in Figure 2. A complete failure of an aileron torque tube may result in loss of the pilot's primary lateral and pitch controls.

**Figure 2:** Elevator cable layout example

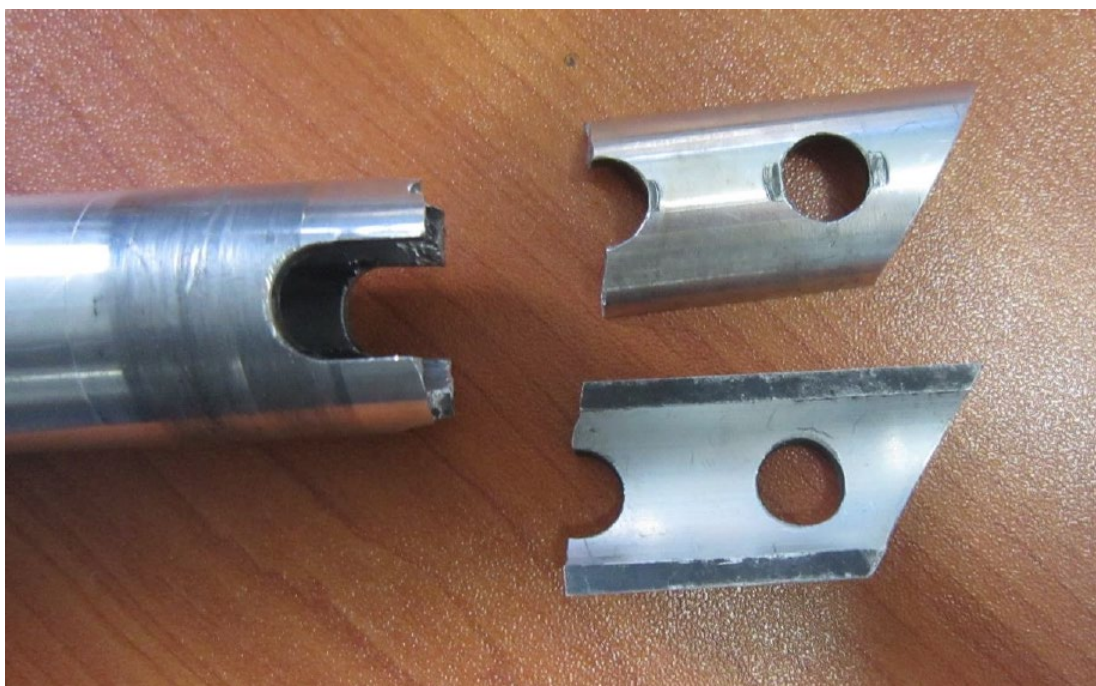
A failure of an aileron control tube over 8500 hours total time in service (TTIS) was reported to Jabiru Aircraft whereby the aileron control tube failed in fatigue at the second control stick attachment bolt. With no connection, aileron and elevator control could have been lost. Figure 3 shows the failed aileron control tube, showing where the failure occurred.

**Figure 3:** Failed aileron control tube

JSB 042-1 requires an inspection of the aileron control torque tube where it connects to the control stick pivot plate for cracking at each of four quadrants. Analysis of the failed part showed that one quadrant had been cracked through for some time before complete failure occurred.

- b. inspect the aileron control tube in accordance with the technical requirements of Jabiru Service Bulletin (JSB) JSB042-1 Section 4 - 'Inspection Procedure' and repeat the inspection at each routine service interval thereafter.
