Airworthiness Bulletin

AWB 85-020 Issue 4 - 5 October 2021

Lycoming Engines - Connecting Rod Bushing Premature Wear

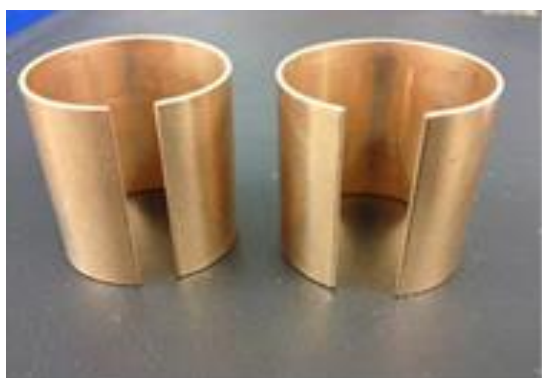
NOTE: Whilst the part number of the connecting rod bush has not changed, its physical appearance was recently altered. Stocks of Connecting Rod Small End Bush P/N LW-13923 received by Australian customers since early 2016 have a wide pre-set split line profile, (see Figure 1 and Figure 2 for more details).

Figure1 - The bush on the right is a Connecting Rod Small End Bush P/N LW-13923, identifiable by the pre-set split line which is almost twice the width of the bushing previously received from Lycoming, shown on the left.

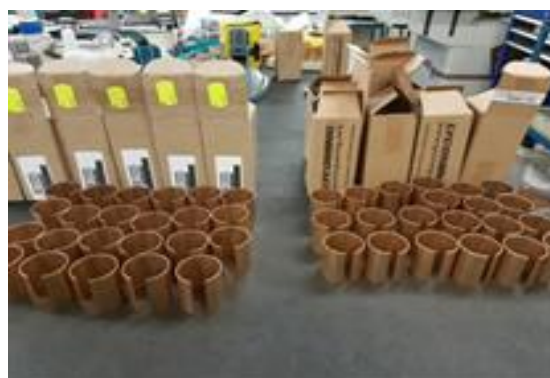
Figure 2 - Packaging on the left with new style bar coding containing bushing with the wide pre-set split line. Packaging on the right without bar coding previously received from Lycoming containing bushing with the narrower split line.

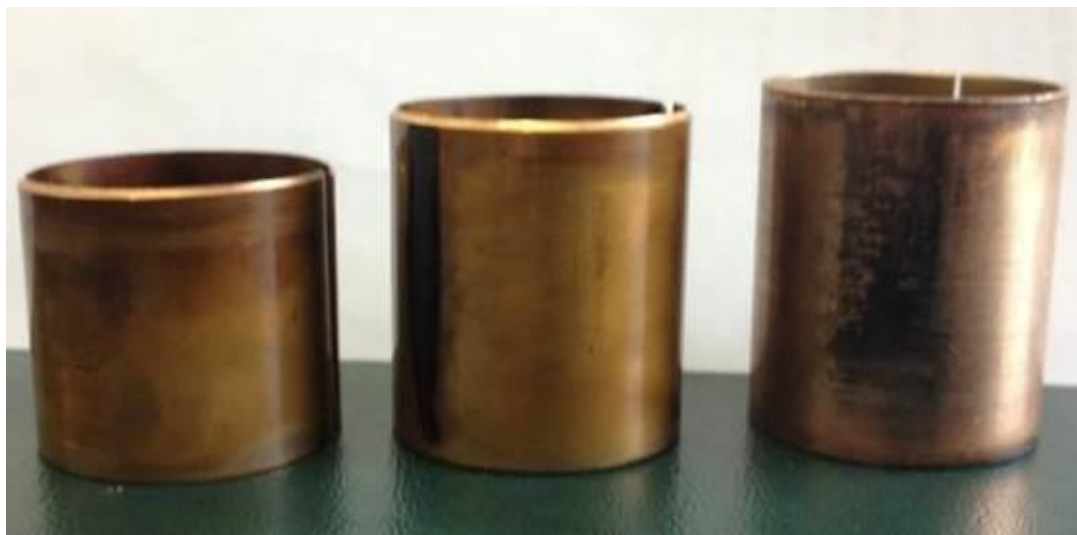
Group 1 Engines - Engines presented with one or more Small End Bushes (P/N LW-13923) that have migrated axially in their Connecting Rod. Migration of the Bushing results in the protruding edge being milled away by contact with the piston pin towers.

A reduction in the bearing surface creates an increasing bearing load on the remaining bushing, leading to an over-load condition and progressive break-up of the protruding bush edge through rocking of the piston pin as a result of the combustion process. The development and progression of the condition is relatively slow and predictable. See Figure 3 and 4 for more details.

Figure 3 - Three (3) P/No LW13923 Bushes from an O-360-J2A engine which had accumulated 1000 Hours since rebuild in September 2011, showing varying degrees of abrasive wear and consequential reduction in bush axial length. The bush on the right has a relatively unworn axial length.

- 1) At each engine oil change - Change the oil and filter and carry out inspection per the provisions of Lycoming SB 480F, (or subsequent).
- 2) When carrying out the engine oil and oil filter change procedure take appropriate precautions to drain the oil whilst the engine is still hot and strain the hot oil through a fine mesh screen filter.

- 3) Inspect for a high concentration of bronze alloy in the oil, oil filter and suction screen, indicated by a shining metallic (brass/copper) residue, particles, shavings, or flakes.

- 4) Visually inspect condition and check security of connecting rod little end bushes in accordance with Lycoming SB No. 630A (or subsequent).
 - i. For engines with less than 800 Hrs TSO - At any time direct access to connecting rod little end bushes is available.

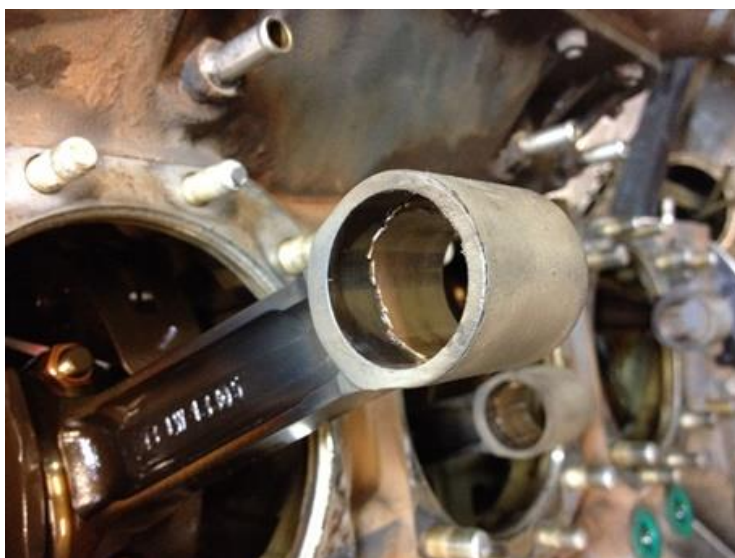
Figure 4 -Partially disassembled O-540-F1B5 engine with an accumulated Time Since New from September 2011 of 1031 Hours, showing material loss and breakup of the connecting rod little end bush. Four (4) of the six (6) bushes from this engine had varying degrees of material loss.
