Metro/Merlin Main Landing Gear Yoke Torque  
Link Lug Inspection

**AWB** 32-023 **Issue** : 1  
**Date** : 4 February 2015

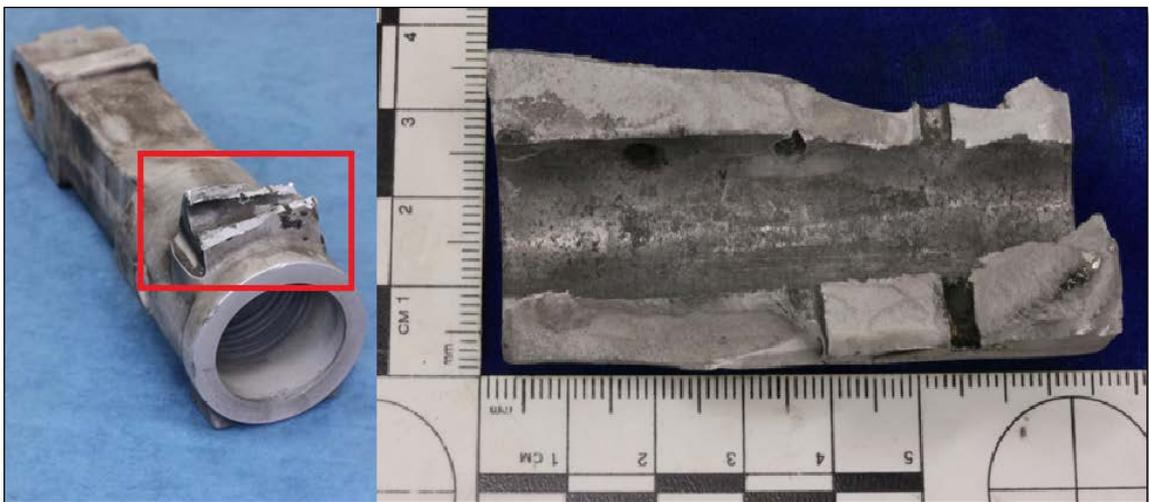
Figure 1 - Failed MLG Yoke Lug

Figure 1 shows the fracture of the lug can occur in the same plane as the spring (retaining) pin. On the inside surface of the lug, pitting corrosion can be clearly seen. The presence of unused spring pin holes on the landing gear torque link shaft may have allowed moisture to enter the bore and initiate this pitting corrosion. As per the manufacturer's instructions, these unused pin holes should be filled with sealant, not non-flexible fillers such as resin. M7 Aerospace SB 227-32-046 and SB CC7-32-012 specify filling these holes with MIL-S-8802 sealant (PR 1422). Importantly the lug shown in Figure 1 above had no sealant present in the unused spring pin holes.

It should also be noted that moisture can also enter the bore of the lug via the interface between the lug and mating torque link lug.

1. At the earliest opportunity, CASA recommends operators consider:
  - A. For operators with landing gear yoke torque link lugs with unused spring pin holes; carrying out a check for the presence of the correct sealant used for filling the unused spring pin holes in the yoke lug to prevent moisture ingress. If any doubt exists as to the type and integrity of the sealant the sealant should be replaced. Refer M7 Aerospace SB 227-32-046 (for aircraft with 16K landing gear) and SB CC7-32-012 (for commuter category aircraft).

2. CASA recommends at the next scheduled maintenance check:
  - A. Performing a detailed inspection of the MLG yoke torque link lug (upper & lower) for any signs of corrosion in accordance with M7 Aerospace inspection criteria (SRM 51-30-07). This will involve the removal of the retaining (spring) pins and the torque link shafts in order to inspect the lug bores. If corrosion is found, act in accordance with approved corrosion prevention and control techniques (SRM 51-30-08).

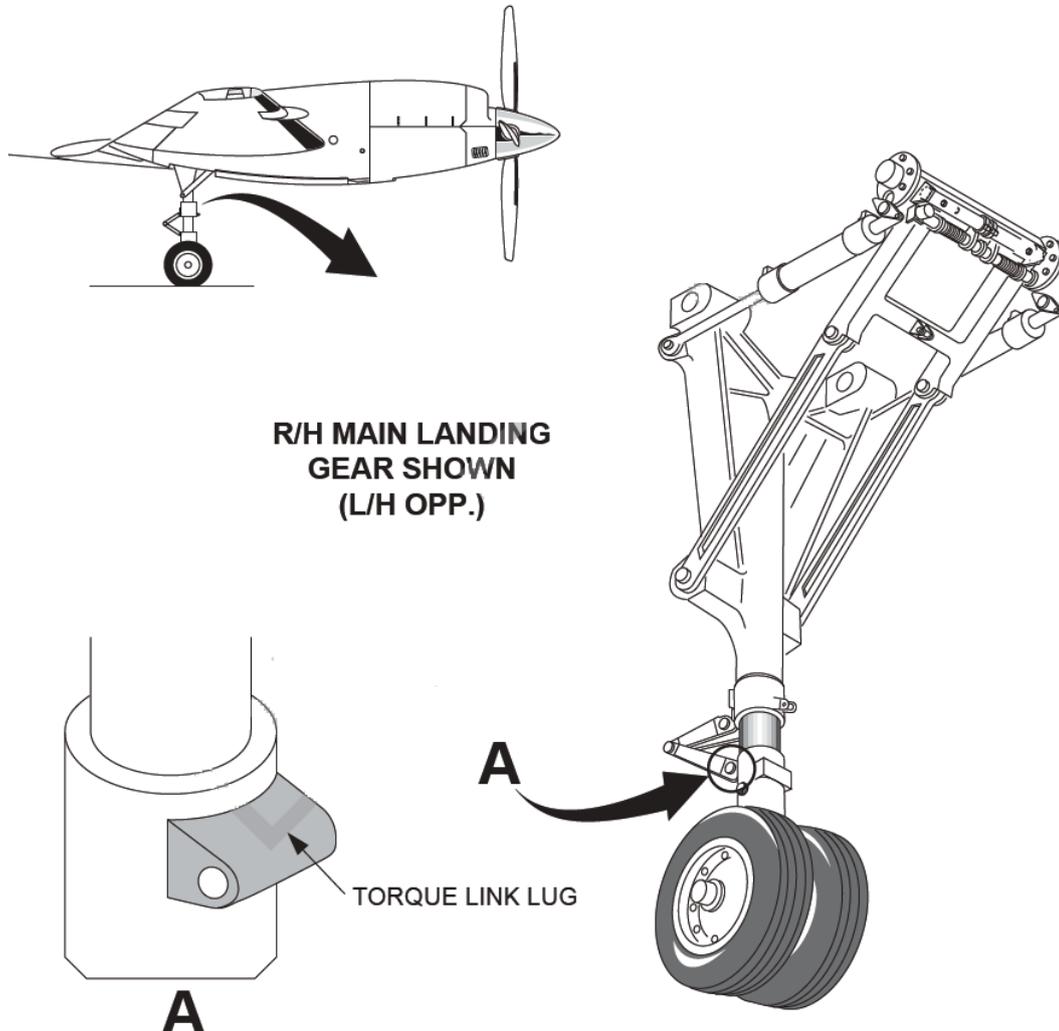
**Figure 2 – MLG Torque Link Lug Location**

Although there have been other areas of the landing gear inspected by NDT or detailed visual inspection, there are currently no detailed visual inspections or NDT requirements for the internals of the lug where this stress corrosion cracking is occurring.

- B. Ensuring all greased fittings on the torque links are working as intended (not blocked). Additionally, inspect all assemblies for excessive wear and replace as necessary. Particular attention should be given to excessive “play” caused by wear and tear on the side faces of the lug and the bushes in the torque links.
