AIRWORTHINESS BULLETIN

AWB 57-017 Issue 1 – 9 July 2020

Piper PA-28 and PA-32 Wing Spar Fatigue

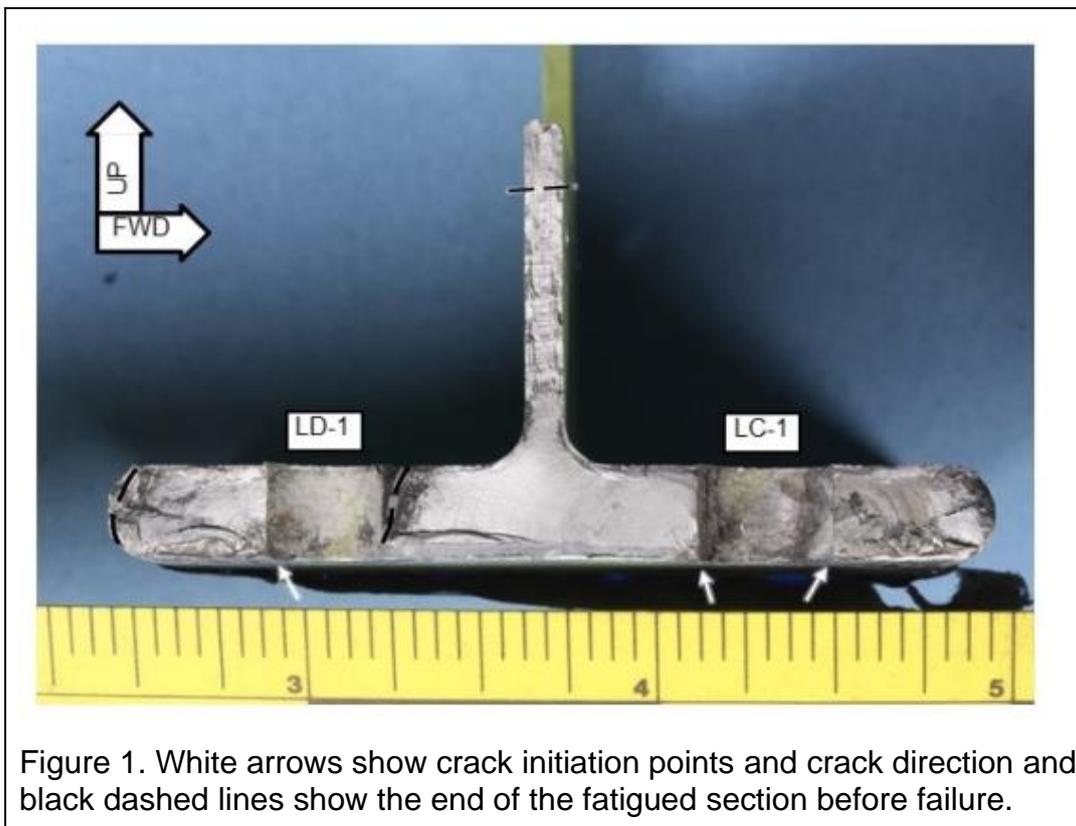
In December 2018 a wing separated from a Piper PA-28R-201 operated at a US flight school due to fatigue cracking of the left wing lower main spar cap (Figure 1.), two pilots were fatally injured. The right wing from the wreckage showed similar cracks in the lower spar attach outer bolts (see Figure 2). A further 16 aircraft from 4 other flight schools were inspected and one was found to be cracked in the same location. Other failures have occurred in the past on similar models, and in a similar location. These areas are not easily inspected during existing routine maintenance.

On accumulating 5000 factored service hours remove the two lower outboard main wing spar bolts (2 bolts on each wing) and inspect all layers inside bolt holes for cracks using bolt hole eddy current inspection method. Replace any main wing spar if a crack is detected with a new spar (zero hours TIS). Install new wing attach bolts. Reference Piper SB 1345.

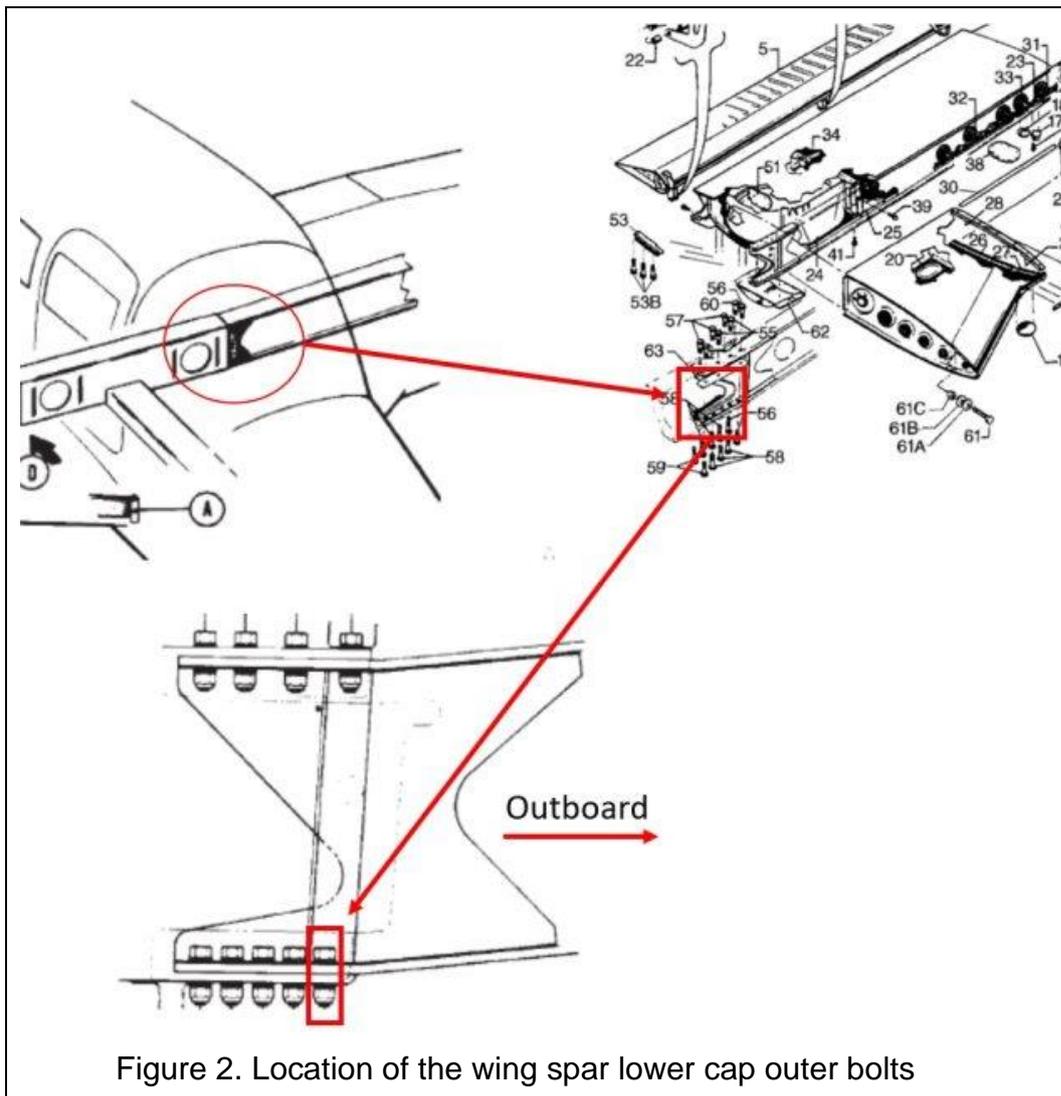
Figure 2. Location of the wing spar lower cap outer bolts
