Airworthiness Bulletin

AWB 85-023 Issue 3 – 10 June 2021

Piston Engine Spark Plug Insulator Cracking

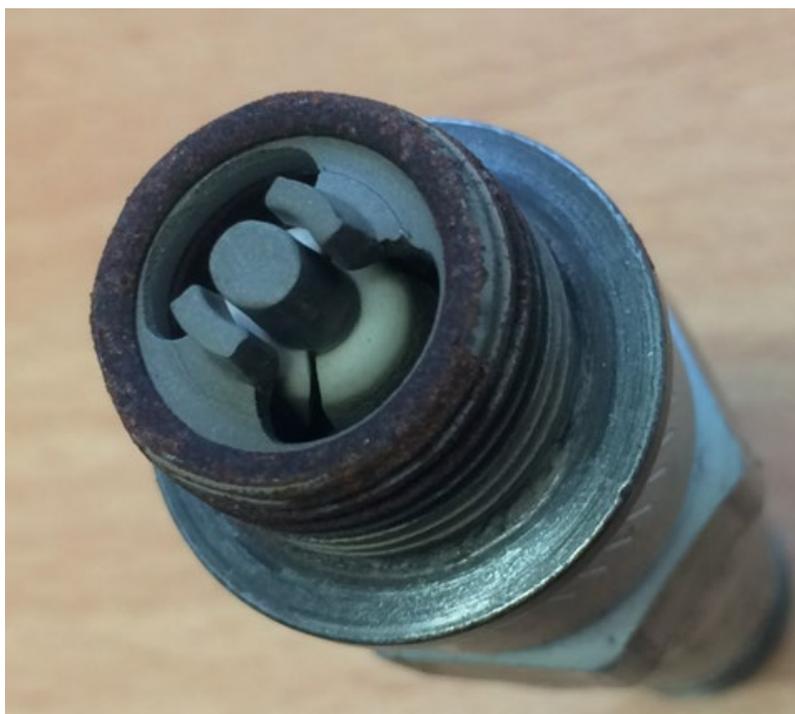
(Source: DRS No: 611851378)

Figure 1 – Spark Plug Insulator Cracking. (Massive Electrode)

The primary contributing factors for spark plug insulator (electrode insulator) cracking are considered to be.

- Pressure shockwaves from detonation
- Mishandling (dropping), improper cleaning or gapping
- Shockwaves and heat from crossfire induced pre-ignition.

Note: The majority of cracked ceramics are from mechanical impact in shipping handling and maintenance. The causes of detonation and pre-ignition are too many and varied to be discussed in detail in this bulletin. The following information provides an overview of the conditions and leading indicators.

Whilst the spark plug insulator material is hard it is also very brittle. If a plug is ever dropped from any height or has any mechanical damage it should be discarded. A cracked or damaged spark plug insulator can induce pre-ignition. Cracks start so small they need to be seen with magnification. If in doubt, throw it out.

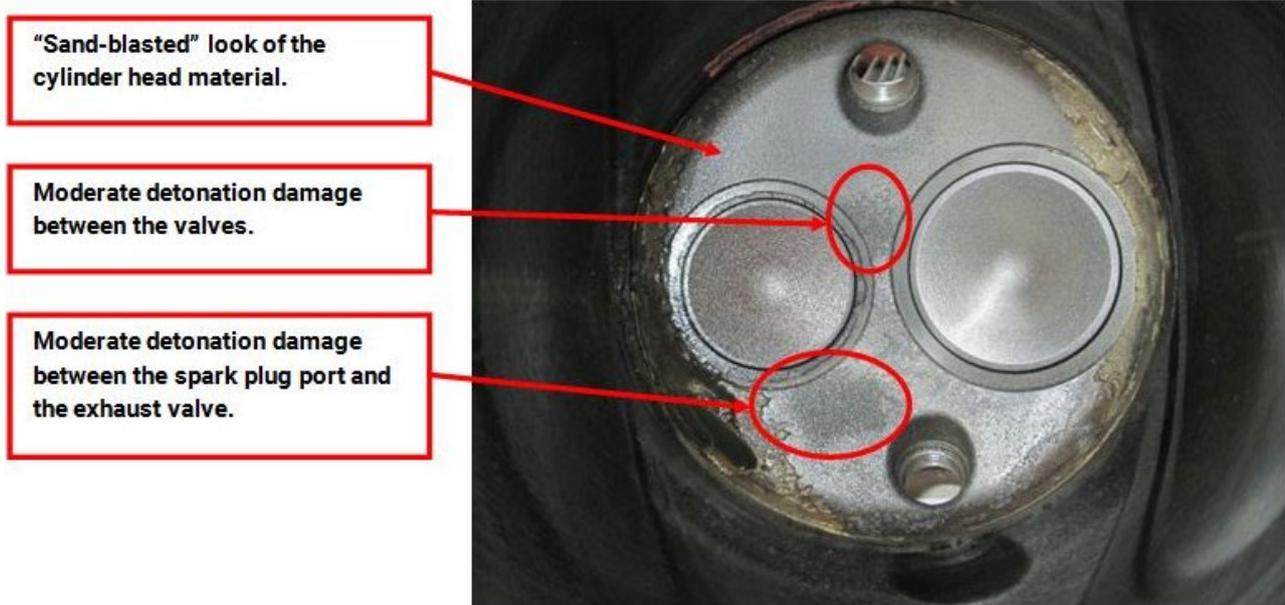
(Source: www.lycoming.com/contact/knowledge-base/tips)

When an engine has experienced light to medium detonation, there can be little or no additional evidence. Prolonged heavy detonation which can lead to spark plug damage becomes apparent upon cylinder removal or via borescope inspection. Detonation damage usually shows in the edges of pistons and on the cylinder head between the spark plug ports and valves. The cylinder head and piston should be inspected for a “sand-blasted” look. A lack of deposits or a clean head and piston face can also indicate that detonation has occurred, (see Figure 2a & 2b).

Figure 2a – Combustion Chamber Detonation

If you suspect that an engine has been experiencing detonation, remove the spark plugs for inspection as soon as possible and follow the engine manufacturer's recommendations for cause and correction.

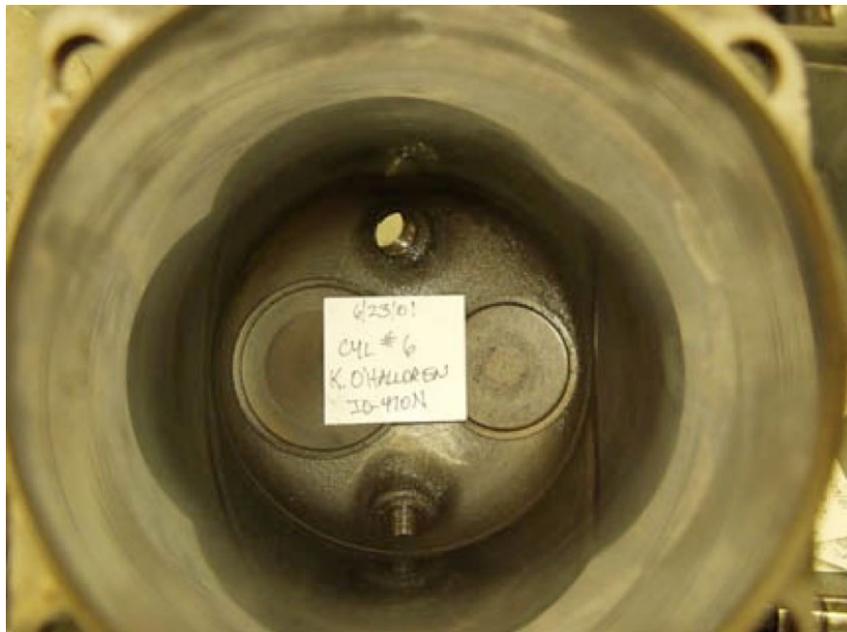
(Source: Advanced Pilot Seminars and General Aviation Modifications Inc)

Figure 2b – Combustion Chamber Detonation Testing*

* IO470N cylinder at TBO, tested with light detonation for 20 hours, medium detonation 2-3 hours and 30min of heavy detonation. Note it is completely clean, yet no physical damage occurred

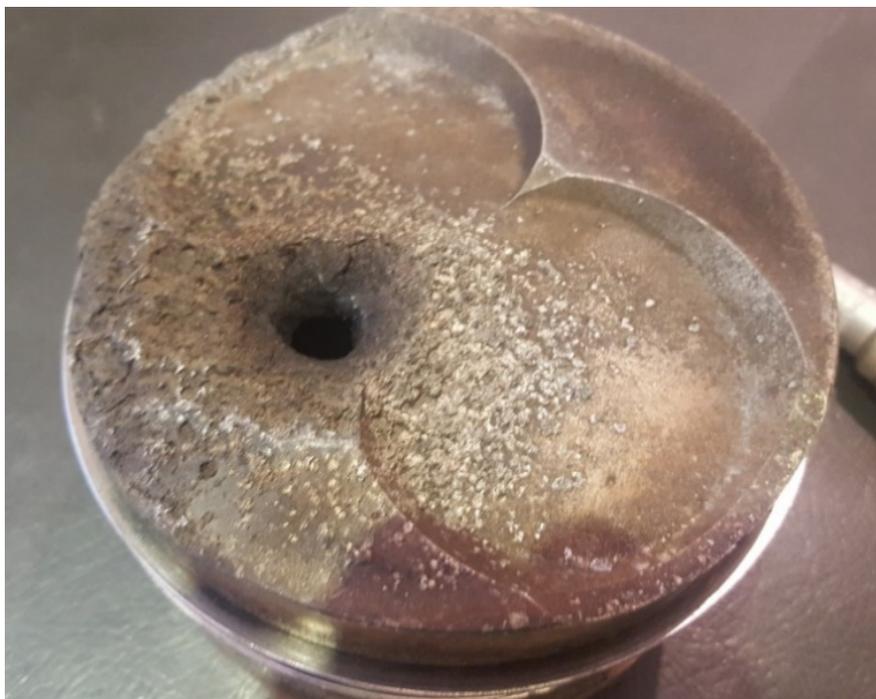
(Source: DRS No: 611851388)

Typically, pre-ignition results in localised overheating of the piston material and fusing of the piston crown. Failure of the cylinder is usually within 1-3 minutes of reaching approximately 500°F (260°C). A properly configured engine monitor is the best method of detection and intervention. Intervention requires full rich operation and any possible power reduction while maintaining flight to a suitable landing.

Figure 3. Pre-Ignition Piston Crown Damage

If you suspect that an engine has operated in pre-ignition, remove all spark plugs from the affected cylinder, discard them and inspect the cylinder with a borescope for possible damage. Follow the engine manufacturer's recommendations for inspection, damage correction and operational protective procedures.
