# Airworthiness Bulletin

**AWB 02-064 Issue 3 – 3 August 2021**

## Preventing Carbon Monoxide Poisoning in Piston Engine Aircraft

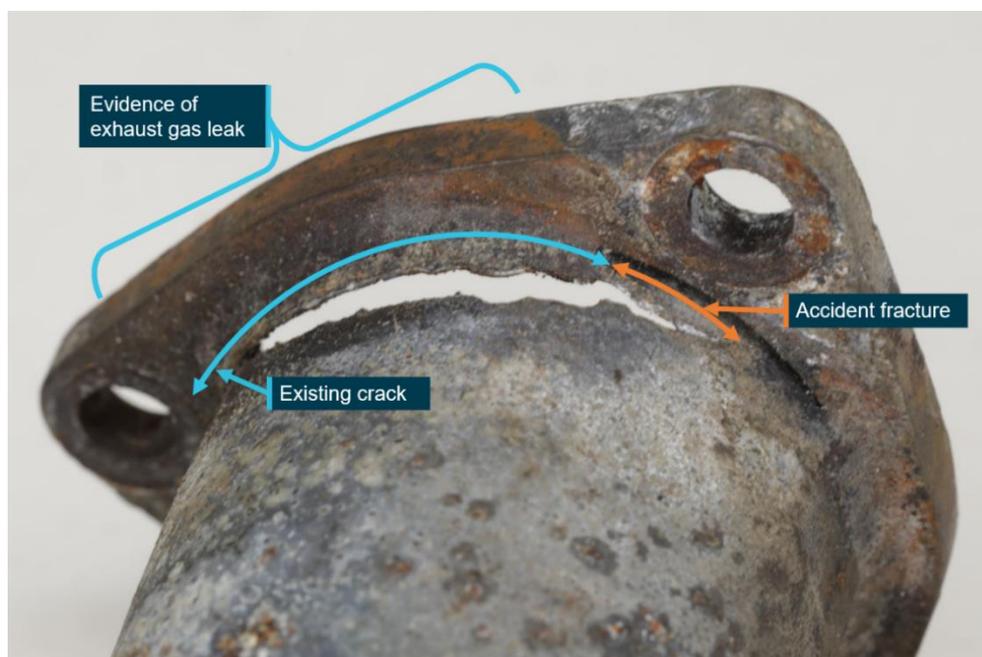
Figure 1

Engine exhaust unit potential to leak CO into the aircraft cabin. Image provided by Australian Transport Safety Bureau.

Firstly, the exhaust collector assemblies on piston powered aircraft are a known source of CO. Manufacturer's instructions for continued airworthiness (ICA) require regular inspection of exhaust pipe collectors and heat exchangers. Their useable life is centred on an "on condition" maintenance inspection philosophy and as such requires increased vigilance with ageing exhaust components.

The Civil Aviation Safety Authority recommends that when LAME/AMEs conduct visual inspections of exhaust collectors and heat exchange units, that a thorough inspection is conducted with the view of finding potential CO poisoning points/cracks. Whilst the internal condition and thickness of exhaust components is difficult to determine visually, if the component exhibits signs of thinning, cracking, bulging or any exhaust leakage the section should be removed and replaced with a new or serviceable/repaired item.

An ideal maintenance program would involve exhaust system replacement at engine change or at a predetermined interval gained from operating experience. To operate these items to a point of failure is not considered appropriate, the maintenance repair organisation or CAMO can instigate a periodic CO detection functional test during which the CO level in the cabin is measured. Quantitative CO must be used and the CO level entering the cabin must be less than 1 part in 20000 parts of air (equivalent to 50 parts per million).

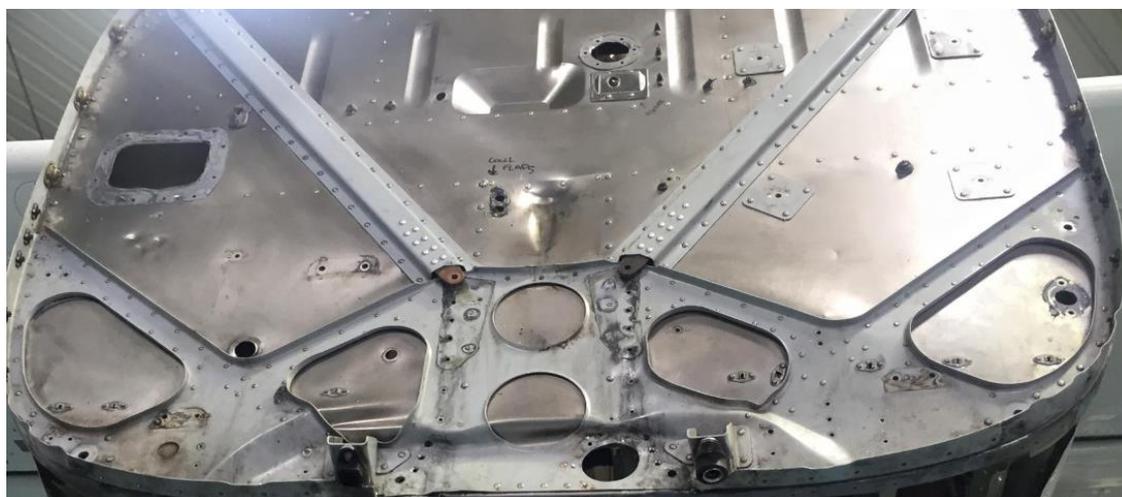
Figure 2

Secondly, the CO potentially enters the cabin either via heating ducting, open voids in the engine firewall or open doors and windows. Whilst the latter two are unavoidable, the firewall integrity, heating ducting and control valves need to be inspected to ensure correct operation and sealing. Modifications and access panels installed within firewalls for maintenance must be re sealed and secured correctly following all maintenance actions.

Engine firewall openings that may be required to be opened for maintenance and repairs must be correctly fastened and sealed prior to flight thus preventing CO from entering the cabin.

Approved modifications that include access panels and attachments to firewalls must be re-sealed following all disturbances to prevent CO entering the cabin. Heating ducts and on/off valves should function correctly, particularly in the off position to allow the pilot to stop the flow of contaminated air entering the cockpit. If an access panel on the engine firewall is opened/removed during maintenance/servicing for gaining access, ensure that the access panel seals/gaskets and hardware are reinstalled correctly to prevent the flow of gases and flammable fluids entering the cockpit and cabin.

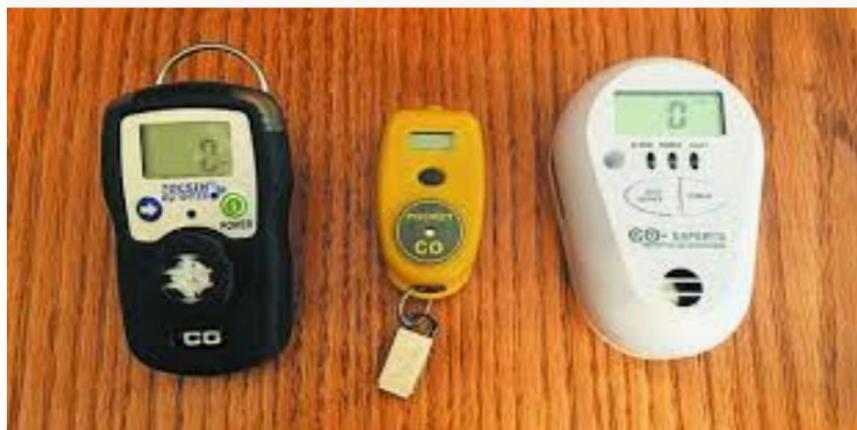
Figure 3

Electronic CO detector devices available for personal use.

CASA strongly recommends pilots wear personal CO detectors. As not all aircraft are required to have CO detectors fitted, small electronic personal devices are readily available at affordable prices. These devices allow for continual monitoring of CO levels with audible and visual warnings when escalated CO levels are detected.
