Airworthiness Bulletin

AWB 63-010 Issue 2 - 23 September 2021

Robinson Helicopter Drive Train Failure

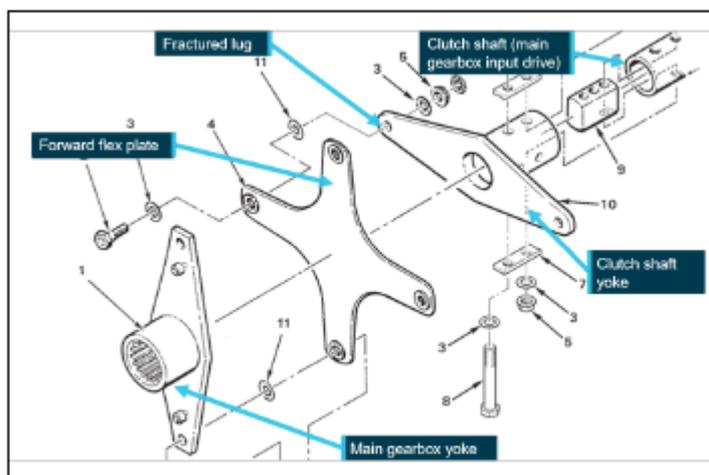
Figure 1 - Main gearbox and forward flex plate and yoke assembly.
Refer RHC online IPC/MM for current configuration data.

The ATSB has provided the preliminary results of an investigation (AO-2020-064) to CASA which highlighted a fatigue crack at a bolt hole on the C907 yoke's arm that connects to the flex plate of the main transmission drive.
