TCM Continental & Lycoming Engines:  
Failure of Weld Repaired Crankcases

AWB 85-015 Issue : 1  
Date : 19 April 2013

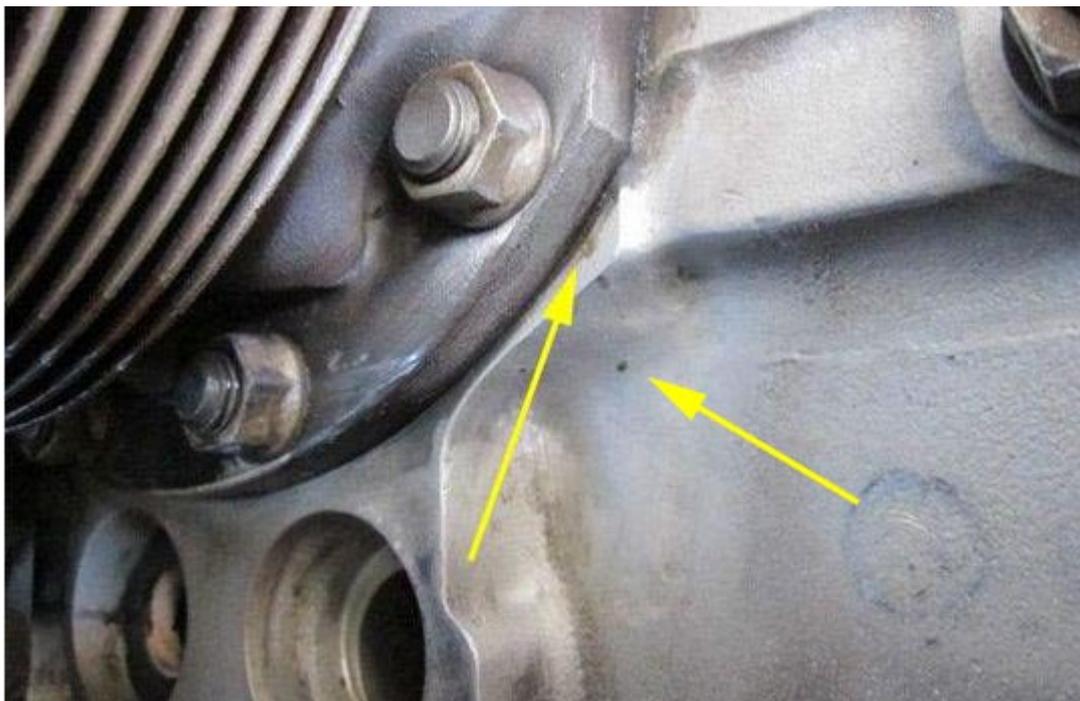
Figure 1 - Failure of a weld-repaired crankcase. Note crack from the cylinder base stud.

Factors such as inadequate pre-weld crack detection and cleaning, poor welding technique including the use of incorrect filler rod material and improper heat treatment prior to and following welding will result in an overall degradation of the parent crankcase material itself, including repaired areas that are weaker or softer than specification.

Weaker or softer crankcase material in the region of the cylinder retention studs can result in loss of stud torque due to the stud partially pulling out of the case and/or via crankcase cracking in the stud retention hole (See Figure 1).

2. After assembling an engine crankcase with weld repairs in the cylinder hold down area, consider implementing a torque check on cylinder hold-down nuts following the test run and again at 50 to 75 flight hours later. Consider removing from service any weld-repaired case with nuts which continue to move during the second check-torque.

3. Identify weld-repaired engines using technical documentation, visual inspection and/or engine case stampings. For those engines which have had an approved weld repair in the cylinder hold down area with less than 500 hours flight time, consider carrying out a torque check on all cylinder hold-down nuts within the next 100 hours of operation. Identify loose cylinder hold-down nuts in the aircraft engine log book and re-check at 50 to 75 flight hours later. Consider removing from service any weld-repaired case with nuts which continue to move during the second check-torque.
