2. Purpose

To alert operators, pilots and maintainers with updated and more comprehensive information regarding the main causes for the fuel system becoming contaminated by water which typically results in loss of power, rough running and engine failure.

Water Contamination of Aviation Fuel
(AVGAS / MOGAS)

AWB 28-008 **Issue** : 2
Date : 8 March 2016

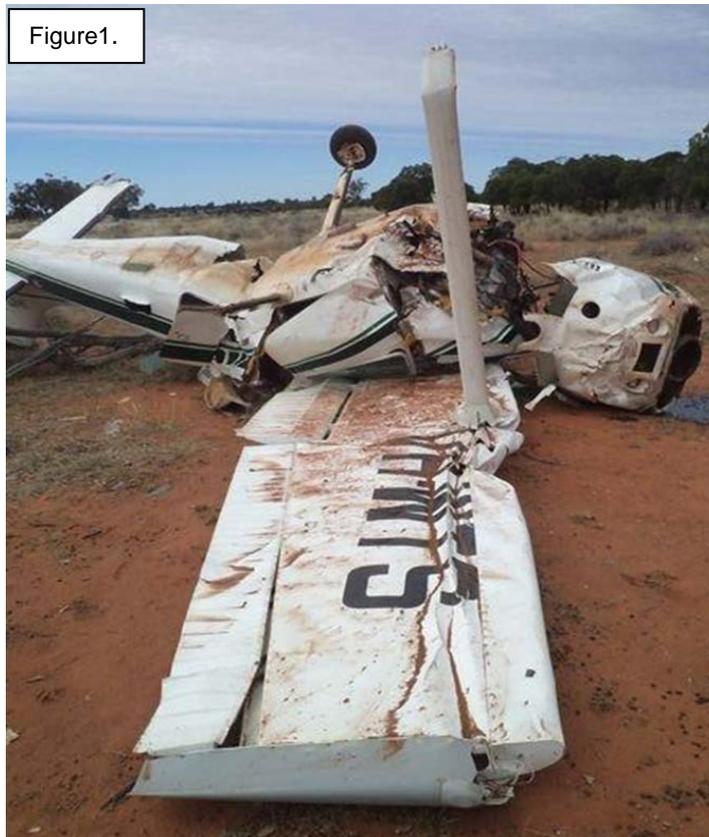
Figure1.

Shortly after take-off, the aircraft pictured opposite (Figure 1) lost power and clipped a tree during the subsequent forced landing.

The day before this flight, the aircraft was re-fuelled with 20L of AVGAS from a previously opened 200L (44 gallon) drum.

Despite the pilot taking fuel samples to test for water contamination, the accident investigation team found a considerable amount of water in fuel samples taken from a number of locations in the aircraft fuel system - and in the drum of AVGAS.

The hand pump used to transfer the fuel from the drum of AVGAS to the aircraft tanks was not fitted with a filter.

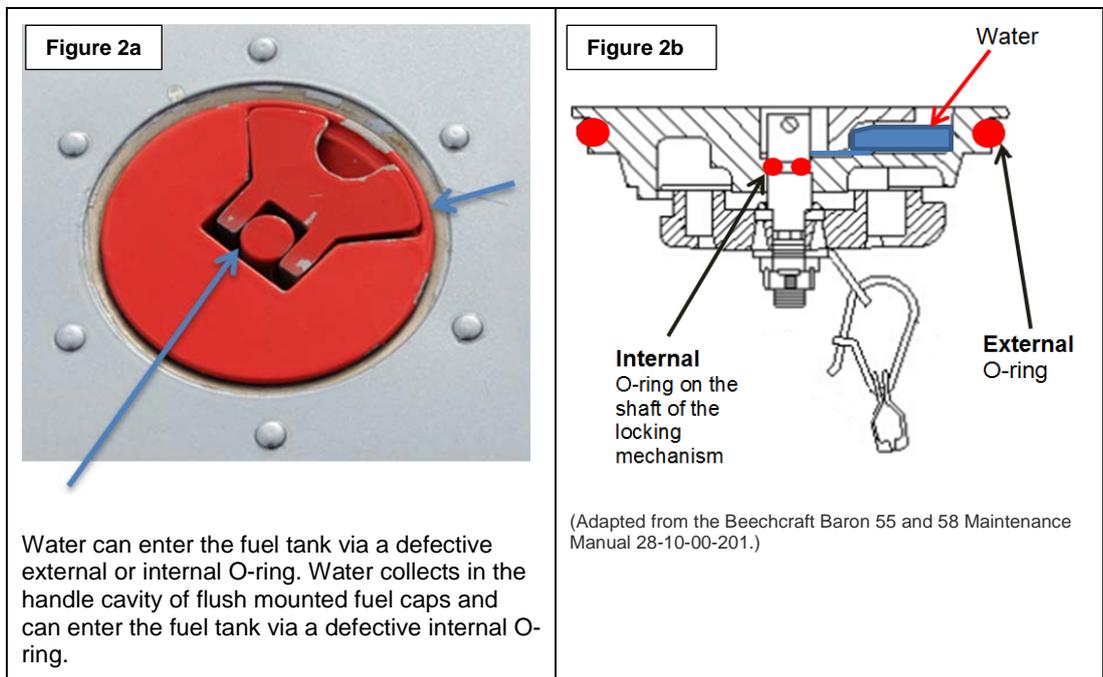
A deficient seal between the cap and tank filler neck permits water to enter the fuel tank, and allows fuel to be siphoned overboard via the cap in flight. Internal and external O ring seals can lose elasticity, perish and fail (Figures 2a and 2b). The final latch action should clamp the cap firmly into the filler neck and 'snap' fully flush on closing without any 'spring back'. The latch cannot be 'adjusted' to compensate for adverse wear on the latch cam or bearing plates (Figure 3).

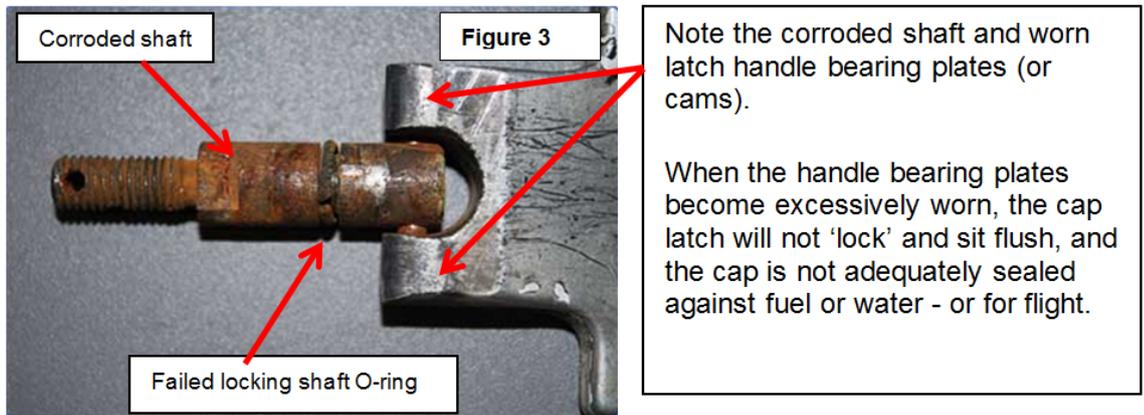
Beechcraft require a periodic fuel cap latch opening pull test. If excessive force is required to operate the latch, this may also be an indication that the locking shaft is binding due to corrosion following failure of the internal O-ring. (Figure 3).

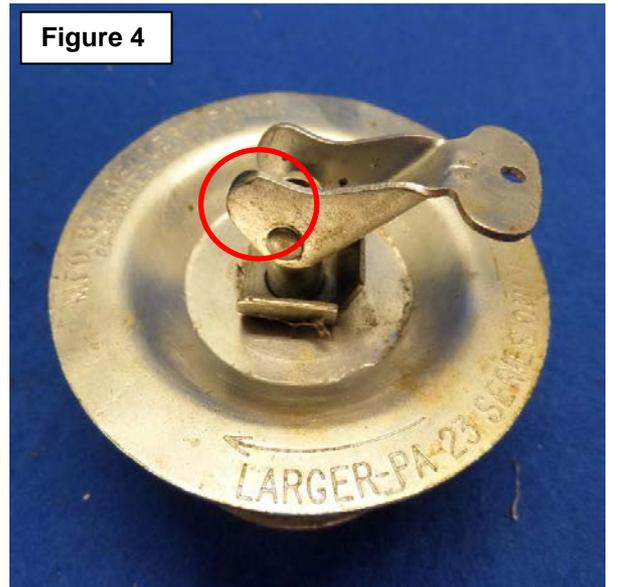
Figure 4

This type of cap sits in a depressed aluminium ring (Scupper) under a hinged fuel cell filler access cover which, when closed, is flush with the top wing skin to reduce drag. As the latch on the top of the tank fuel cap locks down, it shortens the length of the assembly and in so doing, expands the rubber plug section into the fuel tank filler neck for security and sealing. (Figure 4)

While slight wear on the cam (circled) may be compensated for by "larger" adjustment, the over-centre cam latching and locking function can be lost due to adverse cam wear.

The temptation is to adjust the cap for cam wear so that the latch will go 'down' and allow the outer hinged cover door to close.

Such action can result in a loose tank cap. The latch should always have a clearly defined over-centre lock action with the cap firmly sealing the fuel tank filler neck.

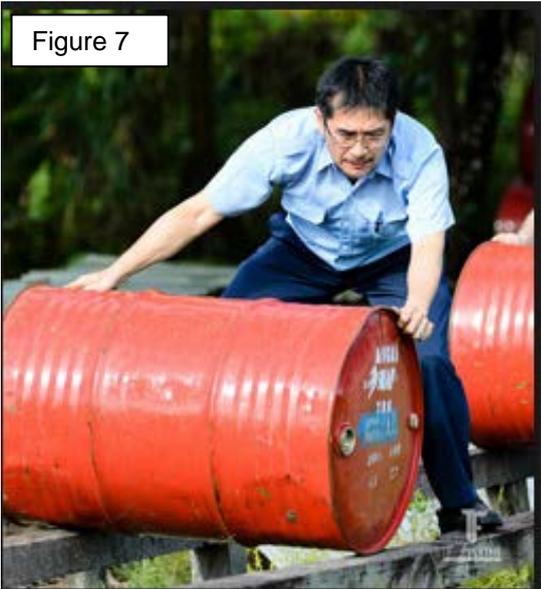
<p>Figure 7</p>	<p>Fuel drums should be stored on their side with the big and small bungs horizontal (9 o'clock & 3 o'clock position) and under shelter.</p> <p>If drums are stored on end (upright) in the open there is a strong possibility that water will collect in the head of the drum and subsequently be drawn into the fuel drum via the sealed bungs during the normal day/night - hot/cold temperature fluctuation.</p> <p>Source: Fuel for Life/MAF Canada</p>
---	--

Reject fuel from any drum if the seals are broken, or if the fuel is past the displayed expiry date. Aviation fuels have a comparatively short storage life. Using fuel past the expiry date may result in unpredictable engine performance.

When fuelling from drums, tip the drum on end, chock the bottom so that the larger bung is on the high side, and allow the fuel to settle for at least 30 minutes.

Test the fuel in the drum for water at the lowest point using a draw-pipe and water detecting paste. The fuel pump used to extract fuel from the drum should be equipped with a micro-filter, preferably with a water sensitive filter element, and a drainable sump.

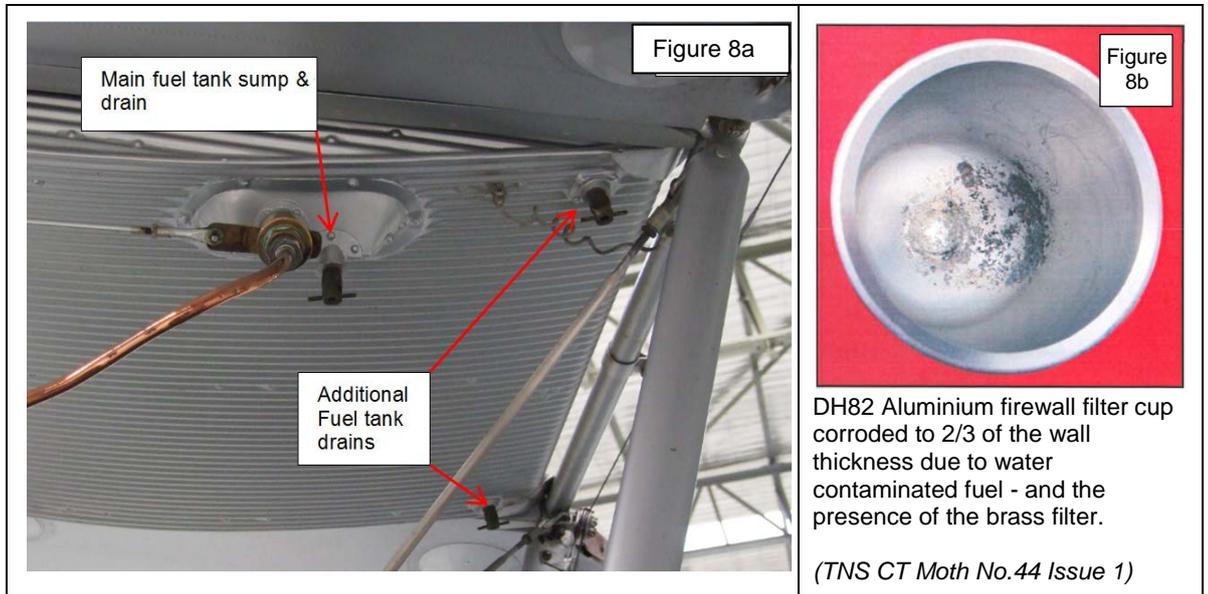
Another example is the DH82 Tiger Moth, and other DH Moth aircraft which, when on the ground (tail down) the main fuel tank sump and drain are not at the lowest point of the fuel tank. A significant amount of water can collect in the aft portion of the fuel tank. A fuel sample taken at the sump drain with the aircraft sitting on the ground will not access this water. Refer: [ATSB Occurrence Report 199503537](#) and [ATSB Recommendation R19980258](#).

As the tail comes up during the take-off run (and the aircraft rocks from side to side a little), the angle of the floor of the tank changes and tilts toward the main sump, and overcomes the acceleration forces on any undrained water which runs forward and collects in the main sump, now the lowest point of the fuel tank. This water is delivered to the engine via the fuel bowl on the firewall. If the fuel bowl fills with water, it will overflow and water will be delivered to the engine, resulting in loss of power and engine failure.

To overcome this problem, some operators have elected to install additional fuel tank drains at the aft portion of the DH82 fuel tank. (Figure 8a).
