Beechcraft Duchess Model B76 Series aeroplanes

Beechcraft Duchess B76 Series
Control Column Pivot Failures

AWB 53-009 **Issue** : 1
Date : 29 January 2016

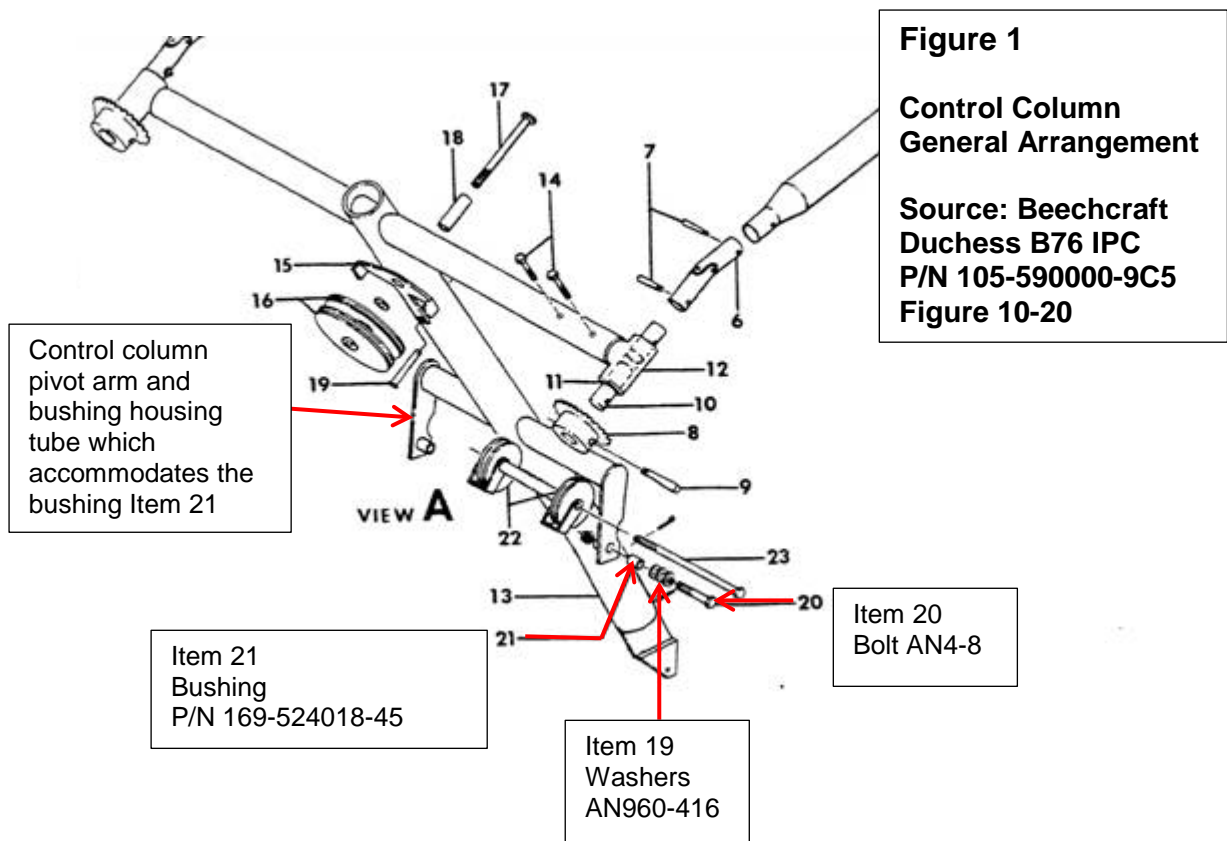
CASA has received multiple reports detailing main control column pivot hole wear, elongation including an occurrence where the AN4-8 pivot bolt head had pulled through a hole worn in Cover P/N 169-400005-387.

Loss of a control column pivot anchor point means the control column has nothing to pivot about, particularly on the side of the aircraft on which pivot failure occurs, and which could lead to a loss of elevator control.

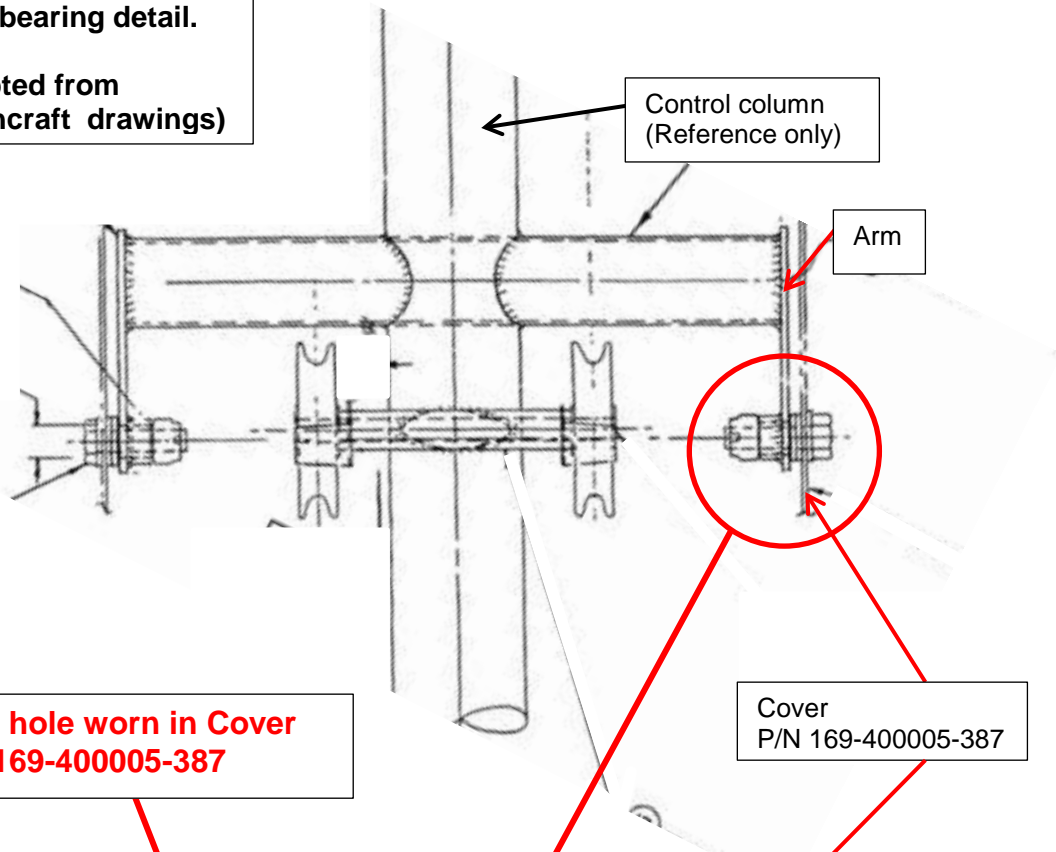
Figure 2a.

**Control Column &
Pivot bearing detail.**

The column is designed to rotate about two bushings (Figure 1 Item 21) which should be tightly clamped against the cover assembly by the bolts (Figure 1 Item 20). The bushes should be slightly longer than, and move freely within the welded tube bushing housings in the control column arms.

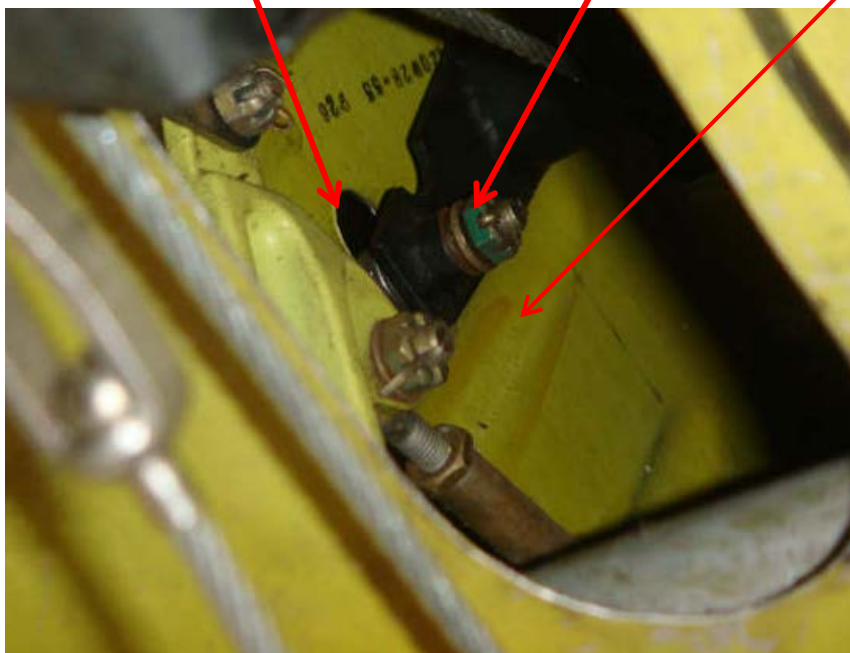
Figure 2b.

**Note hole worn in Cover
P/N 169-400005-387**

As the hole in the cover assembly increases in size, there will be increasing 'slop' or play in the control column pivot assembly, to the extent that the head of the bolt may pull through the cover, resulting in reduced and possible loss of elevator control.

- a. The control column pivots (left and right) are inspected for wear, lack of lubrication, loss of bolt torque and damage to cover P/N 169-400005-387.
- b. The pivot bushings are correctly installed and functioning as intended, and
- c. Defects discovered as a result of the inspection are rectified at each 100 hour/12month inspection, and that consideration be given to reducing the current manufacturers lubrication interval for the control column pivot bushes from 1000 hours to 500 hours, in accordance with the provisions of the Beechcraft Duchess 76 Maintenance Manual Chapter 05 - Time Limits / Maintenance Checks; *SECIAL CONDITIONS CAUTIONARY NOTICE* to reduce the risk of bushings seizing.

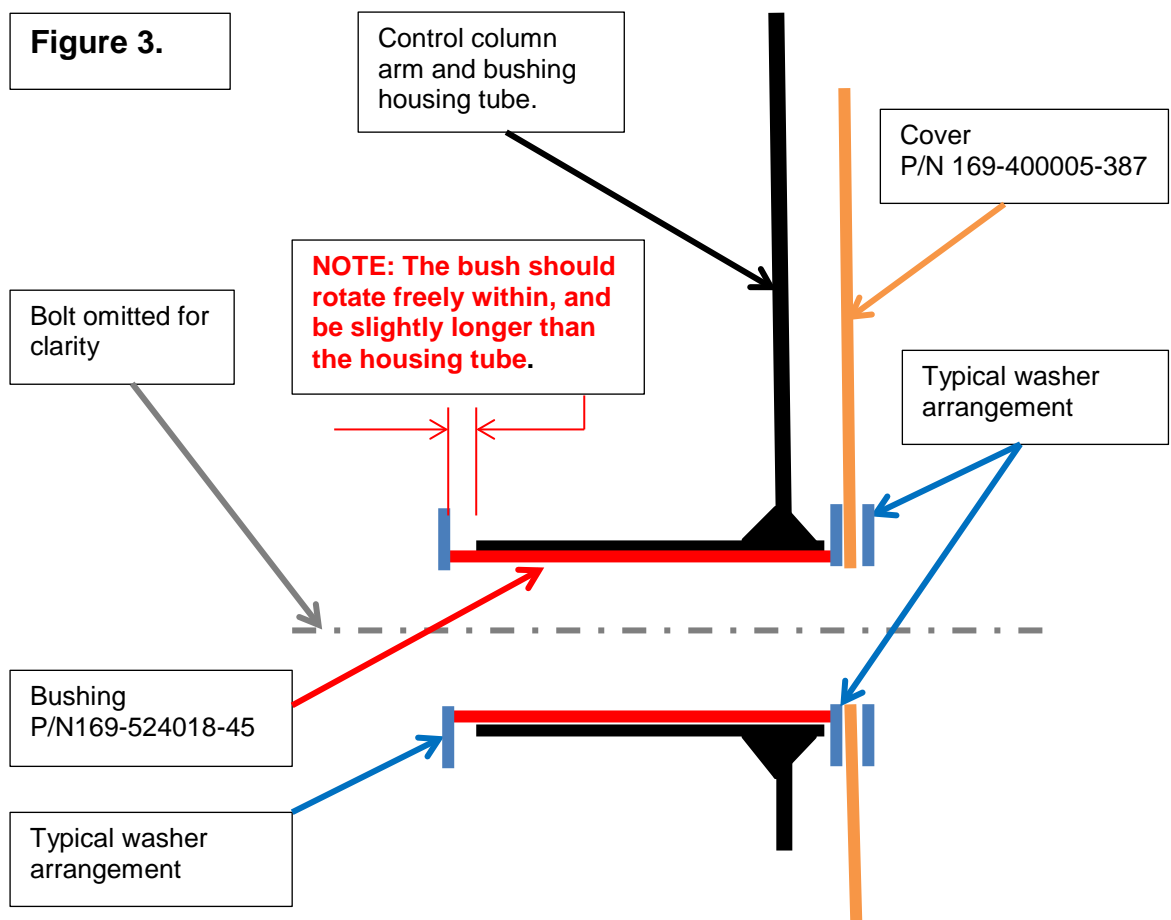
When the bolts are correctly torqued, the bushes will be clamped against the tunnel wall which is protected by steel washers. (Figure 3) The only relative motion should be between the control column and the bushings as the yoke is moved back and forth to control the elevators.

If the pivot bushes are not lubricated, they will likely become seized inside the control column arm tubes, together with the bolt, and possibly wear into the sheet metal cover, reducing the thickness of the cover in the local contact area and severely reducing the clamp-up torque on the bolt. This can then allow the thin sheet metal cover to support the pivot bolt and inadvertently become a bearing, allowing the bolt and washer to rapidly wear a hole in the cover assembly.
