To alert operators, pilots and maintainers with updated and more comprehensive information regarding the main causes for the fuel system becoming contaminated by water which typically results in loss of power, rough running and engine failure.

Water Contamination of Aviation Fuel
(AVGAS / MOGAS)

AWB 28-008 **Issue** : 2
Date : 8 March 2016

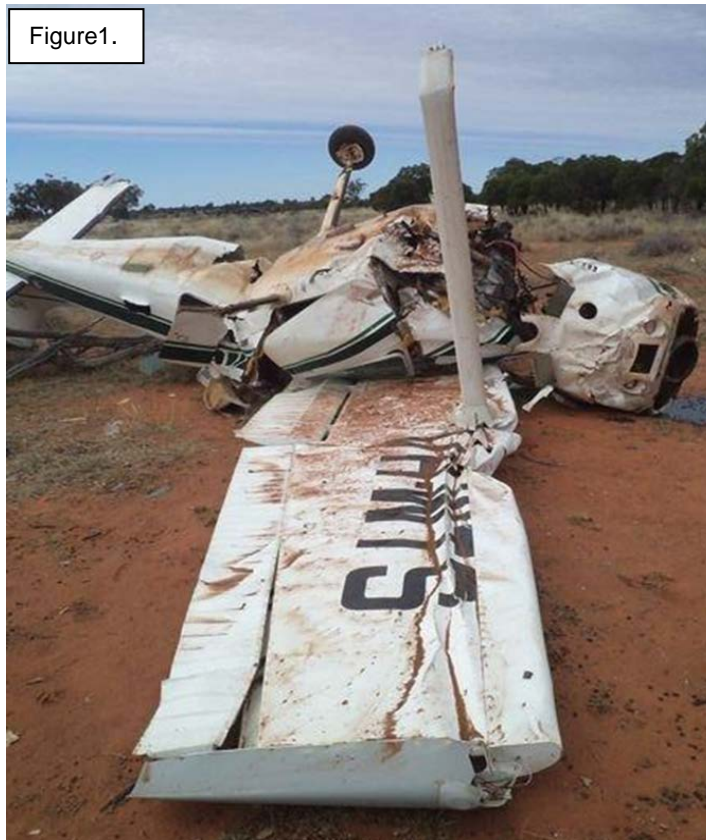
Figure1.

Shortly after take-off, the aircraft pictured opposite (Figure 1) lost power and clipped a tree during the subsequent forced landing.

The day before this flight, the aircraft was re-fuelled with 20L of AVGAS from a previously opened 200L (44 gallon) drum.

Despite the pilot taking fuel samples to test for water contamination, the accident investigation team found a considerable amount of water in fuel samples taken from a number of locations in the aircraft fuel system - and in the drum of AVGAS.

The hand pump used to transfer the fuel from the drum of AVGAS to the aircraft tanks was not fitted with a filter.

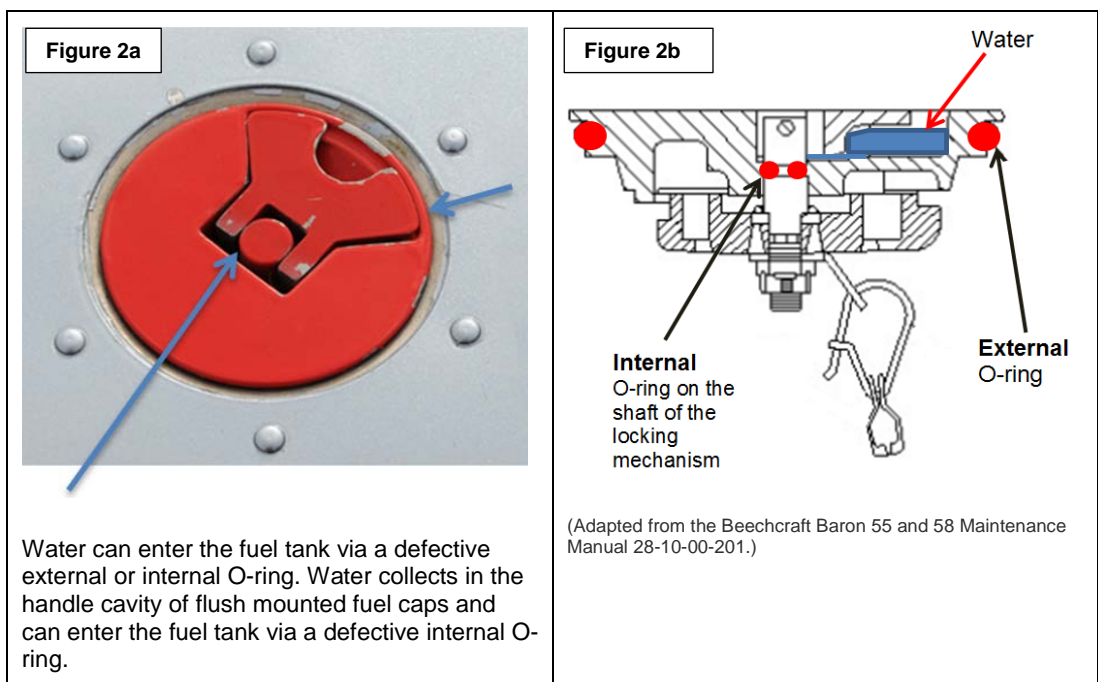
A deficient seal between the cap and tank filler neck permits water to enter the fuel tank, and allows fuel to be siphoned overboard via the cap in flight. Internal and external O ring seals can lose elasticity, perish and fail (Figures 2a and 2b). The final latch action should clamp the cap firmly into the filler neck and 'snap' fully flush on closing without any 'spring back'. The latch cannot be 'adjusted' to compensate for adverse wear on the latch cam or bearing plates (Figure 3).

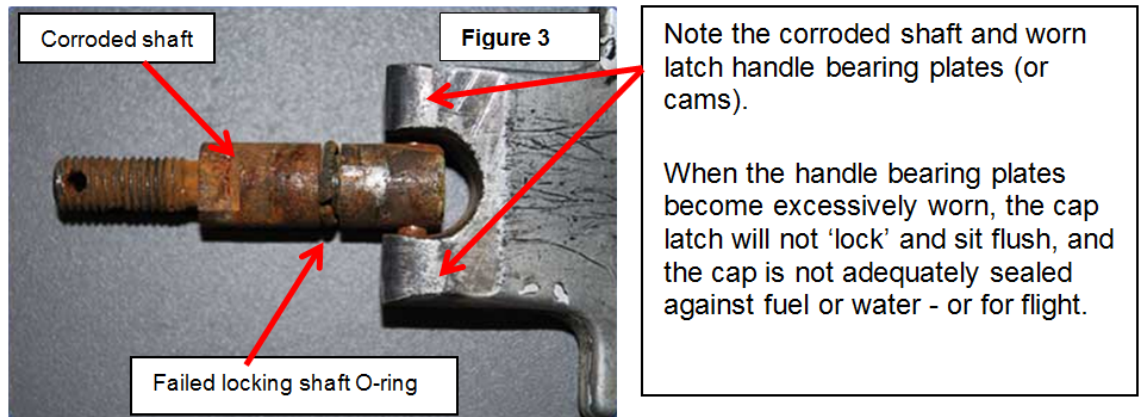
Beechcraft require a periodic fuel cap latch opening pull test. If excessive force is required to operate the latch, this may also be an indication that the locking shaft is binding due to corrosion following failure of the internal O-ring. (Figure 3).

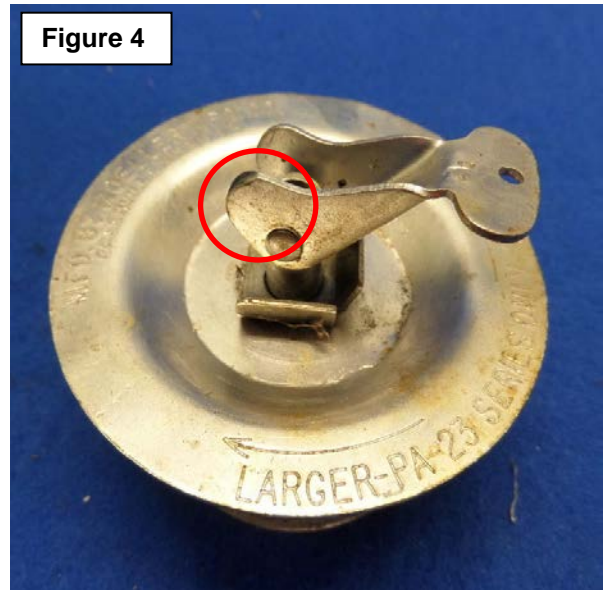
Figure 4

This type of cap sits in a depressed aluminium ring (Scupper) under a hinged fuel cell filler access cover which, when closed, is flush with the top wing skin to reduce drag. As the latch on the top of the tank fuel cap locks down, it shortens the length of the assembly and in so doing, expands the rubber plug section into the fuel tank filler neck for security and sealing. (Figure 4)

While slight wear on the cam (circled) may be compensated for by "larger" adjustment, the over-centre cam latching and locking function can be lost due to adverse cam wear.

The temptation is to adjust the cap for cam wear so that the latch will go 'down' and allow the outer hinged cover door to close.

Such action can result in a loose tank cap. The latch should always have a clearly defined over-centre lock action with the cap firmly sealing the fuel tank filler neck.

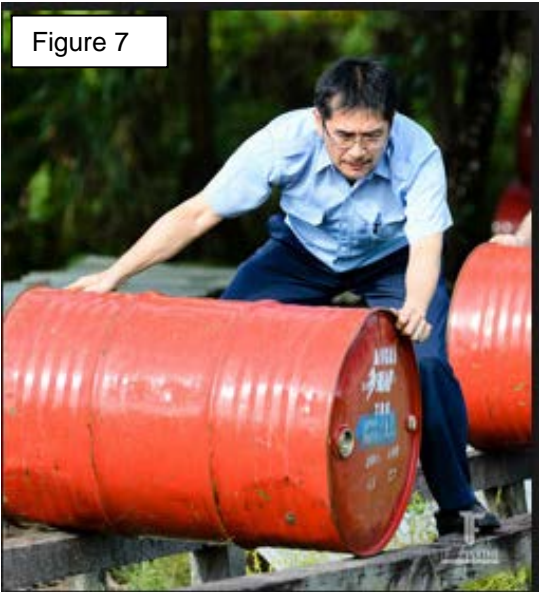
<p>Figure 7</p>	<p>Fuel drums should be stored on their side with the big and small bungs horizontal (9 o'clock & 3 o'clock position) and under shelter.</p> <p>If drums are stored on end (upright) in the open there is a strong possibility that water will collect in the head of the drum and subsequently be drawn into the fuel drum via the sealed bungs during the normal day/night - hot/cold temperature fluctuation.</p> <p>Source: Fuel for Life/MAF Canada</p>
---	--

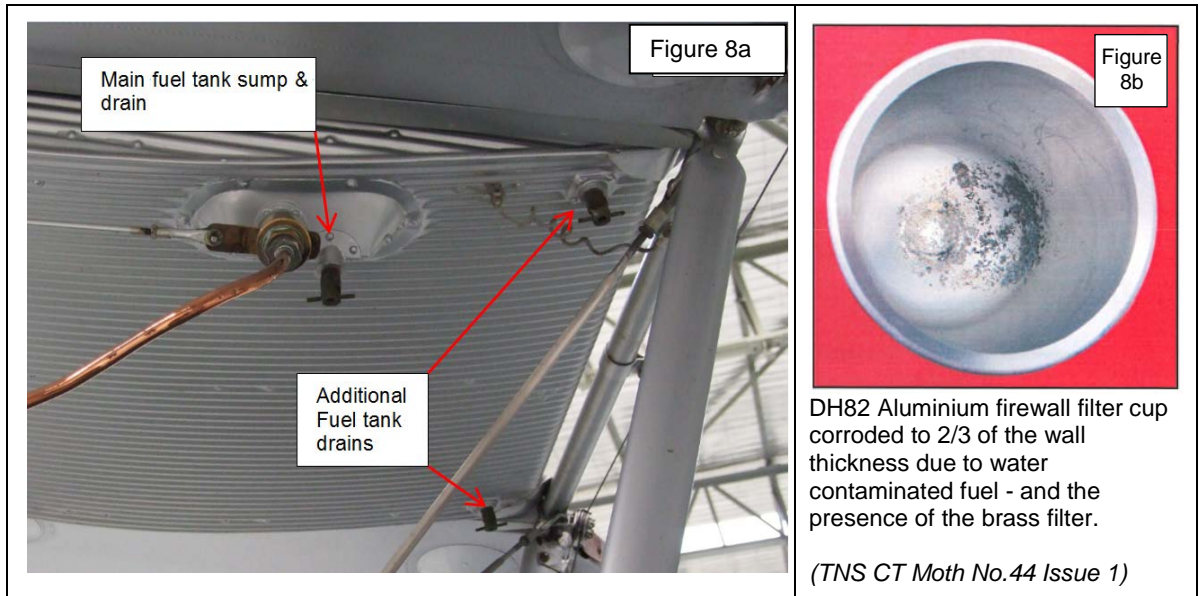
Another example is the DH82 Tiger Moth, and other DH Moth aircraft which, when on the ground (tail down) the main fuel tank sump and drain are not at the lowest point of the fuel tank. A significant amount of water can collect in the aft portion of the fuel tank. A fuel sample taken at the sump drain with the aircraft sitting on the ground will not access this water. Refer: [ATSB Occurrence Report 199503537](#) and [ATSB Recommendation R19980258](#).

As the tail comes up during the take-off run (and the aircraft rocks from side to side a little), the angle of the floor of the tank changes and tilts toward the main sump, and overcomes the acceleration forces on any undrained water which runs forward and collects in the main sump, now the lowest point of the fuel tank. This water is delivered to the engine via the fuel bowl on the firewall. If the fuel bowl fills with water, it will overflow and water will be delivered to the engine, resulting in loss of power and engine failure.

To overcome this problem, some operators have elected to install additional fuel tank drains at the aft portion of the DH82 fuel tank. (Figure 8a).
