AIRWORTHINESS BULLETIN

Cessna Single Engine
Retractable Undercarriage Failures

AWB 32-026 **Issue** : 1
Date : 10 March 2016

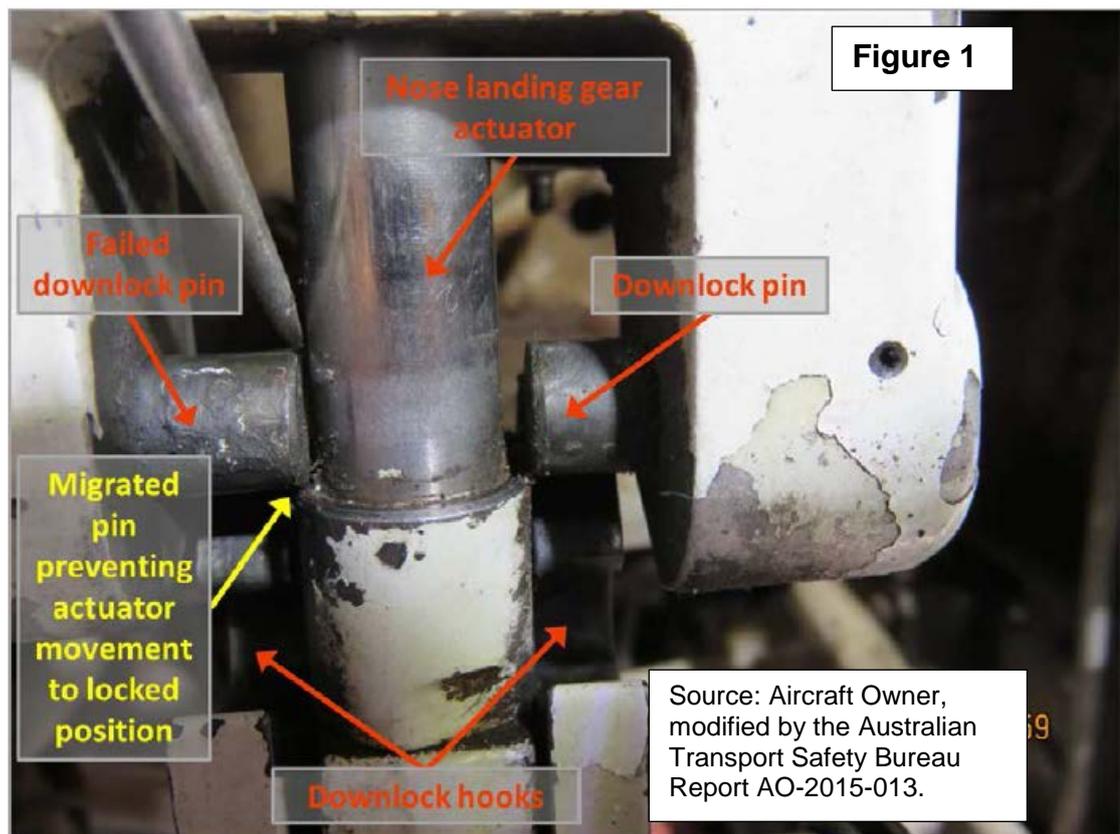
Following multiple reports of nose gear actuator down lock pin failures in Australia and overseas, in 1998 CASA issued AAC 1-102 Nose Gear Actuator Down Lock Pin Failures in Cessna 172RG, R182 and 210 aircraft, and recommended the incorporation of Cessna SEB95-20 and SK210-155 to inspect for and replace cracking and loose lock pins. (Figure1).

The old style nose landing gear down lock pins work loose, crack and fail at the retaining groove, which allows them to move out and jam the undercarriage actuator. This prevents the nose landing gear from locking fully down. The nose gear typically collapses on landing. ATSB report AO-2015-013 reflects that the US National Transport Safety Board (NTSB) has received over 30 reports of failed nose landing gear down lock pins.

Cessna SEB 95-20 was raised to address these failures and is applicable to a wide range of Cessna 172RG, R182 and 210 aircraft.

CASA strongly recommends the incorporation of Cessna SID inspections for all Cessna aircraft undercarriage structures and systems, including Cessna SEB 95-20, currently omitted from the SID requirements for the Cessna 210 series.

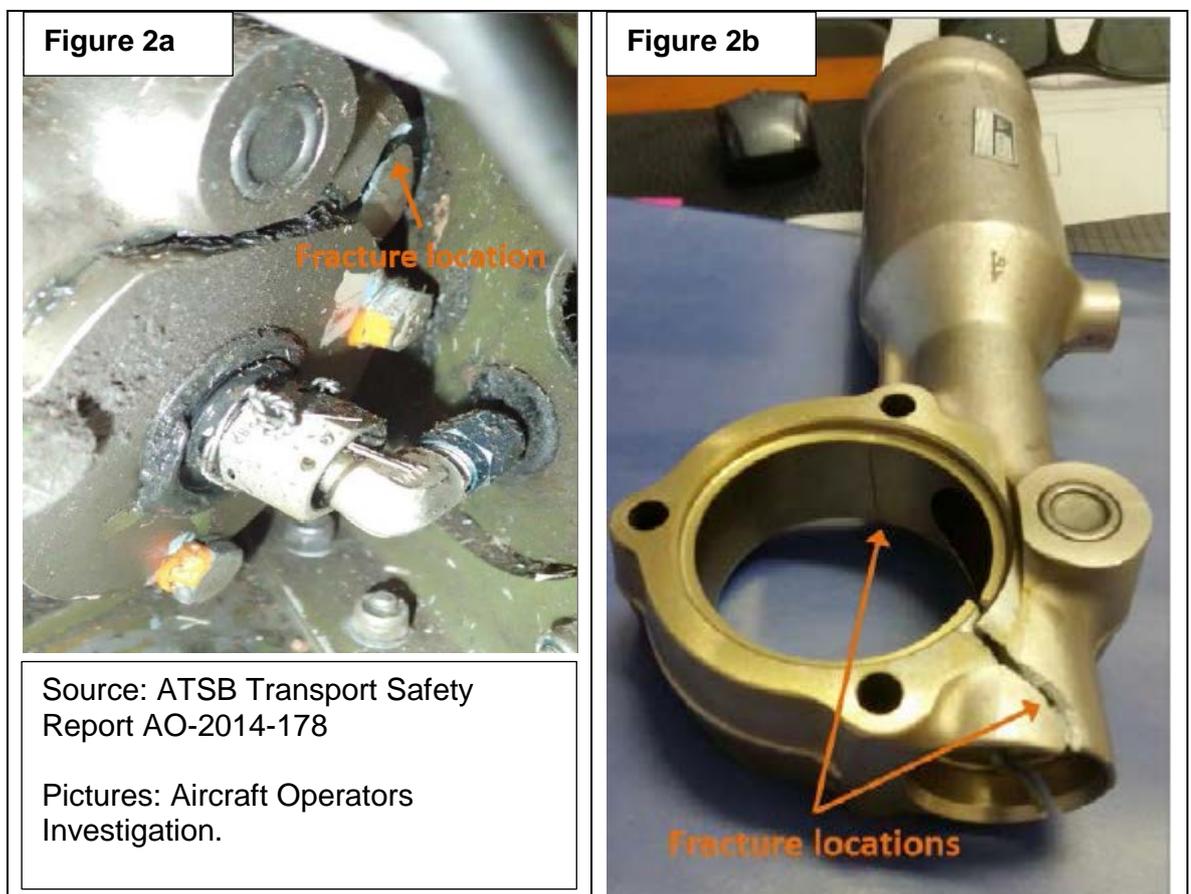
For example, ATSB Report AO-2014-178 describes a Cessna 210 left main landing gear actuator which cracked open (Figure 2a and 2b) and failed to extend the left main gear leg. The pilot elected to land with the undercarriage retracted.
