AIRWORTHINESS BULLETIN

AWB 62-006 Issue 1 – 23 December 2016

Alert – R22 Main Rotor Blade cracking

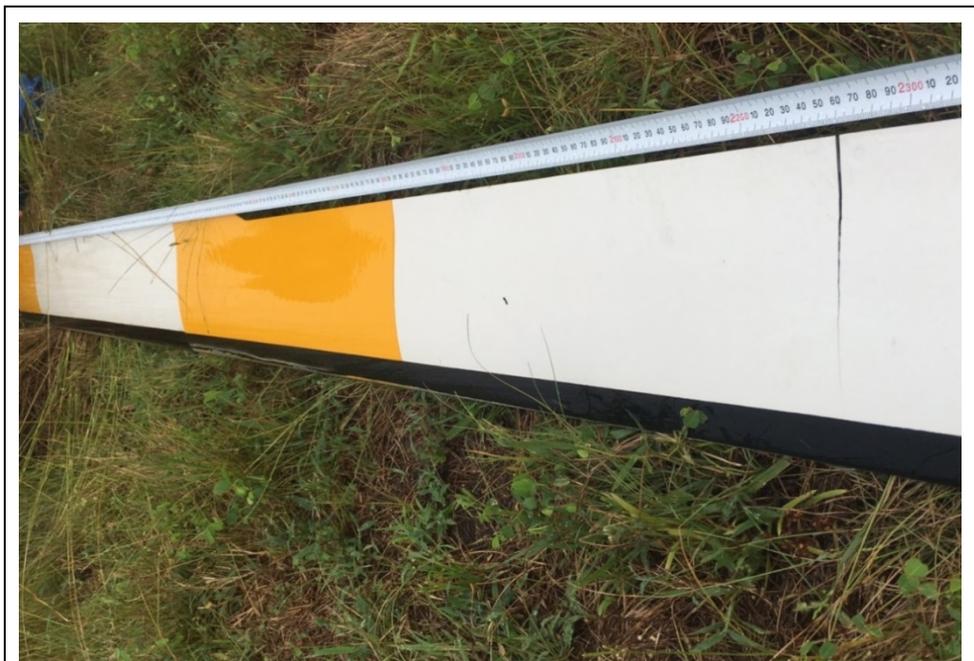
Figure 1 – Location of crack

During low level operations at slow airspeed the pilot of a Robinson R22 Beta II helicopter experienced an unusual increase in vibration levels and commenced a landing. Shortly before making a successful landing and whilst in the hover the pilot reported an increase in vertical vibration levels and a decrease in power available. Subsequent inspection revealed a crack approximately 160 mm in length emanating from the trailing edge and running chord wise toward the D section spar; refer to figure 1.

The crack location is in the vicinity of blade station RS61 which, measured from the blade tip (with tip cap removed) is approximately 2285mm inboard of the blade end.

Evidence of very minor corrosion was observed on the trailing edge in the vicinity of the crack. The operator reported that the total time in service of this blade was 1782.7 hours, the manufacturer stipulates a life limit of 2200 hours or 12 years for part number A016-6 Main Rotor blades.

CASA highly recommends that when carrying out the MR blade inspection required as part of the Daily or Preflight checks contained in the Robinson R22 Pilot's Operating Handbook (POH) particular attention should be directed to the MR blade trailing edges.

This inspection may provide more reliable results by conducting the inspection on the white upper surface of the blades due to colour contrast.

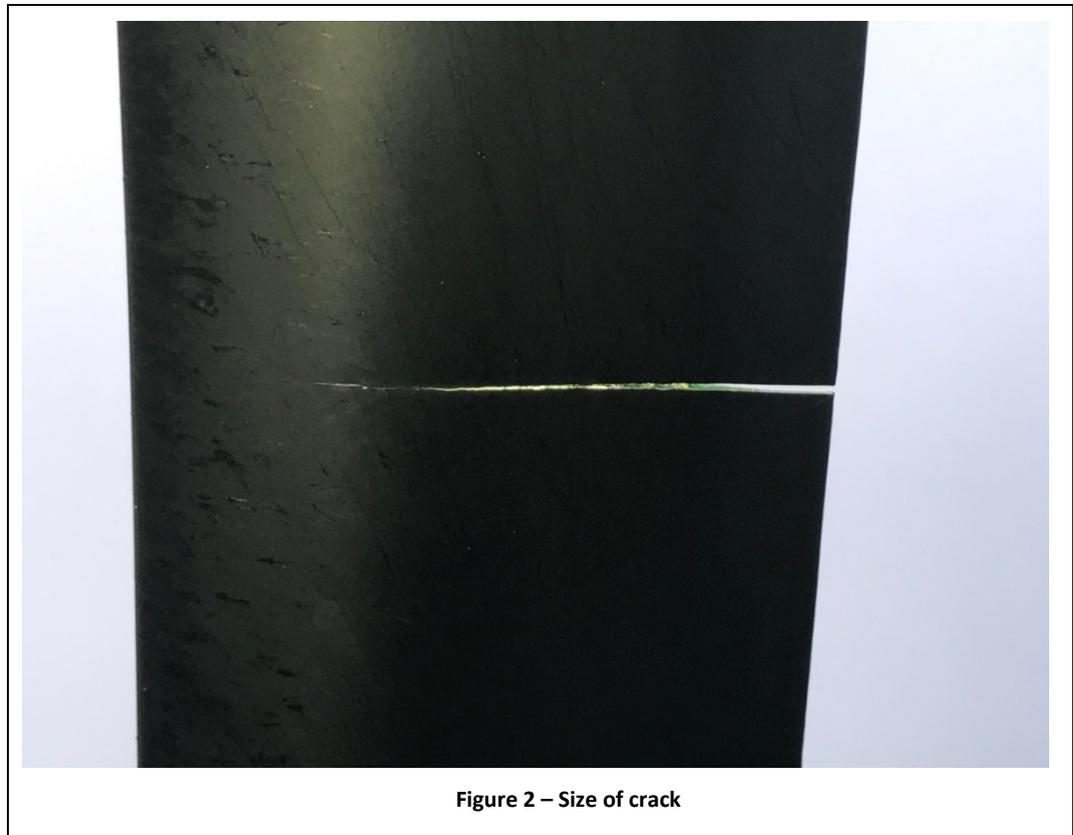
The blade is currently being investigated by the ATSB however at this stage details are limited with the root cause yet to be determined.
