AIRWORTHINESS BULLETIN

AWB 57-017 Issue 1 – 9 July 2020

Piper PA-28 and PA-32 Wing Spar Fatigue

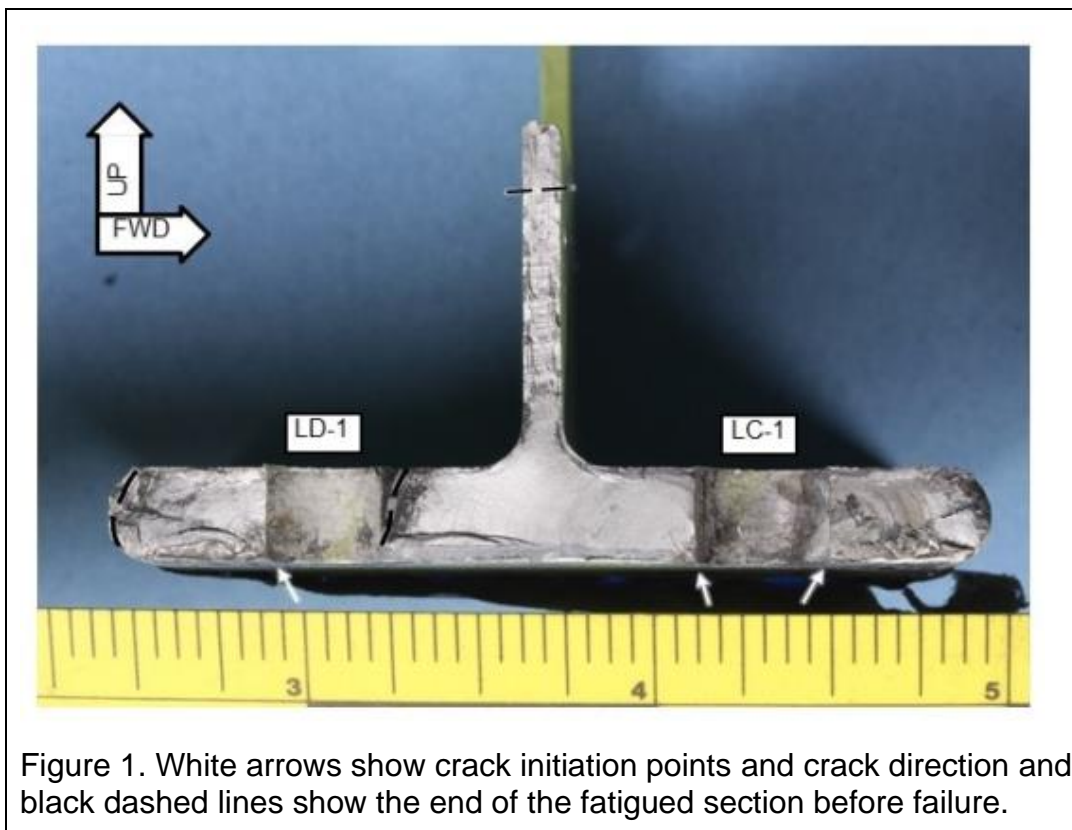
In December 2018 a wing separated from a Piper PA-28R-201 operated at a US flight school due to fatigue cracking of the left wing lower main spar cap (Figure 1.), two pilots were fatally injured. The right wing from the wreckage showed similar cracks in the lower spar attach outer bolts (see Figure 2). A further 16 aircraft from 4 other flight schools were inspected and one was found to be cracked in the same location. Other failures have occurred in the past on similar models, and in a similar location. These areas are not easily inspected during existing routine maintenance.

On accumulating 5000 factored service hours remove the two lower outboard main wing spar bolts (2 bolts on each wing) and inspect all layers inside bolt holes for cracks using bolt hole eddy current inspection method. Replace any main wing spar if a crack is detected with a new spar (zero hours TIS). Install new wing attach bolts. Reference Piper SB 1345.
