Control Cable Terminal - Retirement

AWB 27-001 **Issue** : 7
Date : 8 March 2016

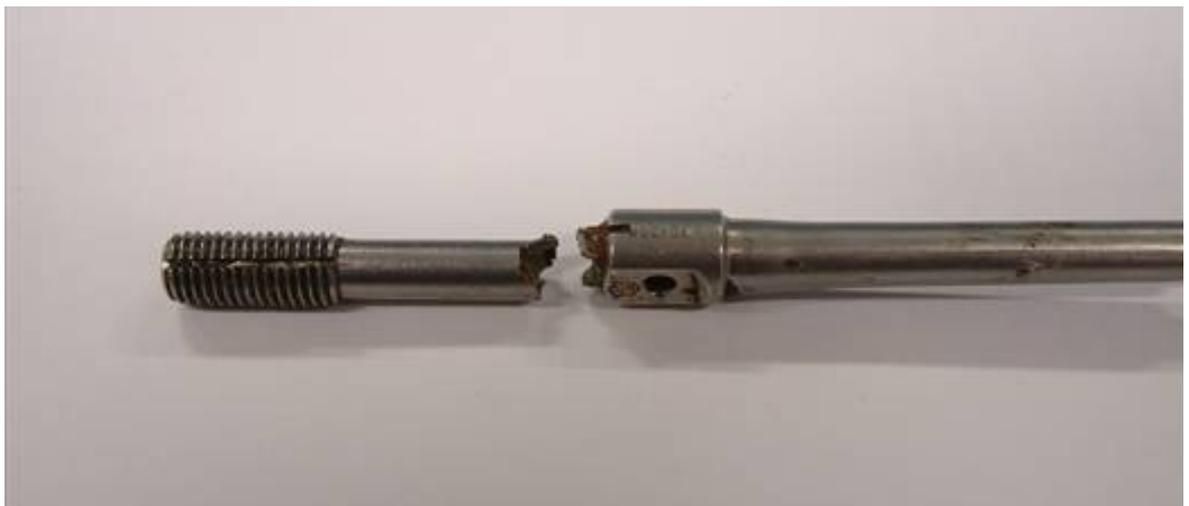
Reports of flight control cable terminal fitting separation failures continue to be received in Australia, New Zealand and in the United States. Failure of a flight control cable terminal can result in loss of control.

Investigations have revealed that the failed terminals had been in service for approximately 15 years or more and were typically identified by standard terminal fitting part numbers AN669, MS21260 and NAS650.

Figure 1 – Flight control cable terminal separation

- b. Retire all flight control cable assemblies with terminals made from stainless steel (SAE-AISI 303Se and SAE-AISI 304) including, but not limited to, terminals manufactured to MS20658 (AN658), MS20667 (AN667), MS20668 (AN668), MS21259 (AN666) and MS21260 (AN669 or NAS650), before reaching 15 years total time in service.

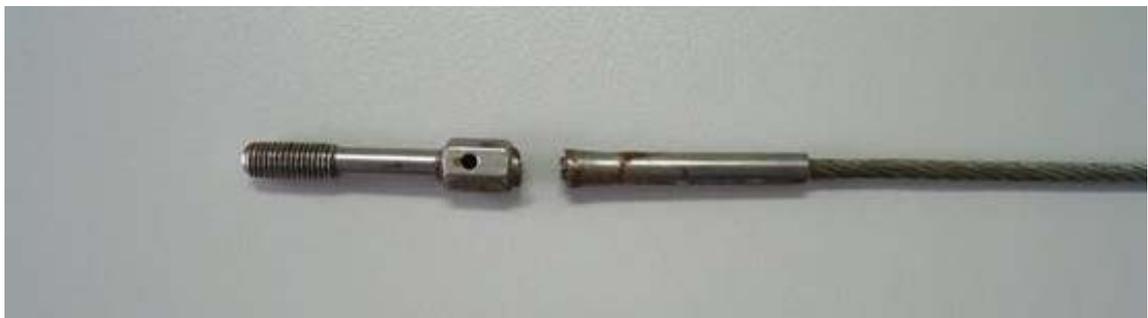
Terminal fitting separation as described in this AWB is due to chloride stress-corrosion cracking (CSCC) a form of intergranular cracking which does not provide clear visual clues to the full extent of the internal structural damage and can originate from within the terminal (See Figure 7).

This means that even very small corrosion pits, cracks or rust deposits on the surface of the terminal fitting may be indications that the terminal could be very close to failure.

Figure 2 – Flight control cable terminal separation. Note that the failure has occurred outside the safety lockwire hole.

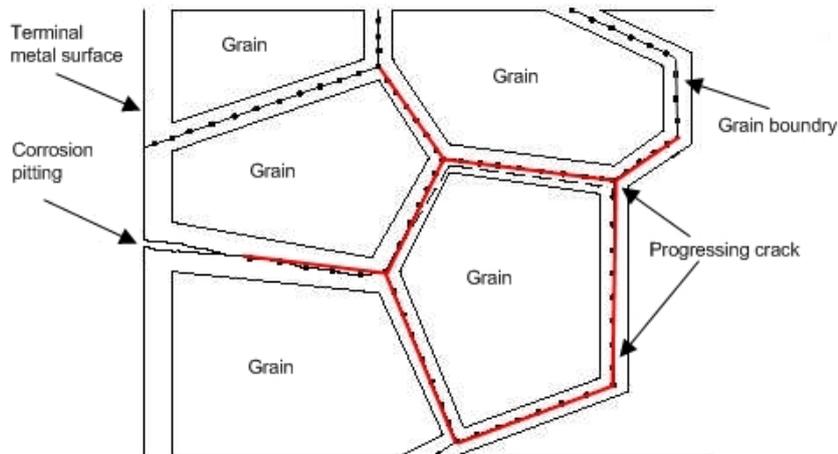
Figure 3 - Intergranular Corrosion Cracking

The sketch above (Figure 3) shows small surface pitting can be evidence of advanced intergranular corrosion. Rusty stain deposits, when removed usually reveal areas of small pitting.

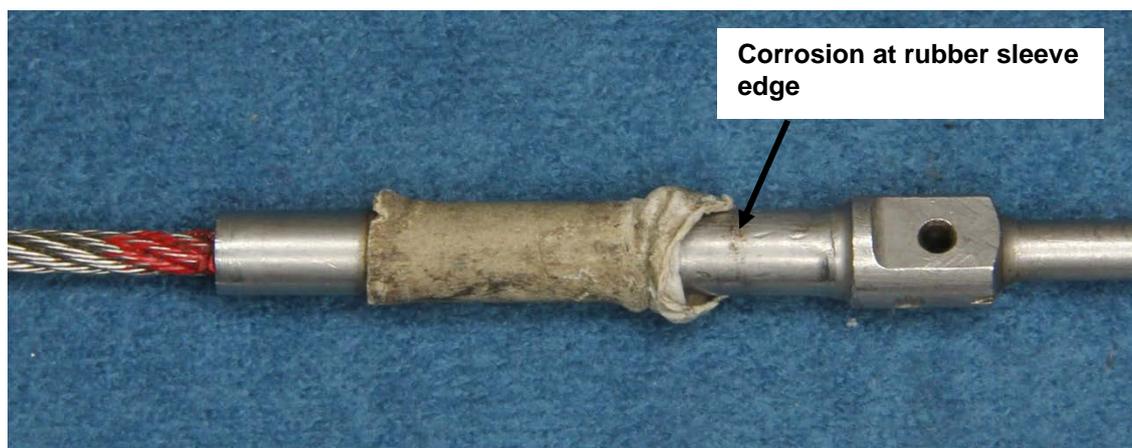
Corrosion pitting has been found under the rubber sleeves and tape wrapped around the terminal to provide part number identification. During an inspection corrosion was detected at the edge of a rubber sleeve, as shown in Figures 4 and 5, below. When the sleeve was pulled back, the maintainer found severe corrosion under the rubber sleeve. A total of four flap control cable terminals were corroded in one aircraft. These flap control terminals had been in service for approximately 13 years.

Figure 4 - Control cable terminal section covered in rubber sleeve (Source ATSB Investigation AE-2012-028 Final – 9 April 2013).

- a. Visually inspect control cable terminals, irrespective of the total time in service, for the presence of any rubber sleeves, tape or any other material/substance (other than lockwire) that may prevent the chromic oxide film from forming. Such material should be removed and the terminal inspected for corrosion, particularly in the area that was covered by the rubber sleeve or tape. Any sign of corrosion is cause for rejection.

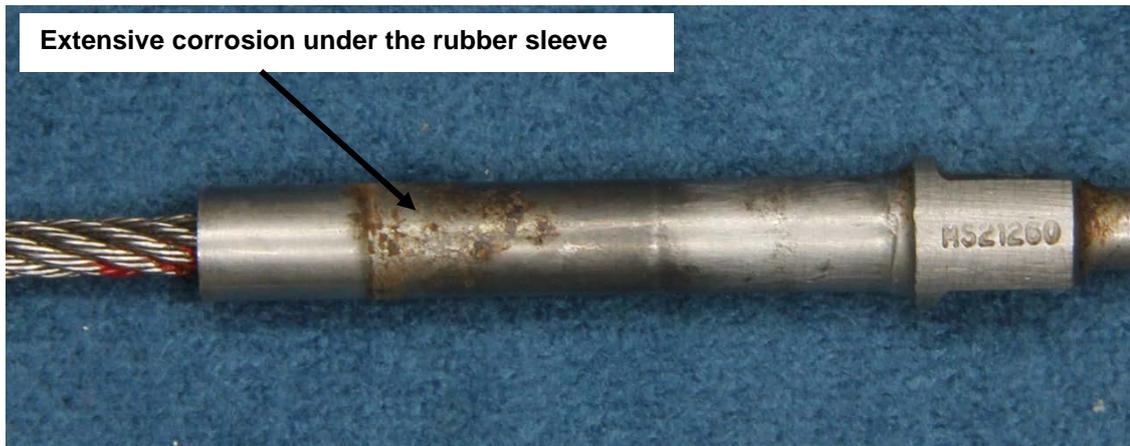
Figure 5 - Control cable terminal shown in figure 5, with the rubber sleeve removed. Note extensive corrosion. (Source: ATSB Investigation AE-2012-028 Final – 9 April 2013).

Stainless steel's resistance to corrosion is primarily attributed to the existence of a thin chromic oxide film which develops in the presence of oxygen in the atmosphere. Stainless steel must be in continual contact with oxygen in order to develop and maintain the integrity of the film. A breakdown in an area of the oxide film due to lack of oxygen can allow localised corrosion cells to form. The presence of the rubber sleeves or tape over the terminals prevented the chromic oxide film to form, allowing corrosion to develop.

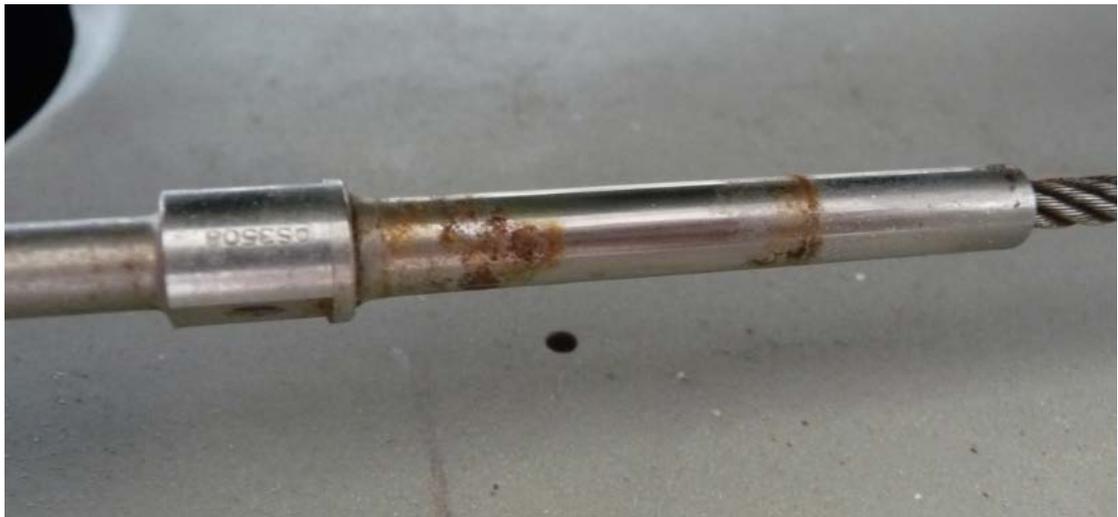
The corrosion on a rudder cable terminal in Figure 6 was also discovered under rubber tubing sleeve installed by the manufacturer. No less than eleven (11) cases of control cable terminal corrosion were discovered on the one aircraft. The cables had been in service for less than 10 years.

Fig. 6. Source: CASA SDR. One of the eleven corroded primary flight control cables on the single aircraft. Corrosion originated from under the rubber sleeve.

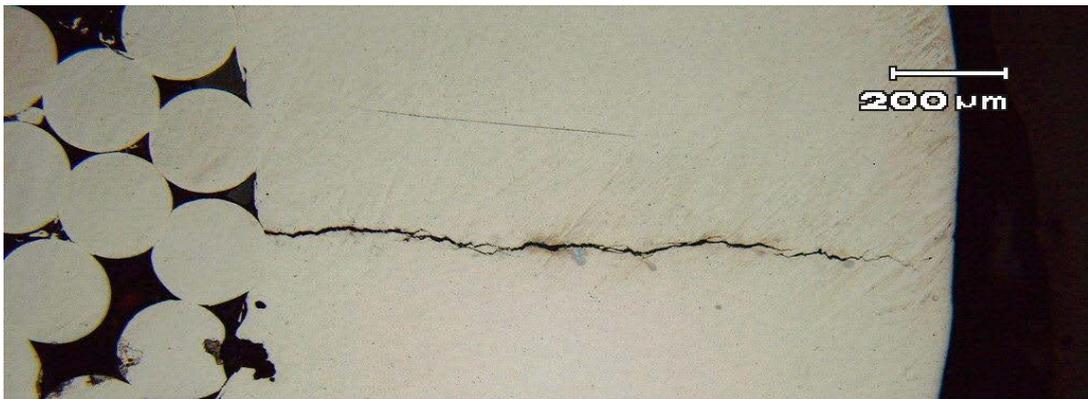
A formal investigation by the New Zealand Civil Aviation Authority into a report of stainless steel control cable terminal corrosion, discovered evidence of CSCC originating from the inside of the terminal. Since such cracking can originate from within the terminal, external surface clues such as pitting or cracking may not provide an adequate basis for determining serviceability. This introduces the possibility that a terminal may be close to failure and may even fail with little or no surface indication.

Figure 7 - Internal corrosion - flight control terminal sleeve.

The crack shown in Figure 7 originates from the cable wires (on the left of the picture) swaged in the terminal sleeve. The corrosion has not yet reached the outside surface of the terminal sleeve.
