Cessna 206, 207 and 210 – cracking of nose gear tunnel wall

AWB 53-003 Issue : 1
Date : 14 March 2007

AIRWORTHINESS BULLETIN

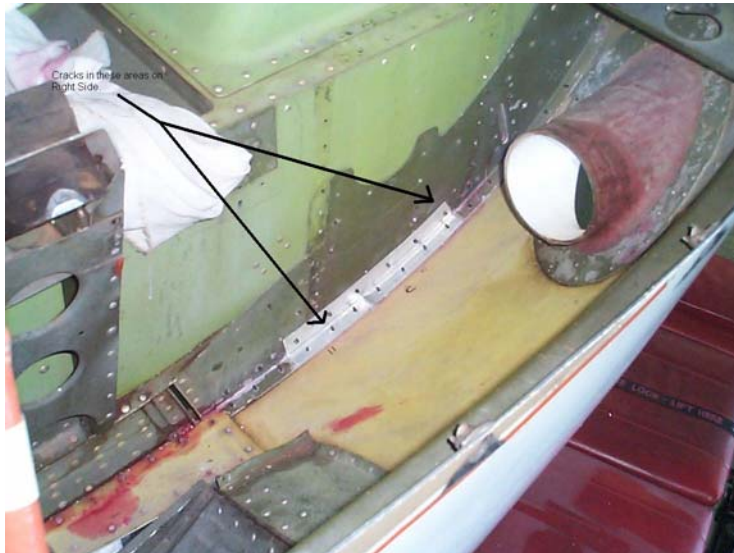
Several SDRs have been submitted reporting that cracks have been found in this area, the left and right nose gear tunnel walls at the lower end of the forward engine shock mount assembly and in the stiffeners (Part Number 1213195-1 and -2).

Cracks in the left tunnel wall are relatively easy to see with a torch and mirror while cracks in the right tunnel are more difficult to see because they are covered by the oil cooler.

- It is recommended that operators of these aircraft type and models note this problem.
- Each operator should advise their respective maintenance personnel of the requirement to thoroughly clean the left and right tunnel area and then inspect the area thoroughly; this may involve removal of the oil cooler to facilitate easy access.

- It is recommended that this inspection be carried out at 500 hrs TIS and then at each periodic inspection thereafter after incorporation of STC SA000796AT.

- It is recommended that if cracks are found the operator will need the area repaired via a CAR 35 approved repair scheme.
- Any operator contemplating incorporation of STC SA 000796AT be aware that in many instances where this STC has been incorporated, that cracks have been reported at around 500 hrs TIS since incorporation and that the STC needs to be modified with additional strengthening to prevent this problem.

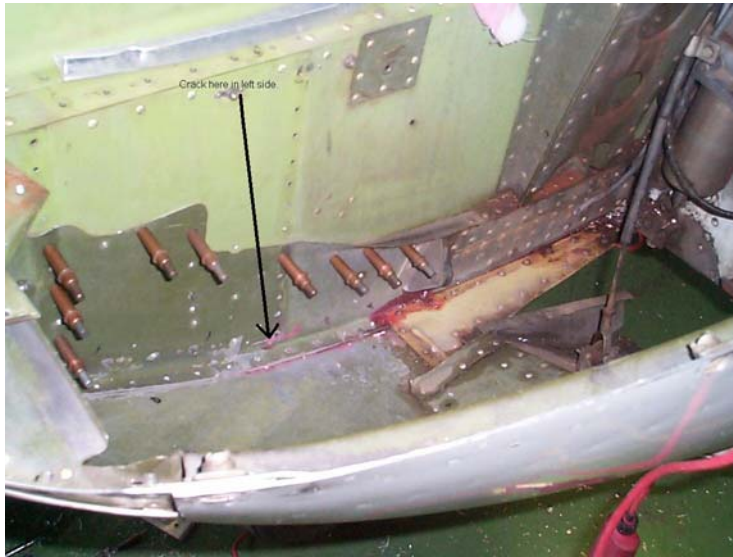
The entire area is covered by dirt and oil during operation making a visual inspection of the area very difficult.

The SDRs submitted indicate that the STC (SA00796AT) does not give adequate strength to the area.
