## Cessna 172 Elevator Corrosion

AWB 53-006 Issue : 1  
Date : 10 August 2007

# AIRWORTHINESS BULLETIN

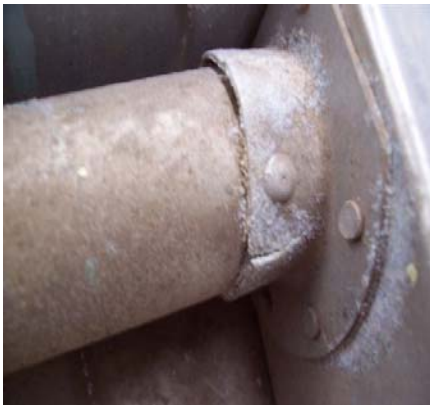
Corrosion has recently been detected in the elevator torque tube adaptor on several Cessna 172N model aircraft. This corrosion is hard to see during normal inspection. It is likely that this corrosion will be present in other Cessna 172 series aircraft up to and including the 172N, and Cessna 188 series aircraft. These aircraft are getting old and additional corrosion inspections may be required.

Corrosion in a elevator torque tube adapter on a CESSNA 172N

- All Registered Operators of Cessna 172 to 172N and Cessna 188 aircraft;
  - Have the Elevator Torque Tube Adaptors inspected as soon as possible. This will require the use of a bright light and a mirror, and possibly removal of the elevator assemblies.
  - If any corrosion is detected the elevator should be removed and the corrosion be removed in accordance with an approved repair scheme.

- The area of the elevator torque tube adaptors should be inspected at every periodic inspection.
- Amend the maintenance schedule to include any Cessna Continuing Airworthiness Program (CAP), Corrosion Prevention and Control Program (CPCP), and Supplemental Inspection Document (SID) when they become available.
