Piper PA28, PA32, PA34, and PA44 Series -
Structural Corrosion / Wing Trailing Edge
Flaps

AWB 57-014 **Issue** : 1
Date : 9 October 2014

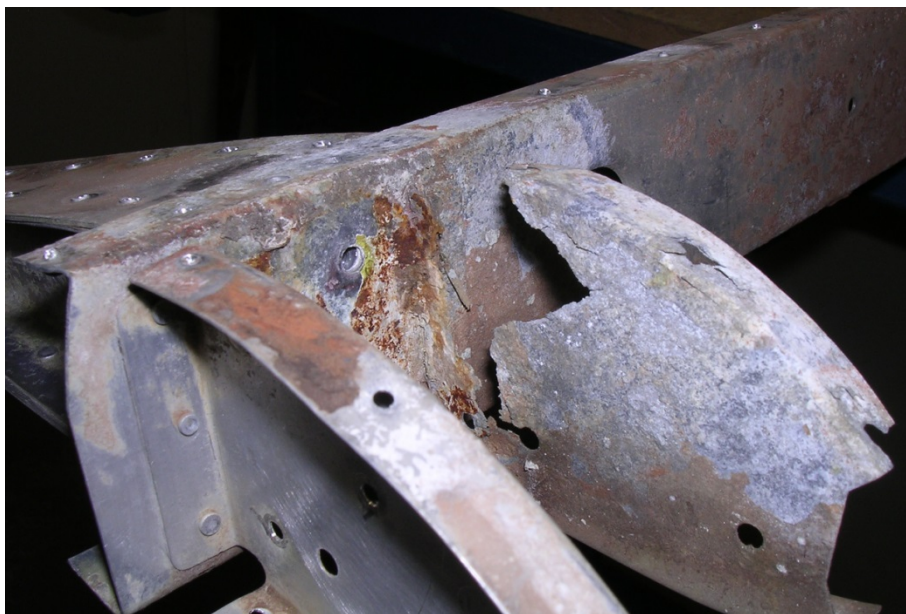
Wing flap nose ribs PN 62328-00 and PN 62328-01 are frequently found badly corroded in the enclosed flap leading edge area. In one case, removal of the leading edge revealed heavy corrosion in all six nose ribs, three of which had separated from the spar. The aluminium spar had been completely corroded through where attached to the steel centre hinge bracket (Figure1).

Figure 1. Typical flap nose rib and spar corrosion The steel hinge arm has been removed.

1. Conduct detailed inspections of the external and particularly the internal structure of the wing trailing edge flaps and attachment fittings for corrosion, missing rivets and other defects.
2. Such inspections should be completed at the frequencies detailed in the aircrafts' approved maintenance program or at the periods stated in the Piper maintenance data.
3. Where the manufacturer does not provide access for an adequate internal inspection of the flap structure, consider CASR Part 21M engineering approval for the installation of access holes / panels, as required.
4. Consider CASA AWB 02-042 'The Use of moisture Corrosion Inhibiting Compounds and Effects on Aircraft Structural Joints'.
5. Replace or repair corroded structure in accordance with approved data.

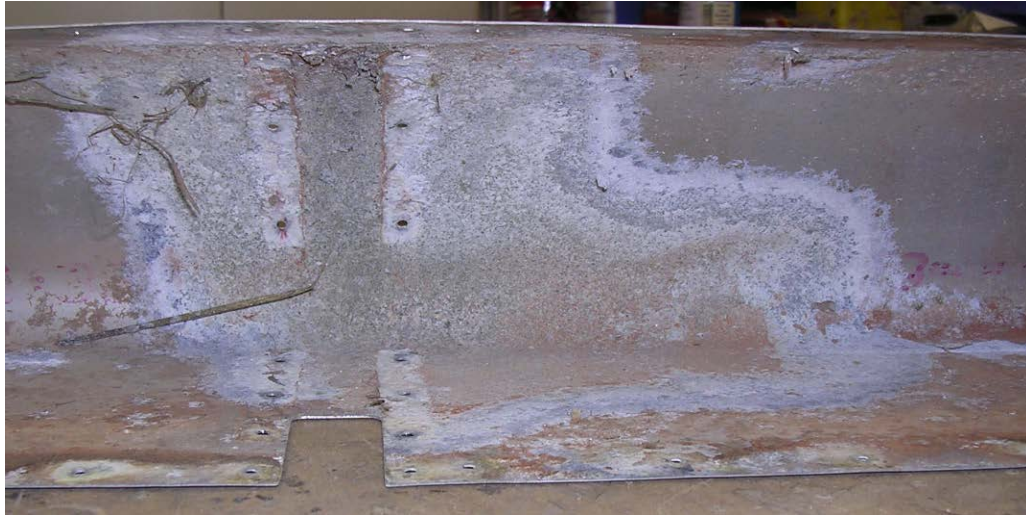
While periodic inspections of the internal flap structure using borescopes etc. can detect corrosion, the true extent of any damage can only be fully appreciated when the skin is removed (Figure 2).

Figure 2. Removed flap skin showing extensive flap nose skin corrosion.

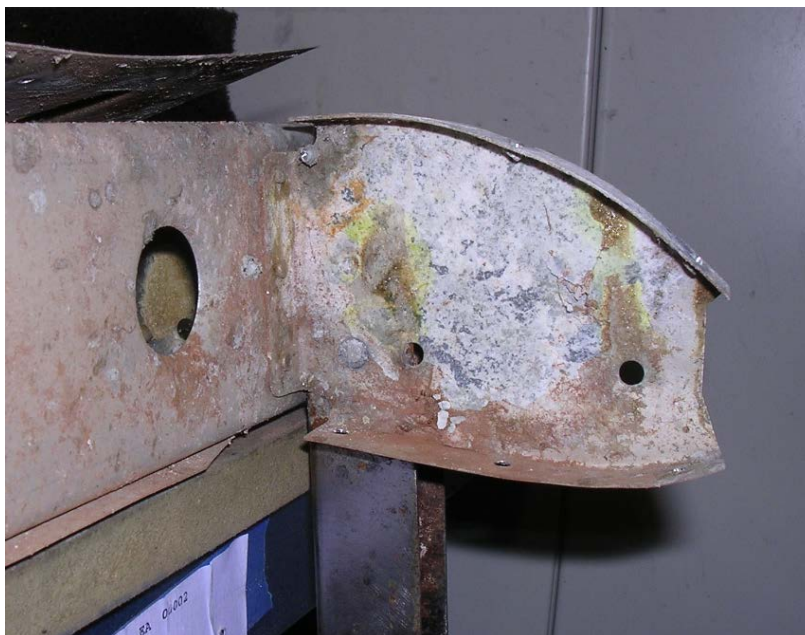
An external inspection would not have likely detected the missing rivets and corrosion shown in Figure 3.

Figure 3. Missing rivets and rib corrosion.

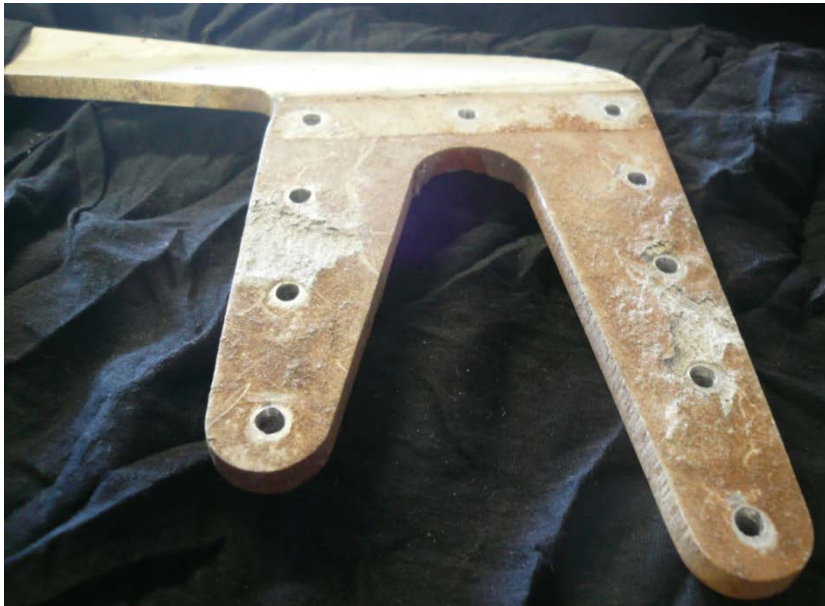
The aluminium wing flap attachment hinge/hanger brackets have been found to contain severe exfoliation corrosion on the exposed surface of the bracket (inside the wing), accompanied by missing rivet head/tails due to corrosion (Figure 4).

Figure 4. Corroded section of flap hanger bracket.

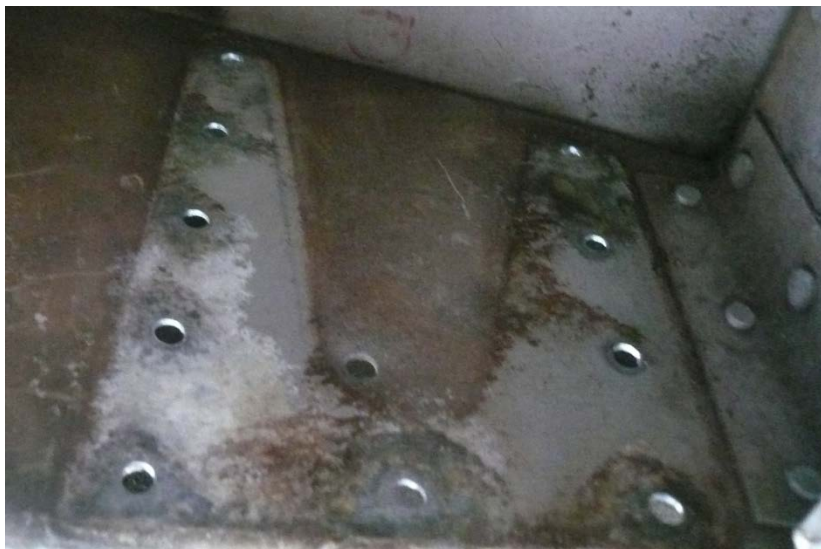
This intergranular corrosion weakens the strength of the bracket. When a corroded flap hanger bracket is detected, the wing structure underneath the bracket could also be expected to be damaged from corrosion (Figure 5).

Figure 5. Corroded wing structure under the flap hanger bracket.
