Piper Seneca PA-34-200 Propeller Damper

AWB 61-010 Issue : 1
Date : 19 April 2013

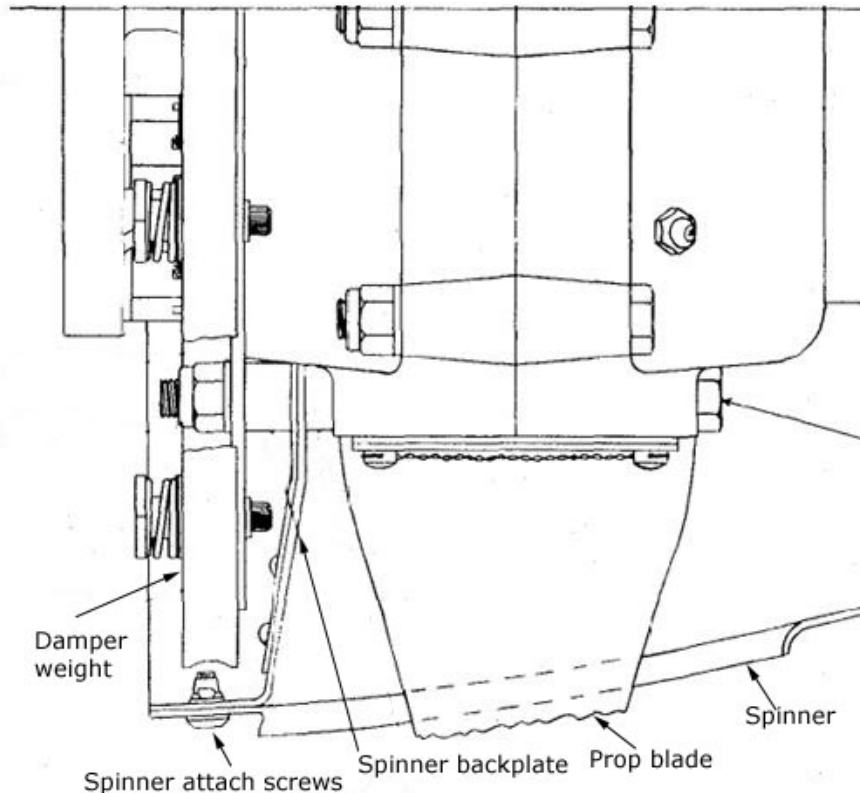
Fig. 1. Propeller and vibration damper assembly. Note the location of the spinner attachment screws and how close the ends of the spinner attachment screws are to the damper weight.

1. Screw-end marks on the outer face of the damper assembly. These marks are due to the ends of spinner attachment screws contacting the weight. If the spinner attachment screws are too long they contact the outer face of the damper weight and restrict or stop damper movement.

Restricting damper motion will affect the vibration attenuation function of the damper assembly resulting in increased engine/propeller vibrations and possible propeller/engine fatigue damage. It is also possible that overlong screws could lock the damper to one side of the propeller hub thus amplifying the propeller vibration level.

1. There is adequate clearance between the spinner attachment screw ends and the damper assembly. The correct attachment screws to hold the spinner in place when a propeller damper is fitted are MS35207-263 pan head type, Piper P/N 411 532.
2. The damper assembly is overhauled at the same interval as the propeller.
