TCM Continental & Lycoming Engines:
Failure of Weld Repaired Crankcases

AWB 85-015 Issue : 1
Date : 19 April 2013

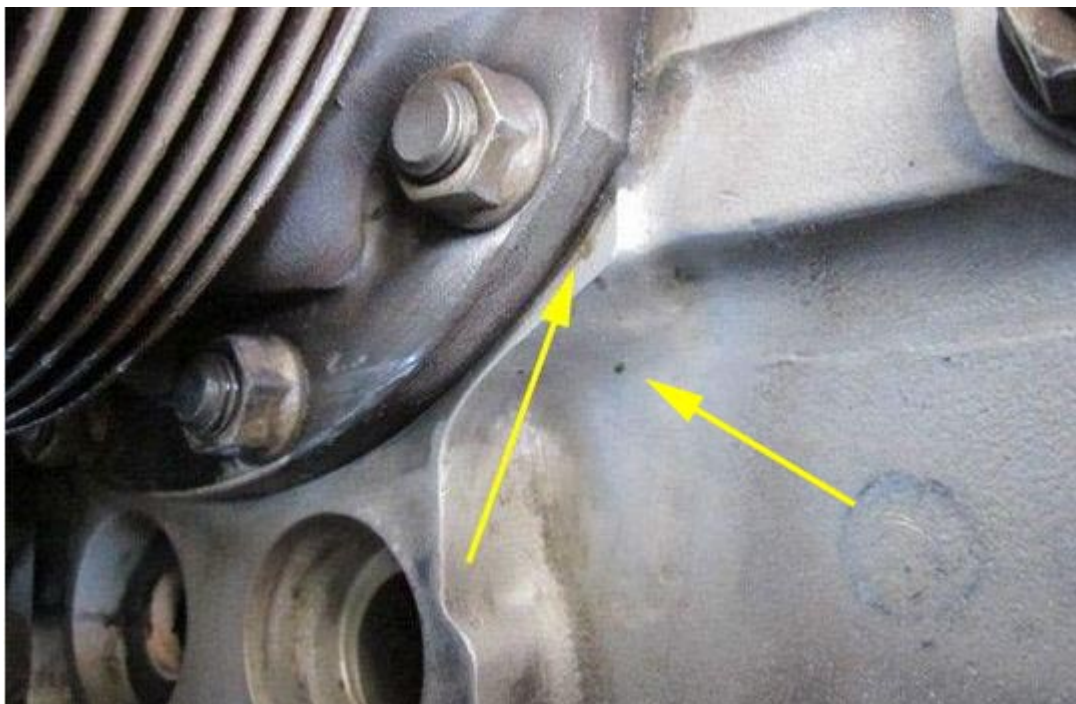
Figure 1 - Failure of a weld-repaired crankcase. Note crack from the cylinder base stud.

Factors such as inadequate pre-weld crack detection and cleaning, poor welding technique including the use of incorrect filler rod material and improper heat treatment prior to and following welding will result in an overall degradation of the parent crankcase material itself, including repaired areas that are weaker or softer than specification.

Weaker or softer crankcase material in the region of the cylinder retention studs can result in loss of stud torque due to the stud partially pulling out of the case and/or via crankcase cracking in the stud retention hole (See Figure 1).

2. After assembling an engine crankcase with weld repairs in the cylinder hold down area, consider implementing a torque check on cylinder hold-down nuts following the test run and again at 50 to 75 flight hours later. Consider removing from service any weld-repaired case with nuts which continue to move during the second check-torque.

3. Identify weld-repaired engines using technical documentation, visual inspection and/or engine case stampings. For those engines which have had an approved weld repair in the cylinder hold down area with less than 500 hours flight time, consider carrying out a torque check on all cylinder hold-down nuts within the next 100 hours of operation. Identify loose cylinder hold-down nuts in the aircraft engine log book and re-check at 50 to 75 flight hours later. Consider removing from service any weld-repaired case with nuts which continue to move during the second check-torque.
