All Fairchild Swearingen (M7 Aerospace) SA226 and SA227 aircraft.

Aileron Control Column Chains

AWB 27-016 Issue : 1

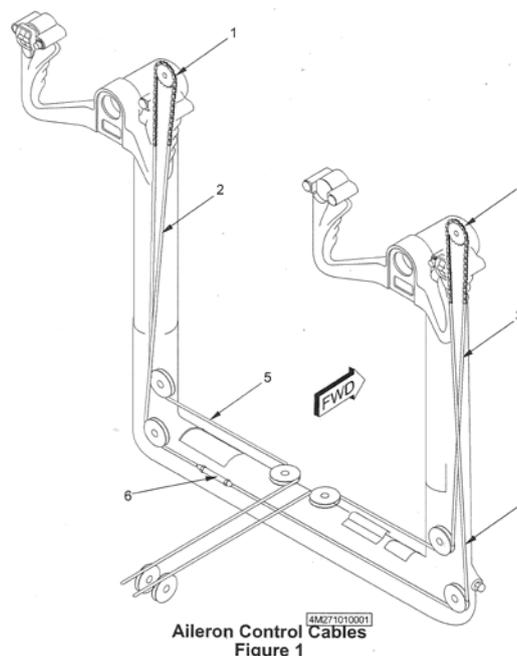
The Aircraft Maintenance Manual (AMM) in chapter 27-10-10 Aileron Control – Description and Operation states that the “aileron control cable is comprised of six cables joined together by a series of turnbuckles and chains to make one continuous cable system”. As an example, for the SA227-DC this can be found in section 27-10-10 page 1. (refer figure 1 below)

- 1) CASA recommends that operators review their maintenance program to ensure the control column chains of the aileron control cable system are scheduled to be inspected or replaced at the 10,000hrs threshold as required by the Airframe Airworthiness Limitations Manual (ST-UN-M003).

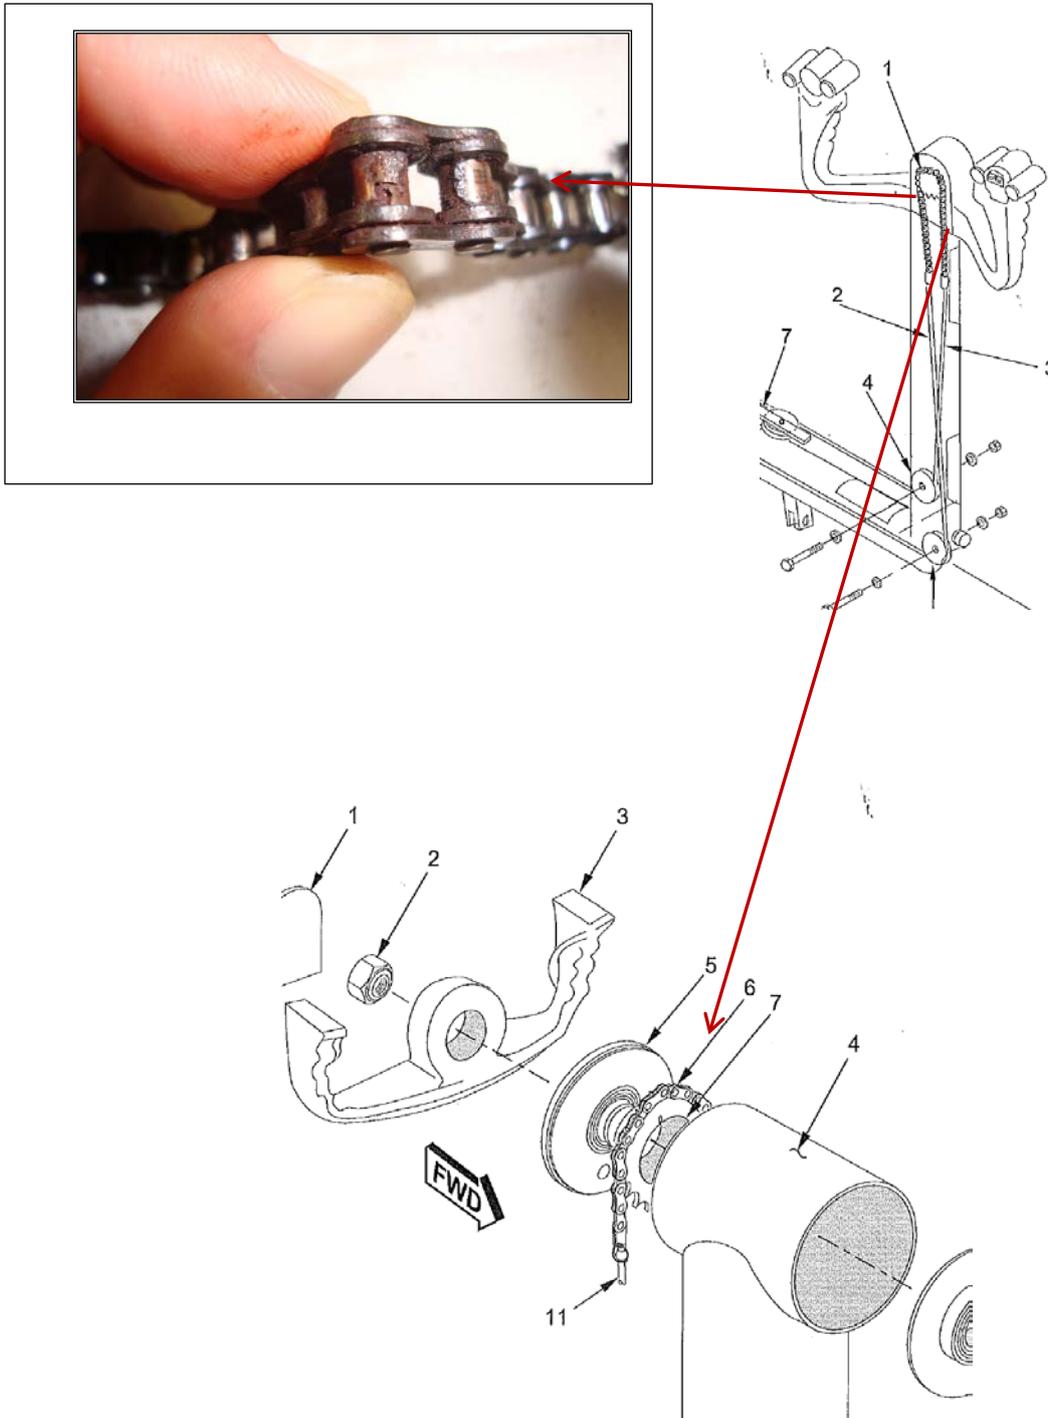
Figure 2

In one example provided to CASA, the control cable chain (item 1, Figure 1) was found to be severely corroded (refer image Figure 2). This chain had not been inspected or replaced per the AWL requirements as it was assumed by the operator that this item was not part of the cable and subsequently not affected by the AWL requirements.

- 3) Should the reviews conducted in 1) or 2) above show that maintenance has not been performed in accordance with the manufacturers requirements, CASA recommends operators contact the Type Certificate holder (M7 Aerospace) for guidance on their specific scenario.

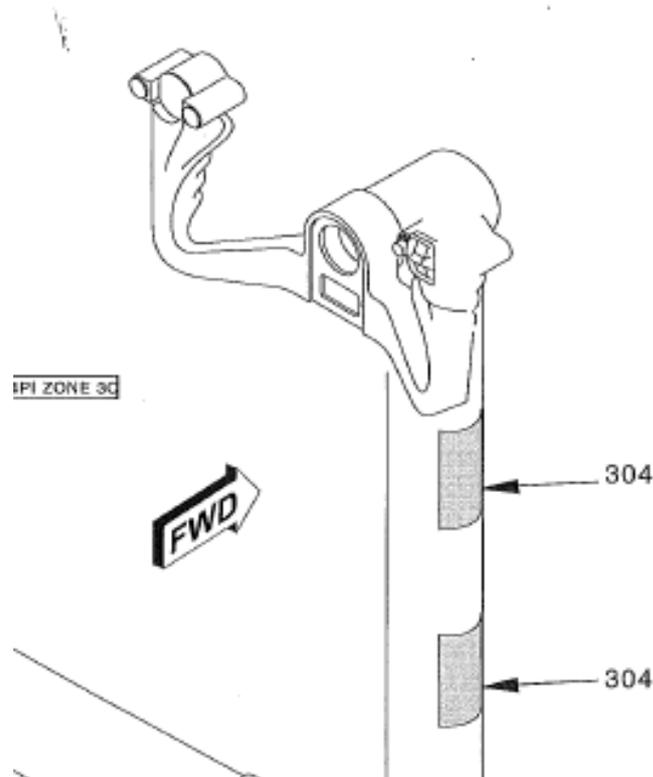
The manufacturers' maintenance schedule has in the detailed inspections for the flight compartment a task to “**Inspect control chain for corrosion, condition and security**” using access panels #303 (for L/H) and #304 (for R/H column), as in Figure 3 below. The interval for this task is at every Phase 5 check at an interval of 900hrs (in Phase 5 of the 6 Phase Check inspection schedule).

Investigation and experience has shown that this area inside the control column is difficult to inspect. The Type Certificate holder is aware of the difficulty to adequately inspect this area and is currently developing enhanced inspection requirements.

- 2) CASA recommends that operators review their maintenance program to ensure the task to inspect the control chain for corrosion, condition and security is adequate to perform a detailed inspection of all areas of the chain, including the rollers, links and pins typically located at the top of the column when the control yoke is in the neutral position.
